August 9, 2010

*Re: 6004 Muirlands Drive, La Jolla, Substantial Modifications & Changes--Lack Of Original Integrity*

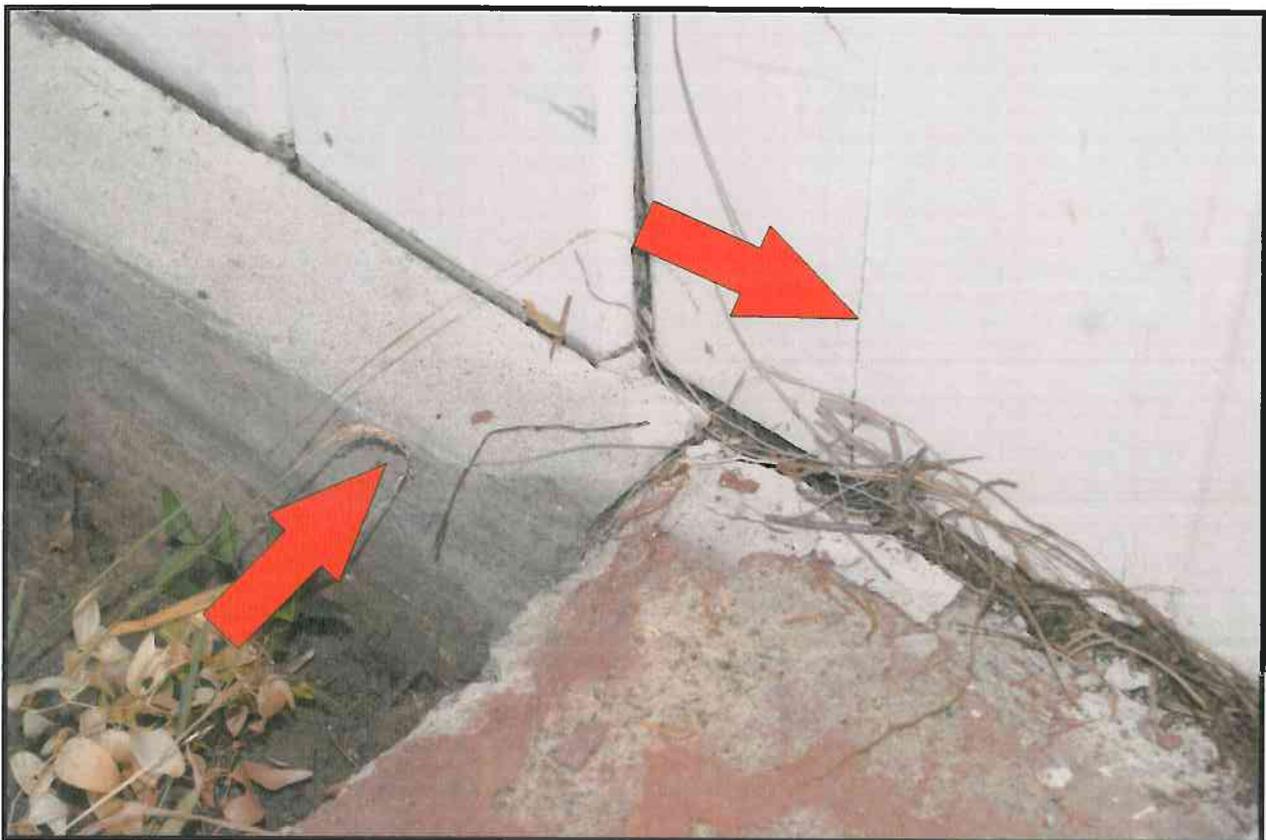
Photo D - Photo showing clear evidence of new foundation and vertical joint in T&G siding.

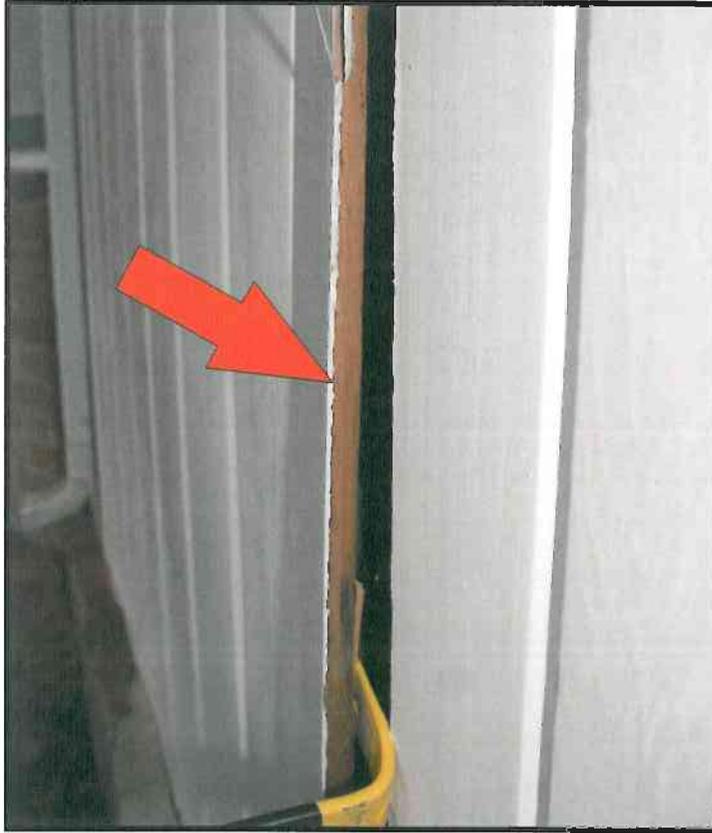
Photo E - Photo showing 45 degree mitre joint mid span on vertical T&G for replaced area of siding under window

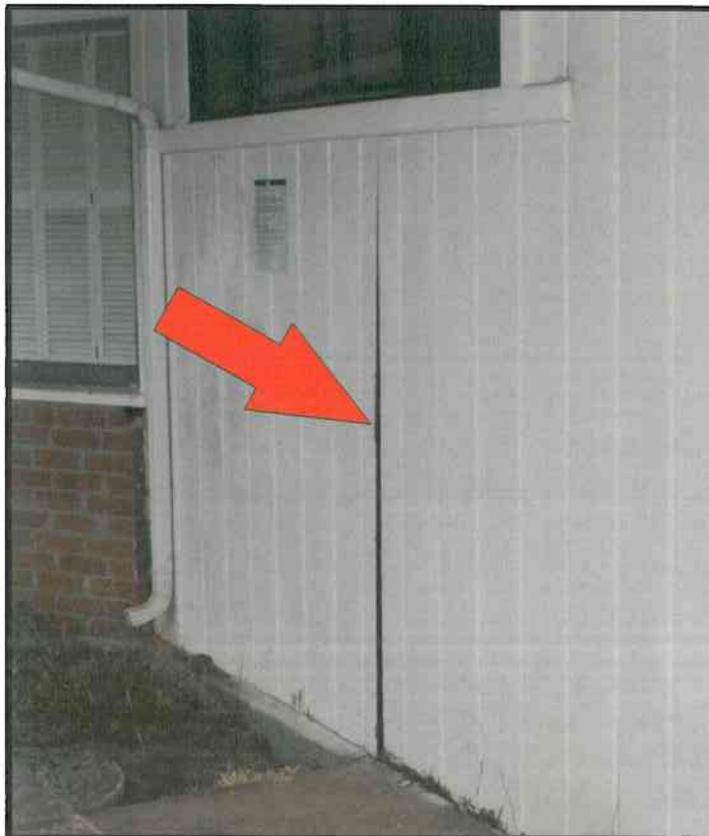
Photo F - Photo clearly showing splice joint in siding under replace window above new foundation

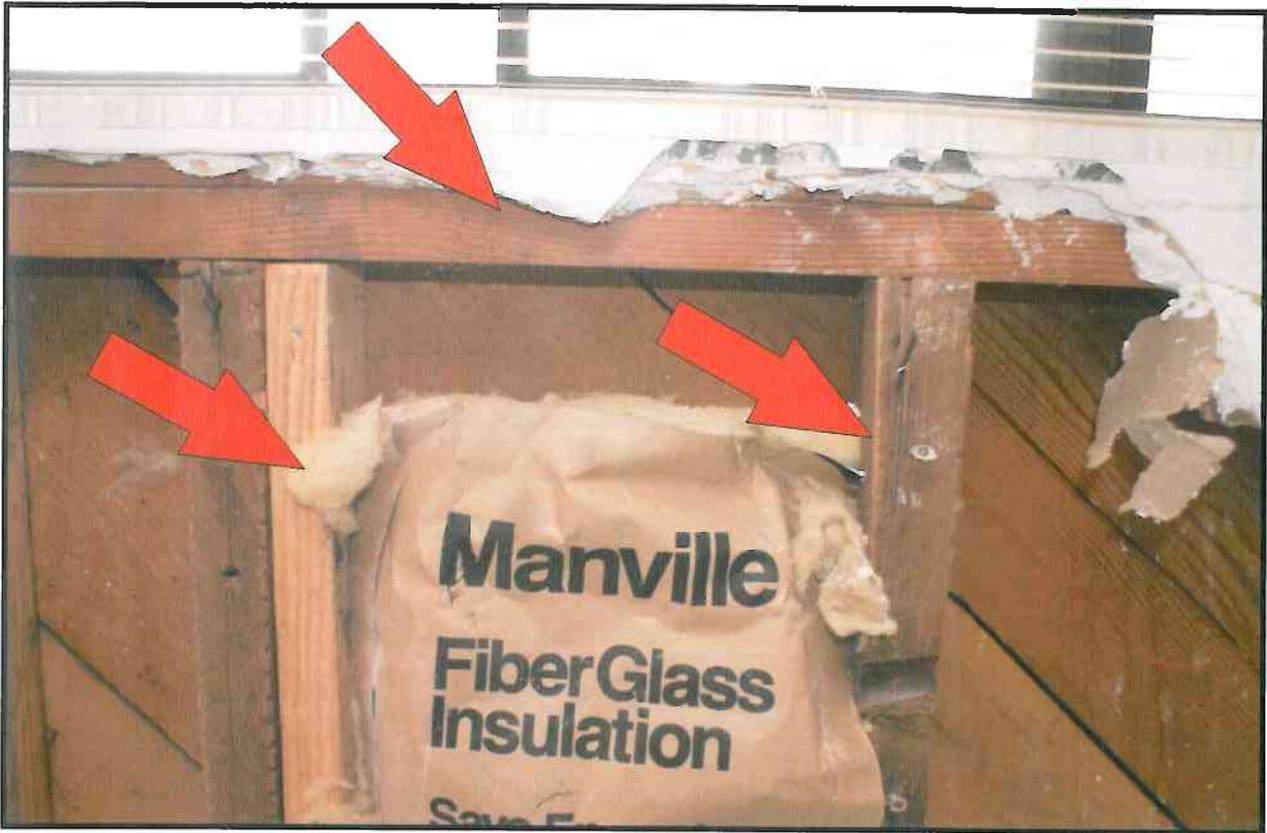
Photo G - Photo clearly showing at least 3 generations of framing lumber at replaced window

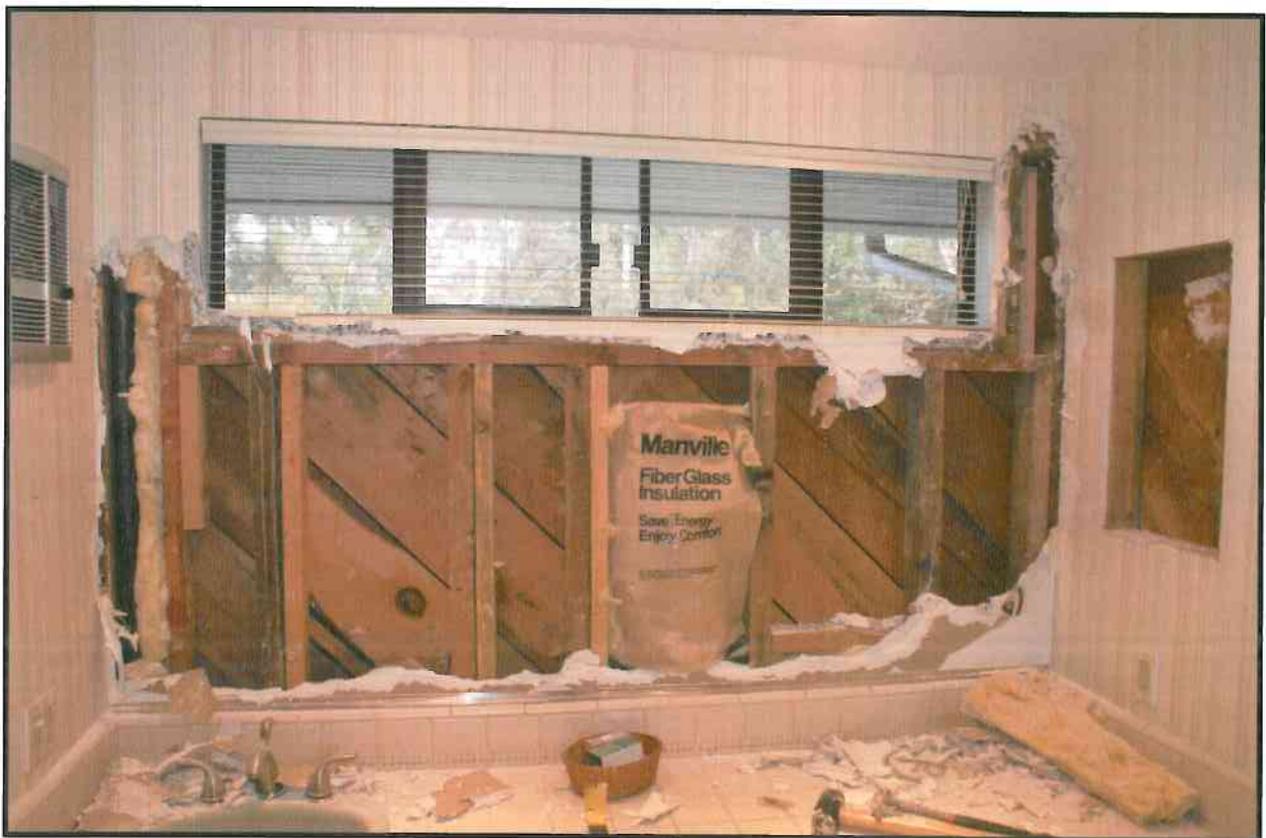
Photo H - Photo clearly showing complete re-framing at replaced window

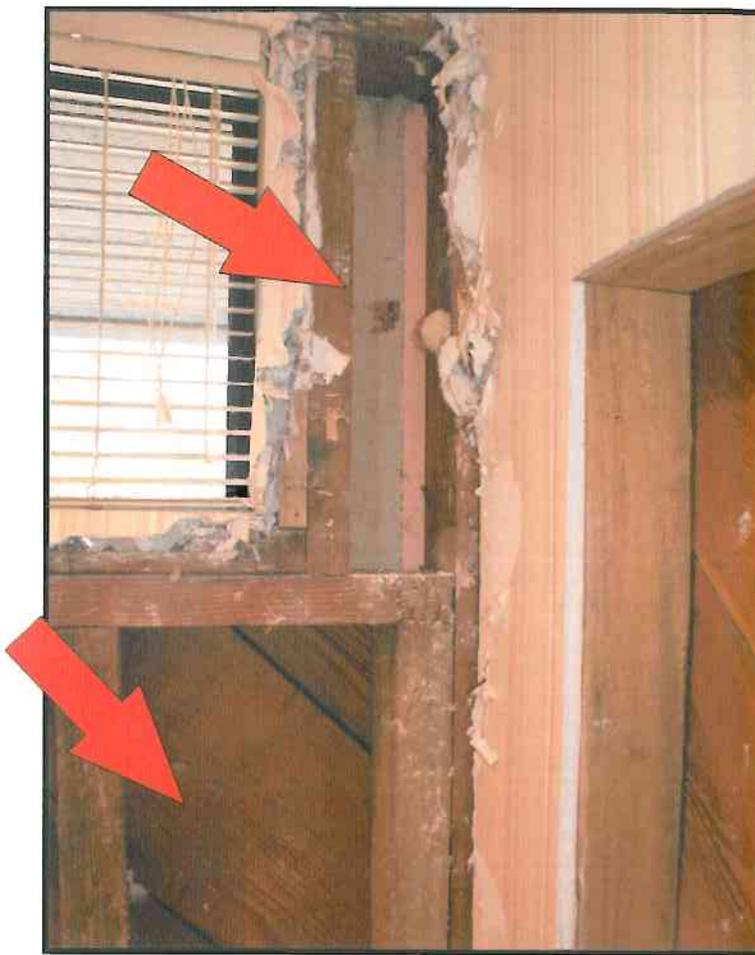
Photo I - Photo clearly showing re-framing of side and bottom at replaced window and new skip sheathing

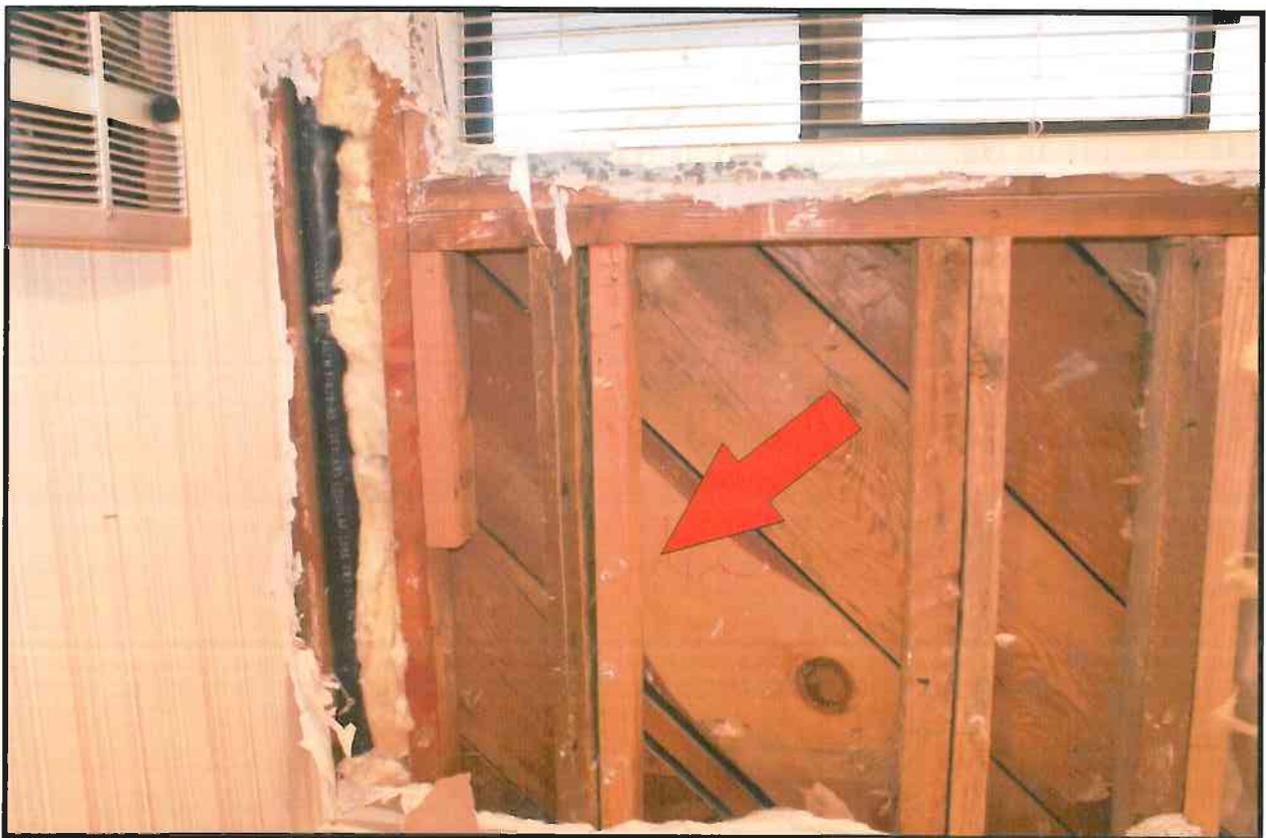
Photo J - Photo clearly showing re-framing of side and bottom at replaced window and new skip sheathing

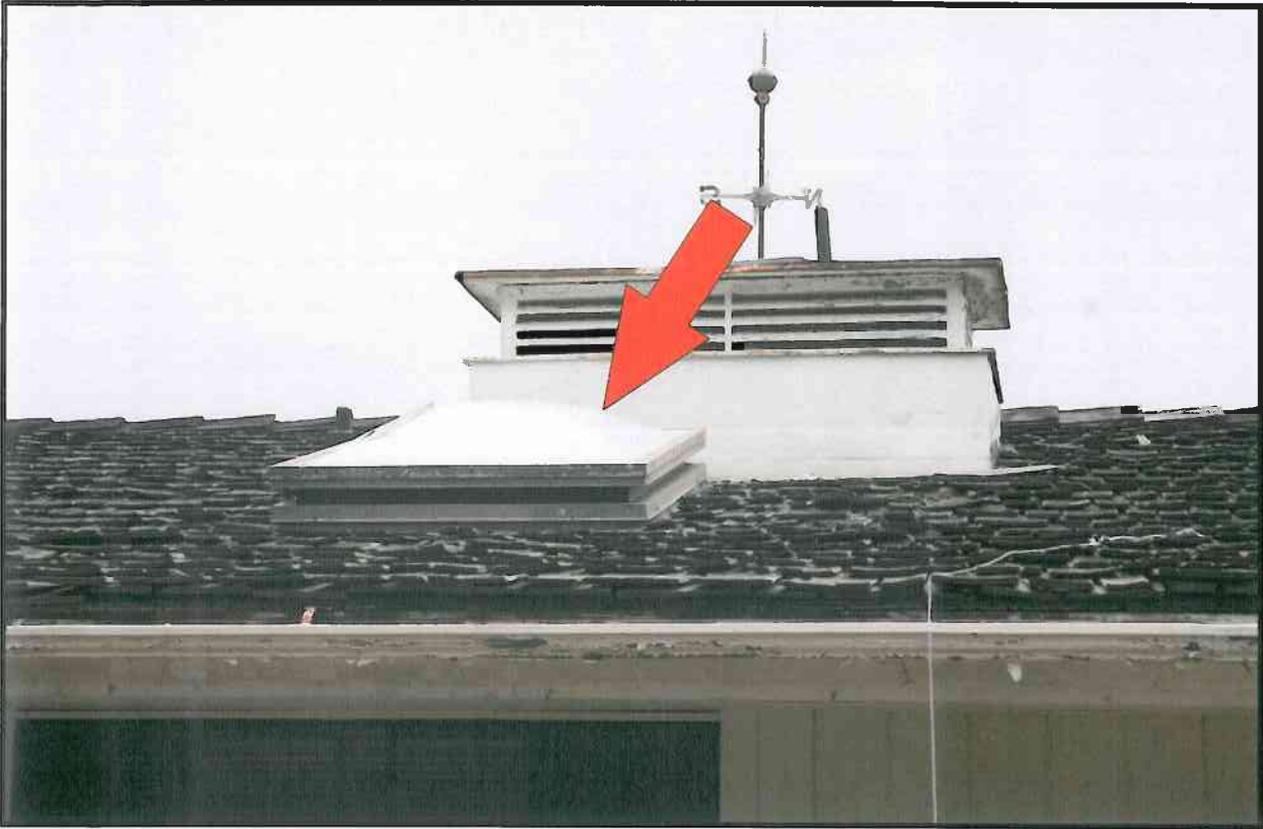
According to Mr. Haines’ signed Declaration, in or about 1978, a skylight was installed over the master bedroom bath “requiring modifications to the roof.” It is not known precisely how the roof itself was modified, but again, a large 48” by 48” white plastic domed skylight was installed

over the Master Bath footprint in plain view on the front facade further eroding the integrity of the façade. *(See presented photo for further background, Item #5, Photo A).*

Photo A - Photo showing 4 foot square plastic dome skylight installed at front facade over bathroom.

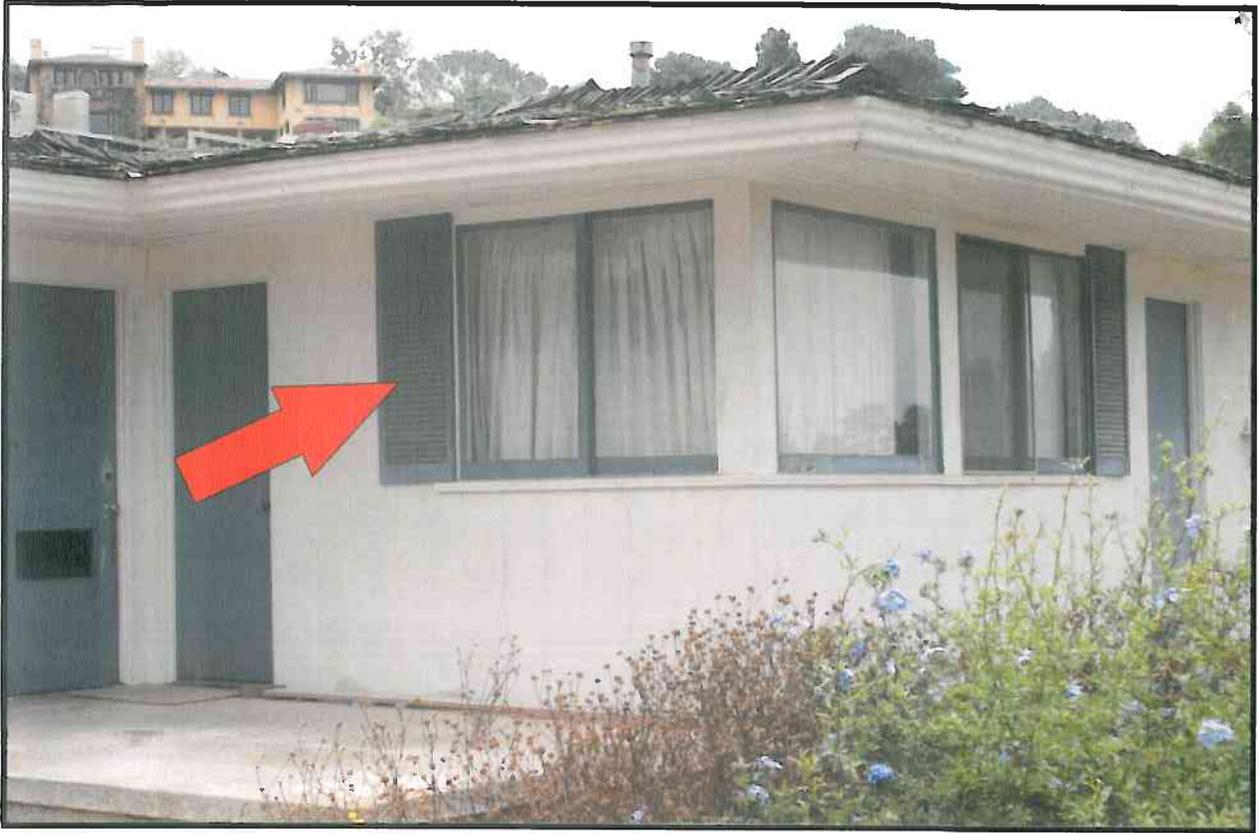
Further, inspection of the two wood shutters on the garage appears to have been added as an afterthought and may not be original to the design. From a design perspective, the "shutters" themselves are only located on one side of the windows and even the width of the shutter represents only approximately 30% of width of the window itself. In any event, the presence of a mere two wood shutters, completely out of scale and proportion, cannot be regarded as any meaningful character defining feature of the Custom Ranch style, as cited in the HRB Staff Report. *(See presented photo for further background, Item #6, Photo A).*

Photo A - Photo showing the only 2 shutters on the home which are not true shutters but tacky ornament.

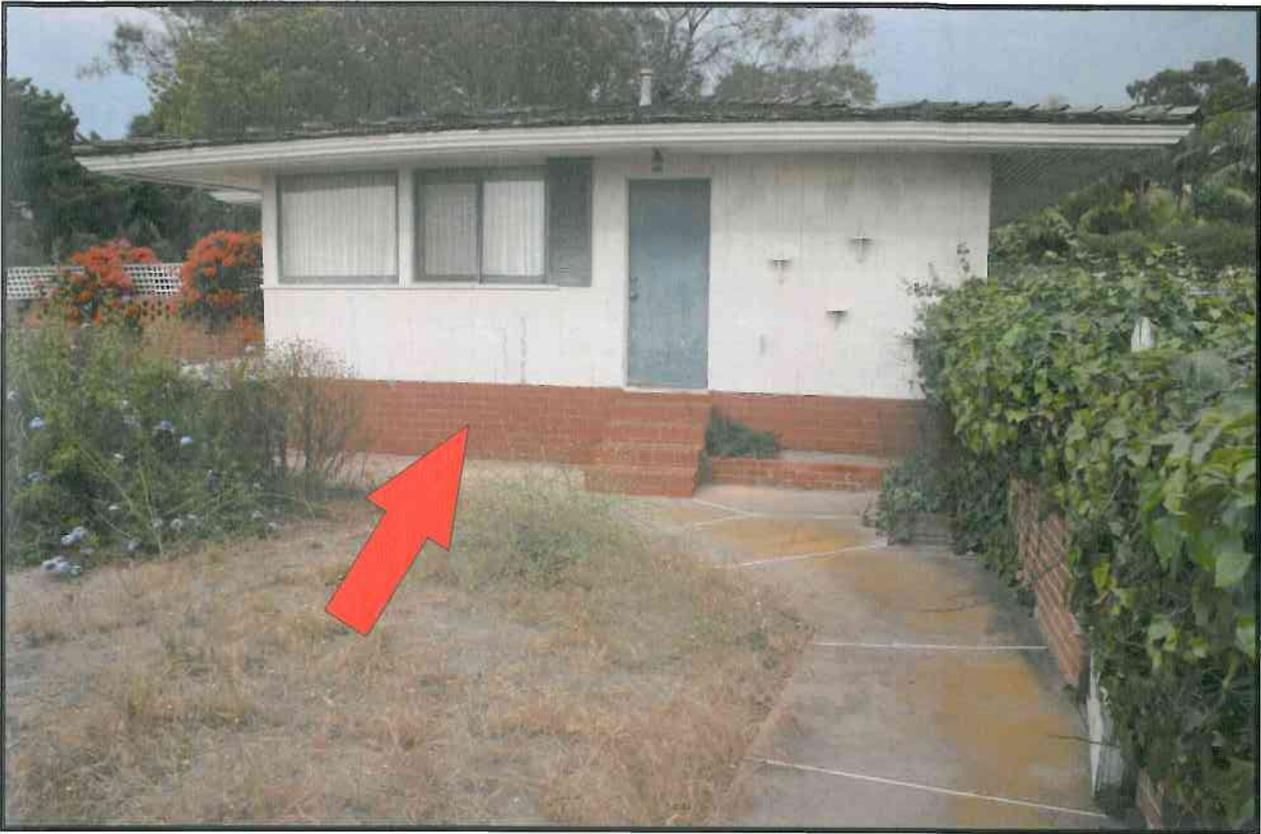
Recent extensive forensic examination and analysis has revealed the garage wall cladding is not brick at all. The brick on the entire garage facing the courtyard living spaces is, in fact, brick tile veneer. This was apparently added at some point in time and is not original based on the look, installation method and style of the ¼" thick tiles. *(See presented photos for further background, Item #7, Photos A-B).*

Photo A - Photo showing applied non-original "brick" veneer to garage

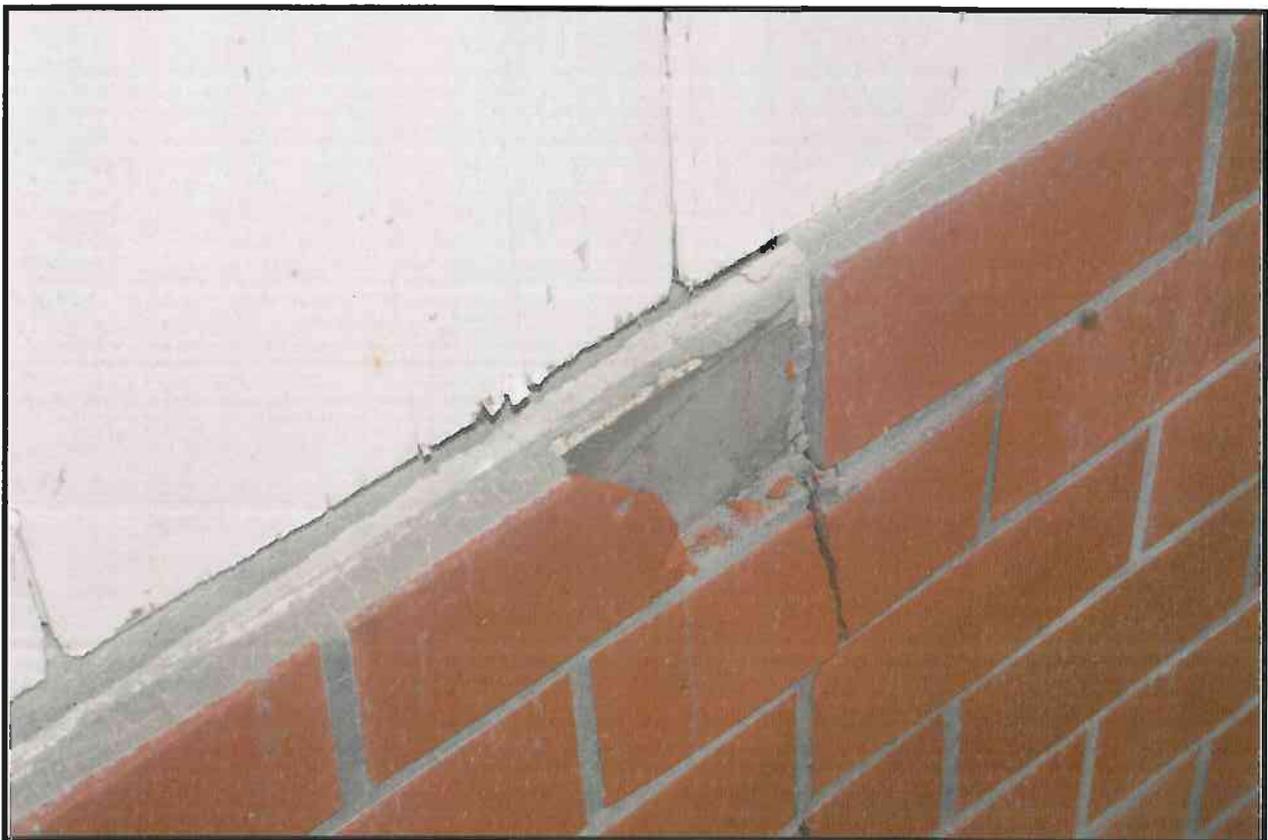
Photo B - Photo showing applied non-original "brick" veneer to garage.

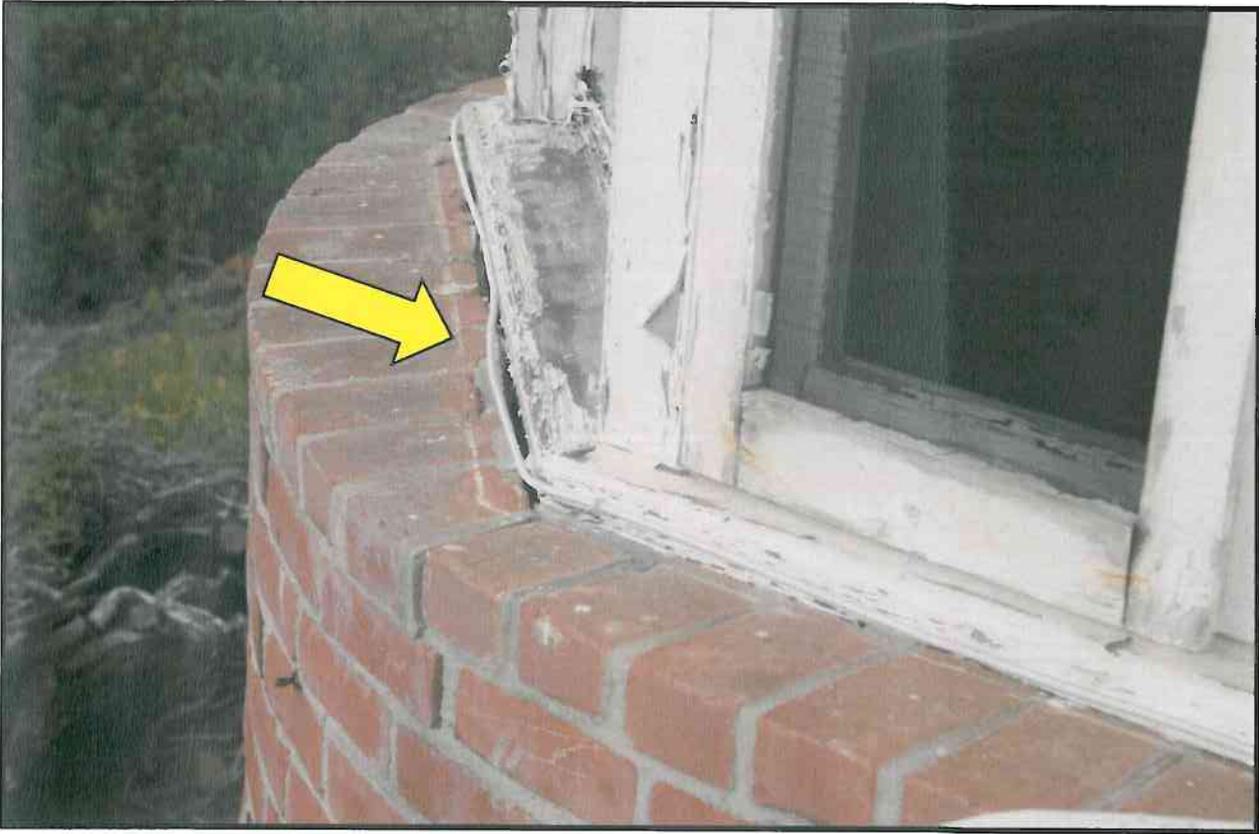
Recent extensive forensic examination and analysis has revealed Haines' statements to be true. From examination, the brick along two entire sections of the west façade have been totally replaced and are not original. Additionally, the replaced brick from the 1980s has now also extensively failed and has either cracked or significantly shifted and moved to a point where it is not structurally sound. *(See presented photos for further background, Item #8, Photos A-B).*

Photo A - Photo showing replaced brick at Kitchen area at rear facade.

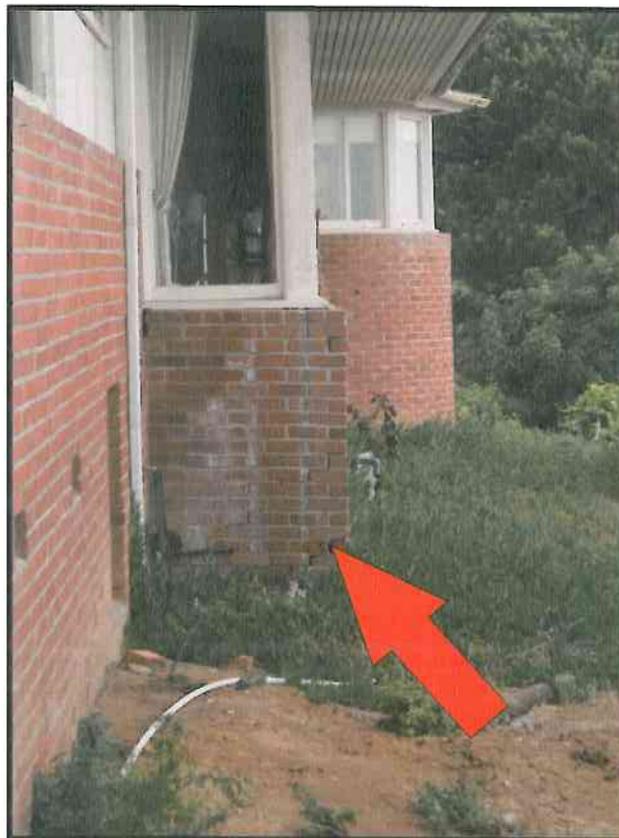
Photo B - Photo showing replaced brick at rear facade.

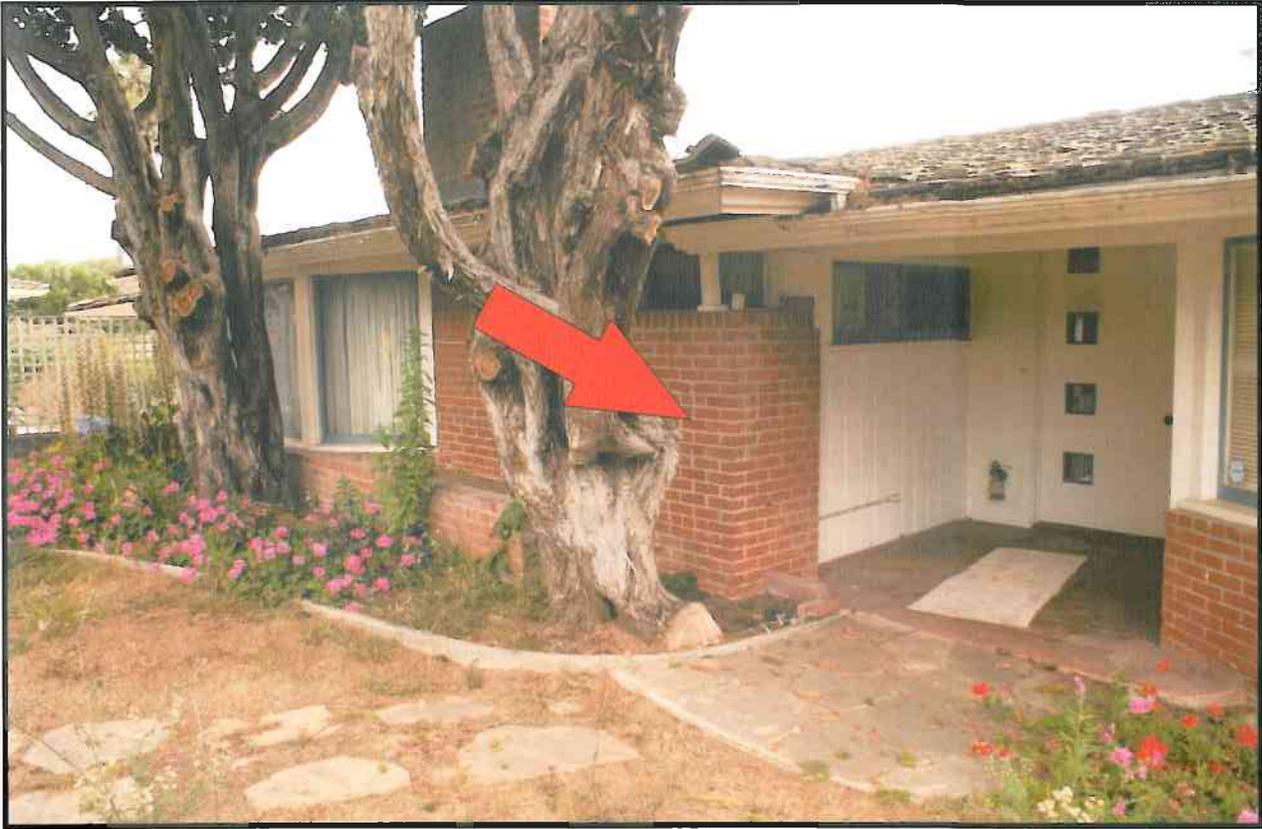
Additionally, and more importantly, in-depth inspection and forensic investigation further indicates that the brick exterior located along the main, front façade of the residence (east elevation), at the bay window and entry fireplace, are also not original. The brick is placed in a fashion with the vertical wood siding behind the brick cladding, indicating it was added after the fact. At a minimum, it reflects an incredibly poor method of construction and a method of attachment void of any craftsmanship. The addition of non-historic brick at these areas of the Property clearly does not represent a character defining feature as cited by the HRB Staff Report as “[e]xtensive use of...brick throughout the house.” *(See presented photos for further background, Item #9, Photos A-D).*

Photo A - Photo showing brick area adjacent to fireplace

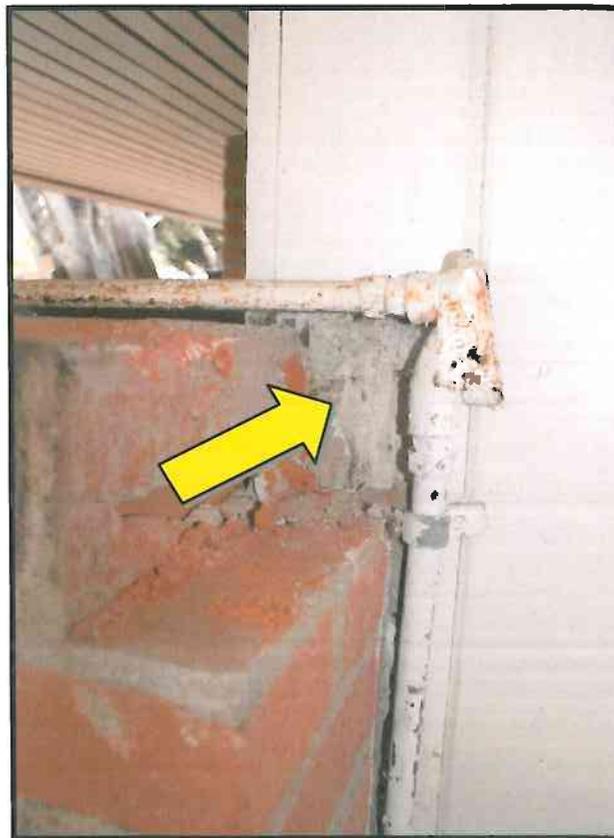
Photo B - Photo of brick at entry area showing wood siding behind the brick .

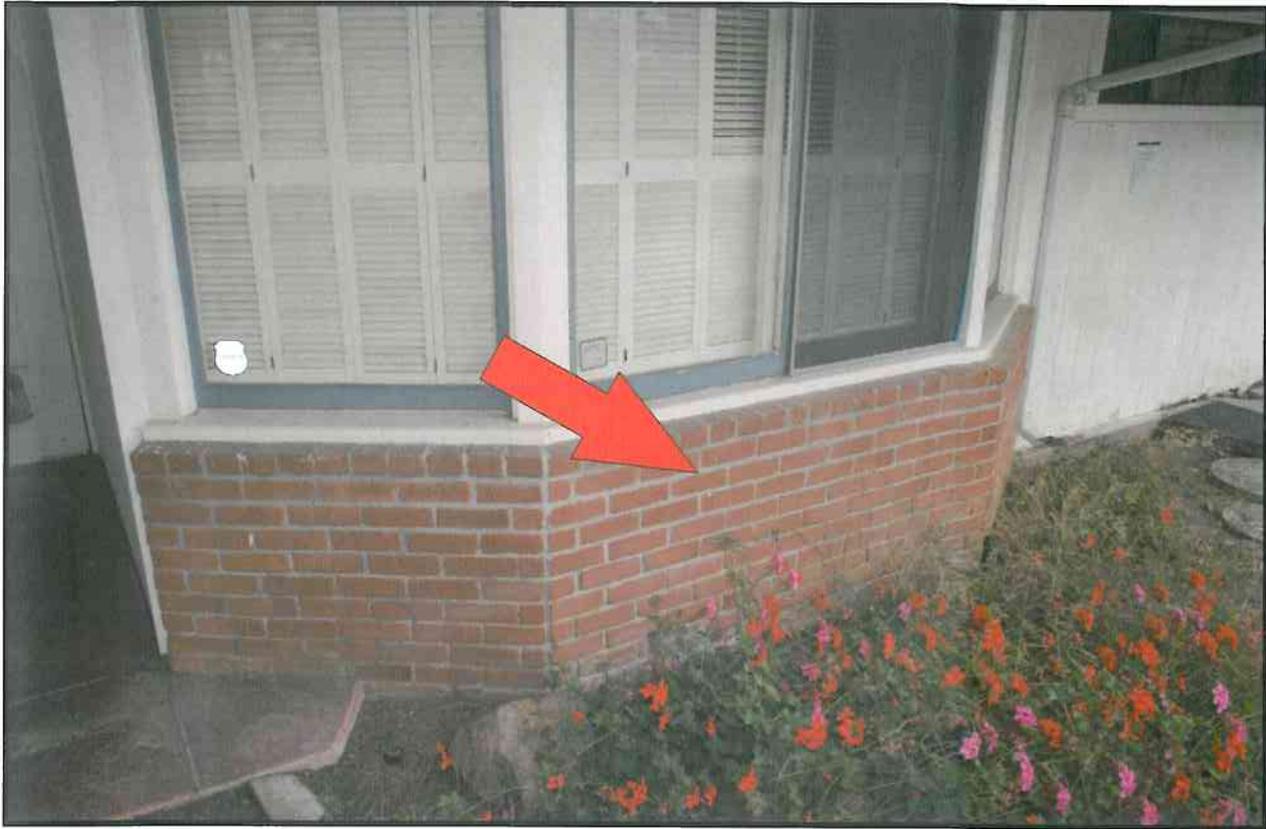
Photo C - Brick cladding at bay window on front facade

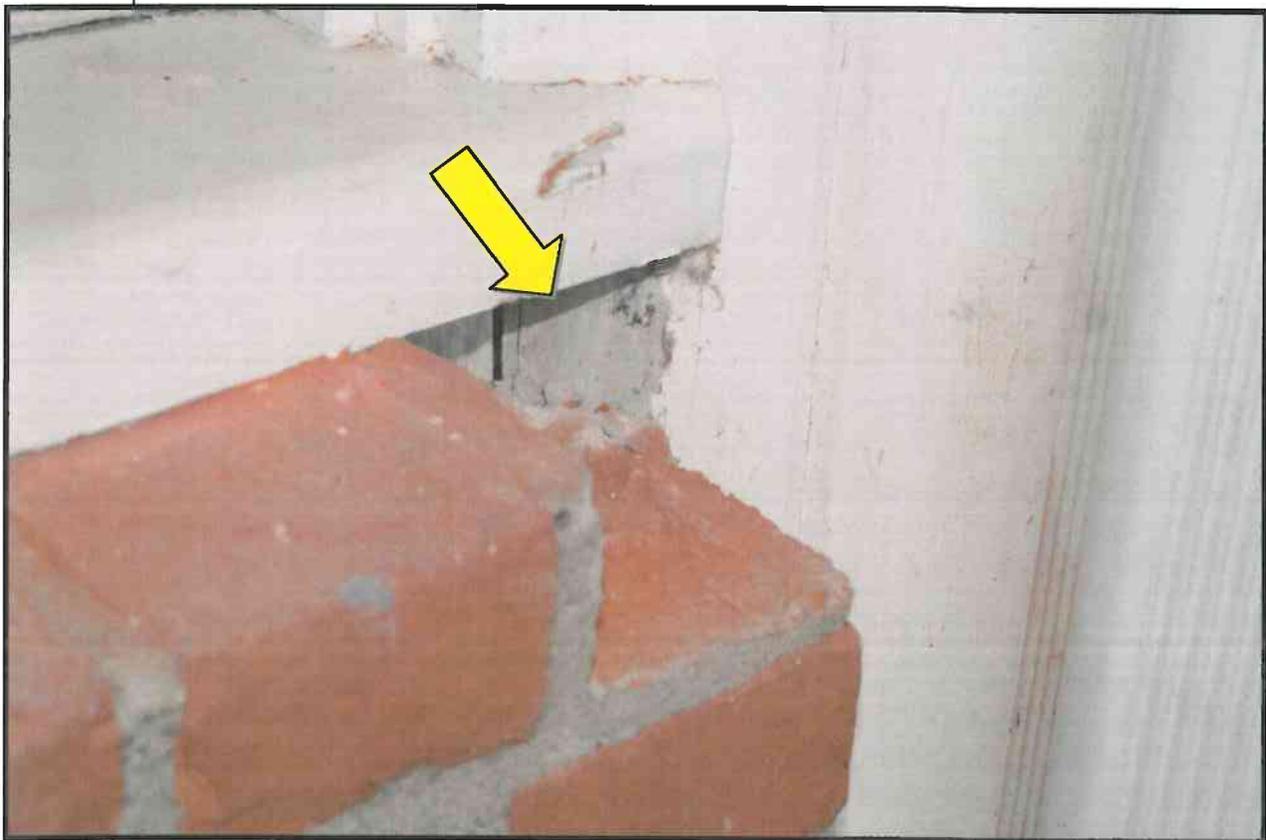
Photo D - Photo showing wood siding installed behind brick cladding

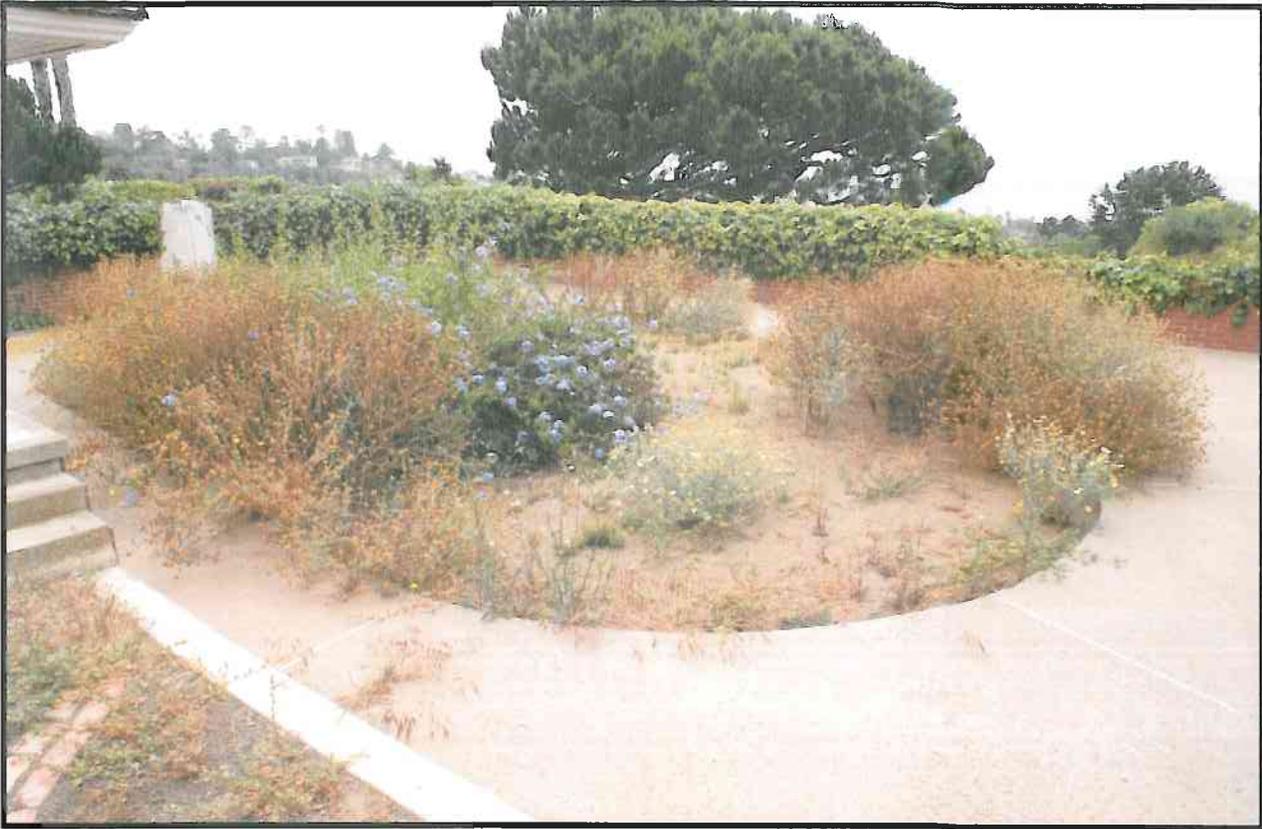
According to Mr. Haines' signed Declaration, in or about 1975, “a swimming pool was installed in the backyard. The entire patio was replaced.” The area referenced by this statement is located along the south side of the residence. Further, according to Mr. Haines, “[i]n the early 2000's, the pool was dismantled [i.e. in-filled]. Given that this was the main outdoor living area for the home, this entire area has undergone significant and complete renovations at least twice in its existence. *(See presented photo for further background, Item #10, Photo A).*

Photo A - Photo showing location of pool that was added and later removed on main entertaining space.

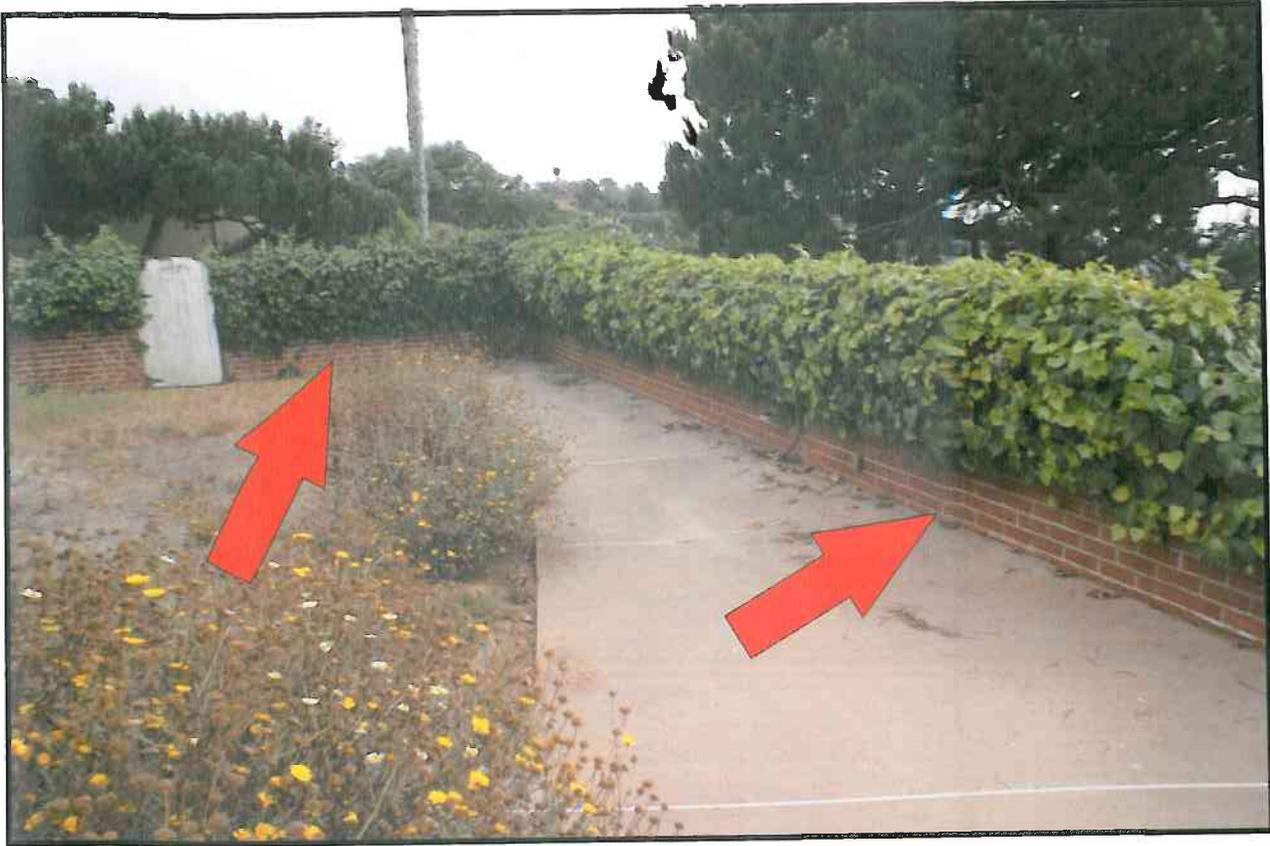
Mr. Haines' signed Declaration also has indicated that around 1978 “a reinforced retaining wall was installed on the west side of the pool.” Recent extensive forensic examination and analysis has substantiated this claim and found that the entire westerly patio wall adjacent to the main outdoor living area is not original and was added in 1978 with new brick cladding that does not match the original brick of the home.

Photo A - Photo of new site walls and retaining walls added .

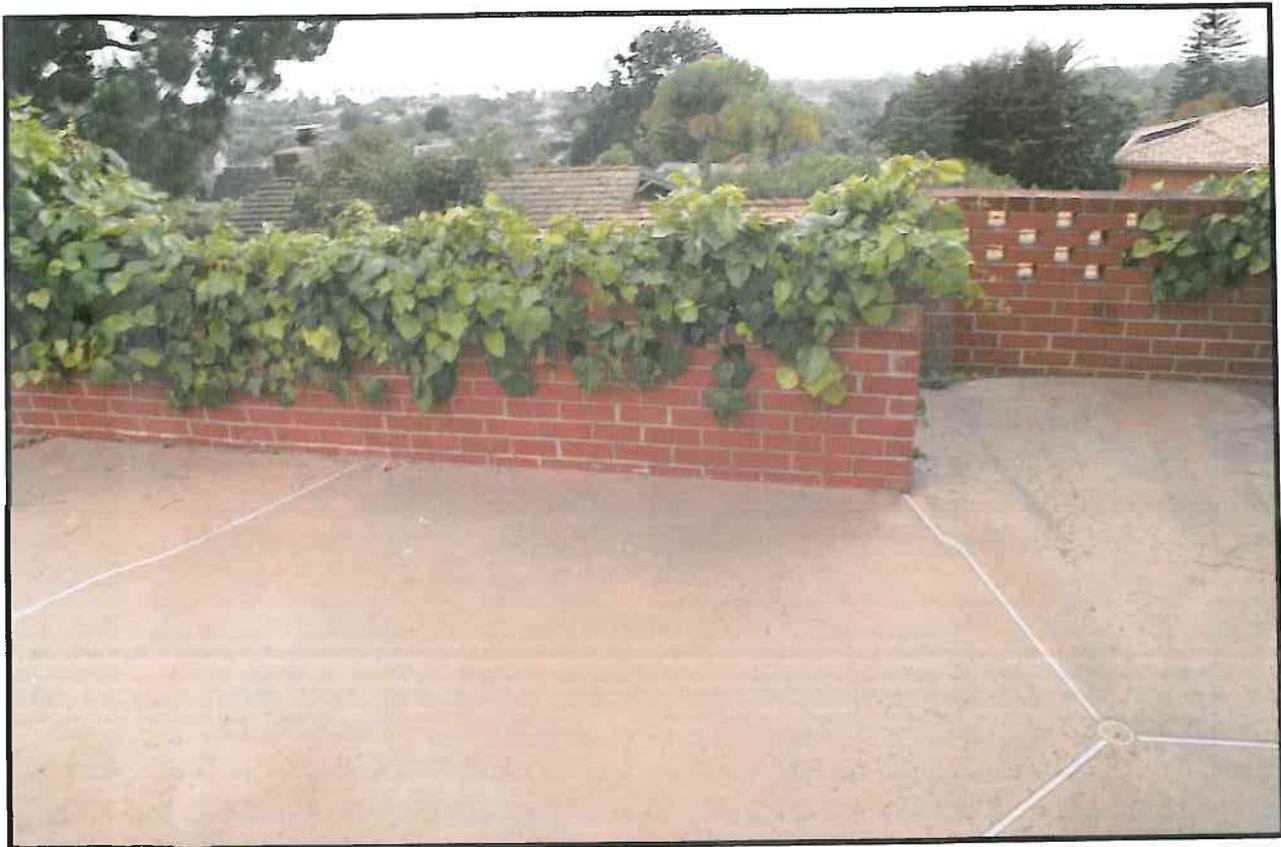
Photo B - Photo of added site retaining walls in new brick

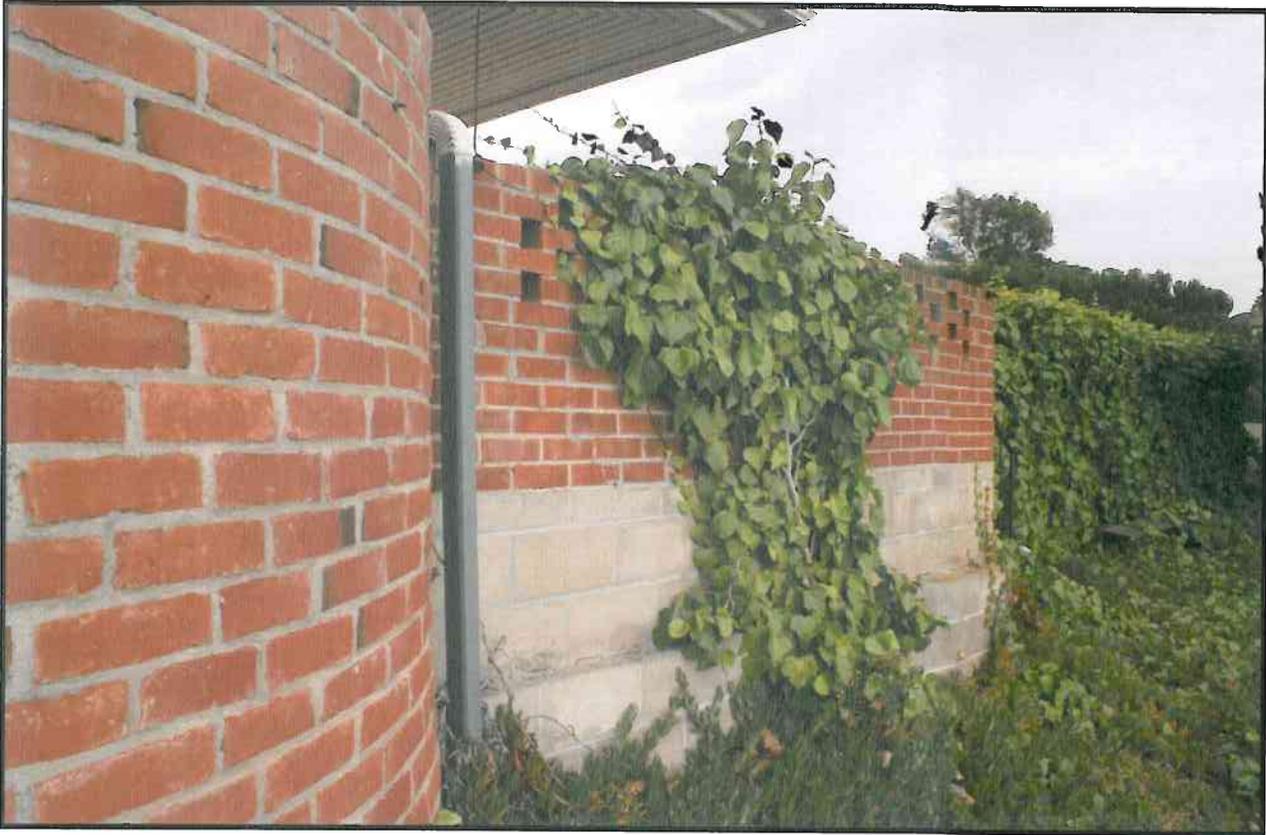
Photo C - Photo showing new block site retaining walls and mis-matched brick

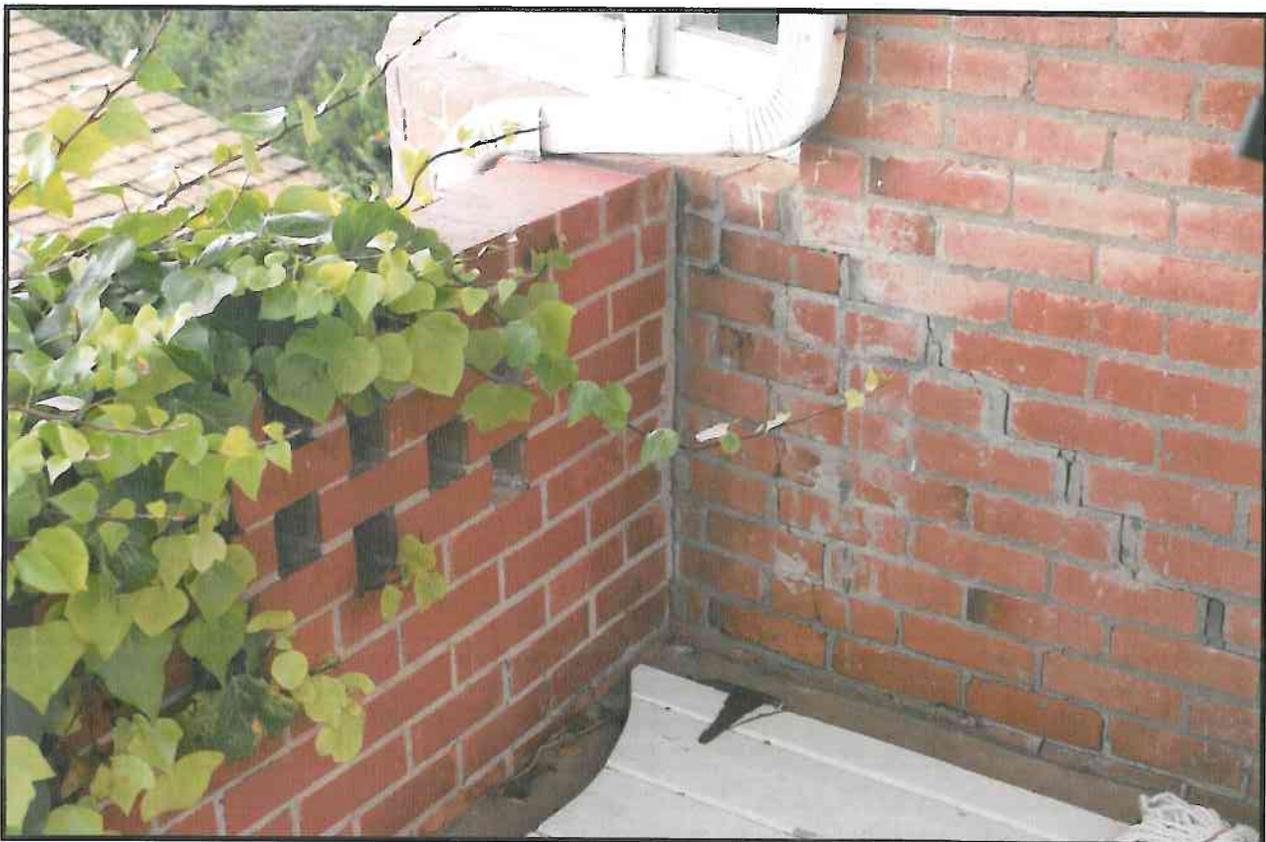
Photo D - Photo showing mis-matched brick at new site retaining walls to house.
