August 9, 2010

*Re: 6004 Muirlands Drive, La Jolla, Substantial Modifications & Changes--Lack Of Original Integrity*

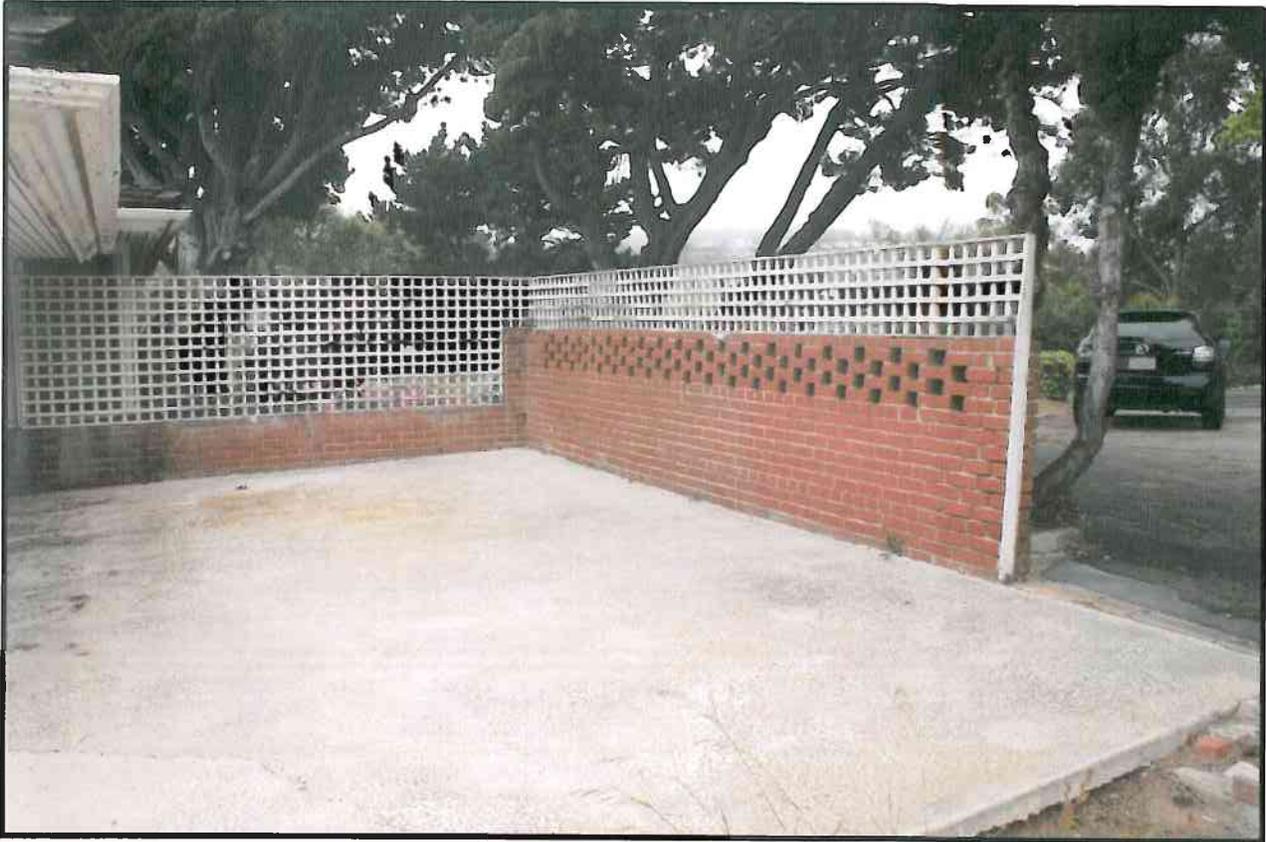
Recent extensive forensic examination and analysis has confirmed this and in fact, the front façade brick walls which are visible to the street, as well as the fence to the main outdoor entertaining area, have been rebuilt several times. No less 6 (six) types of brick are visible in this area.

Photo A - Photo showing added and remodeled brick site wall visible to front elevation

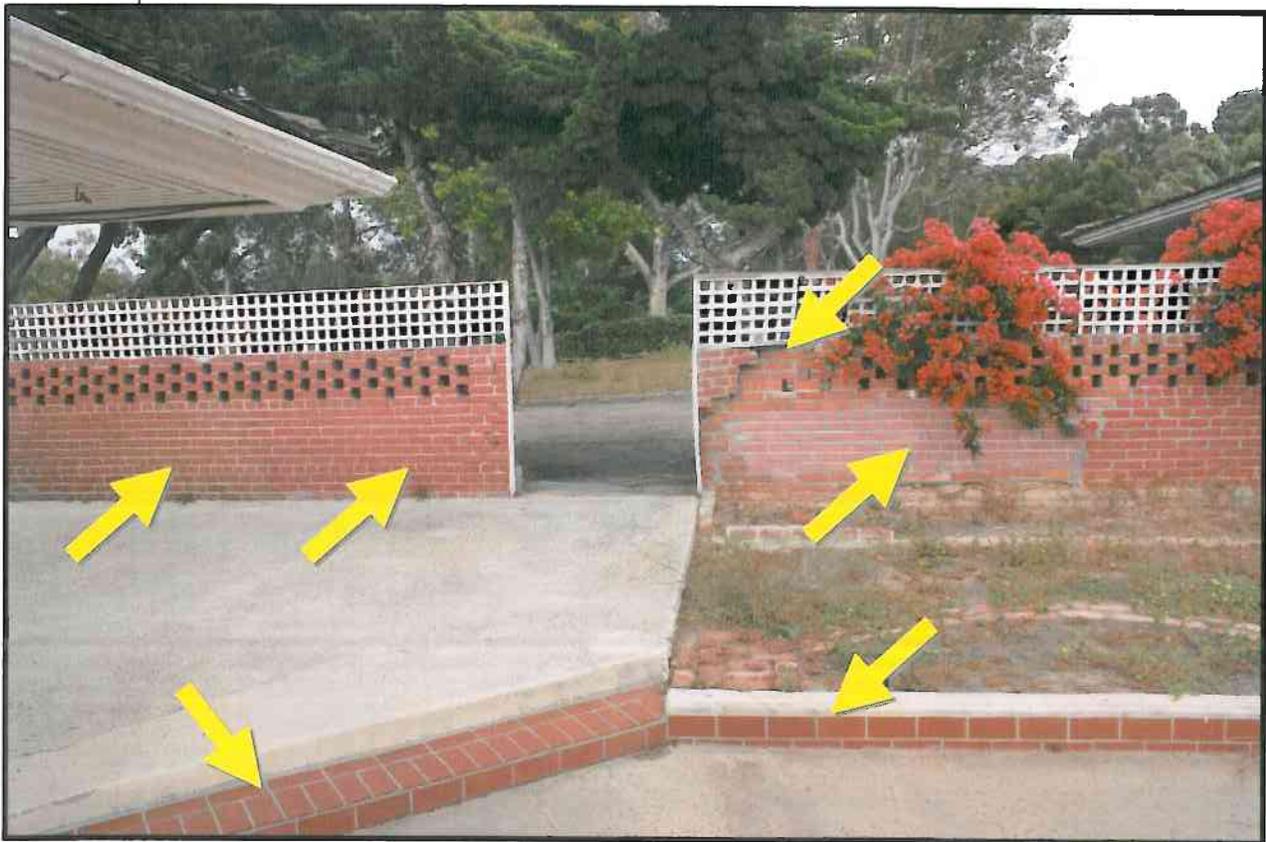
Photo B - Photo from main entertaining space showing no less than 6 brick styles.

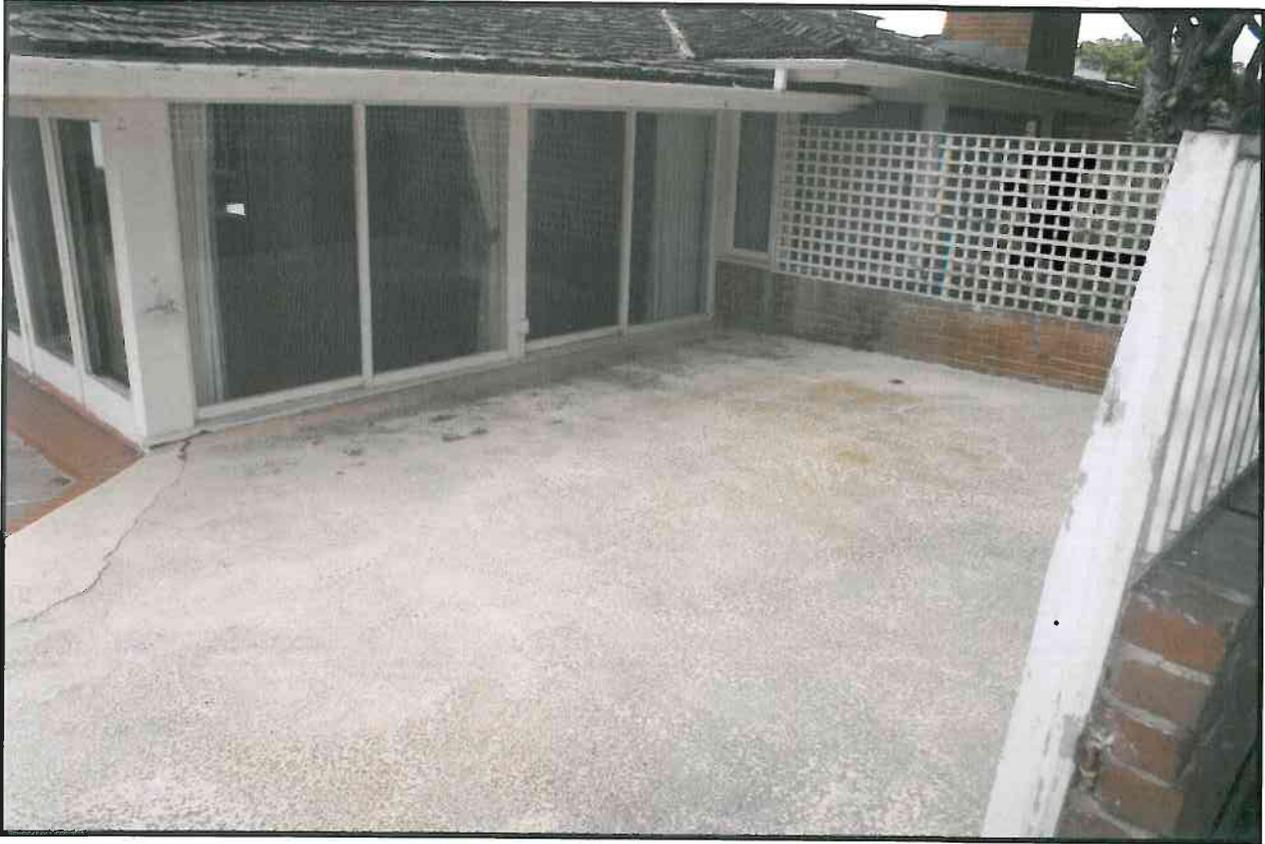
Forensic investigations have revealed that the patio to the east of the enclosed open patio is also new. The slab appears to have been poured after the patio was enclosed and was done to correct a serious site drainage issue. The slab is finished with a pool deck coating (cool-deck) and is poured literally right to the top of the stem wall of the patio enclosure wood framing, and slopes to the south to direct all the water around the house. The slab was literally poured against the wood framing and sill of the new patio enclosure walls, and reflects a further erosion of any original integrity for both the outdoor living areas and front elevation. (See *presented photos for further background, Item #13, Photos A-D*).

Photo A - Photo showing new concrete patio and finish installed to keep water from flooding home.

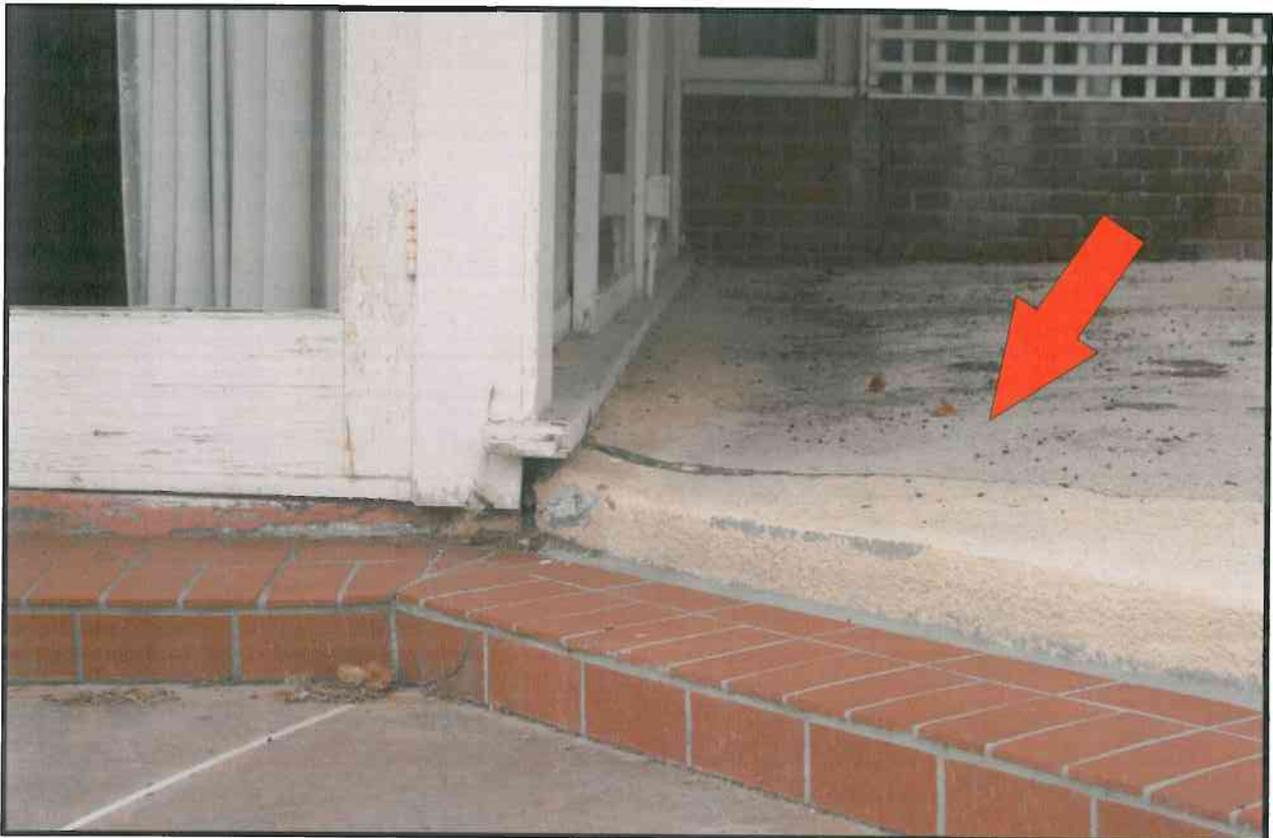
Photo B - Photo showing new concrete patio and finish installed to keep water from flooding home.

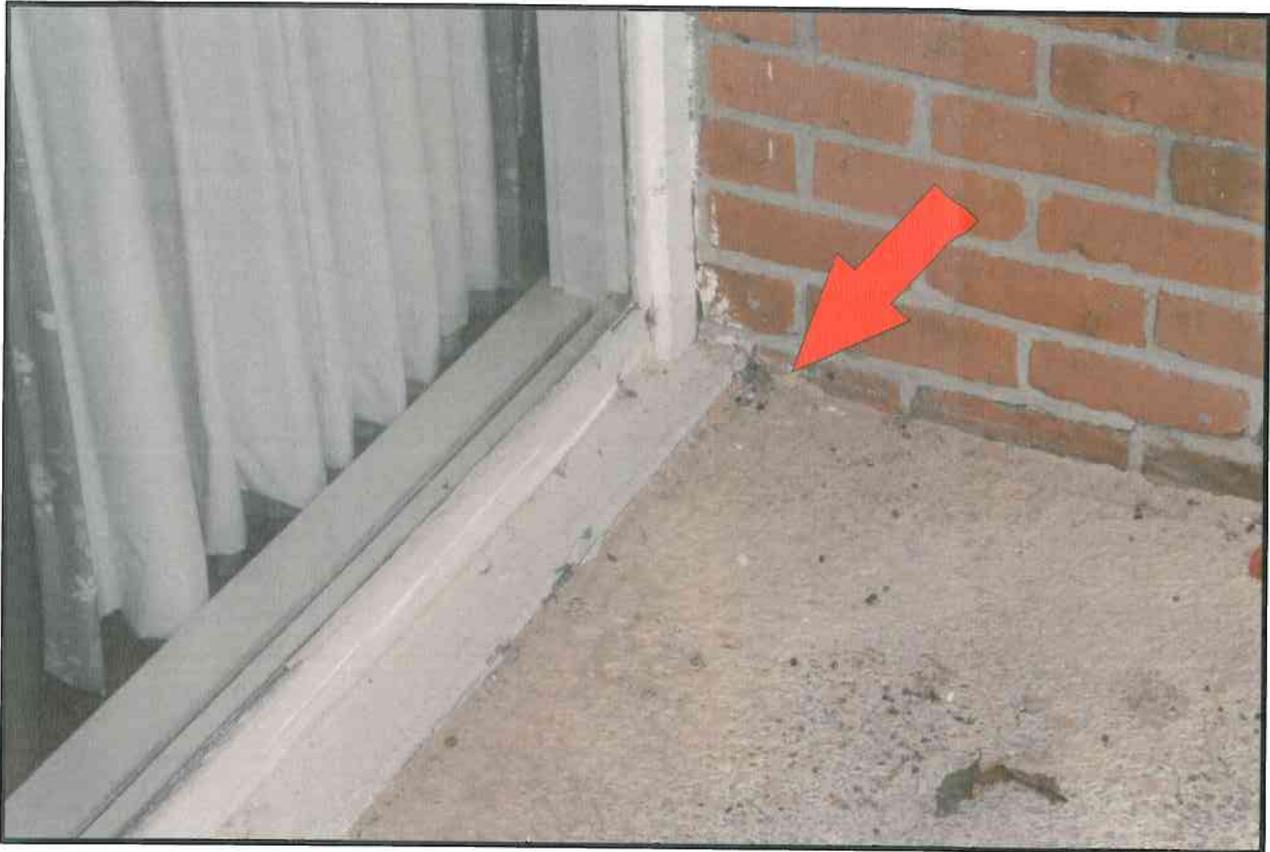
Photo C - Photo showing new concrete patio poured to top of added wood window sill.

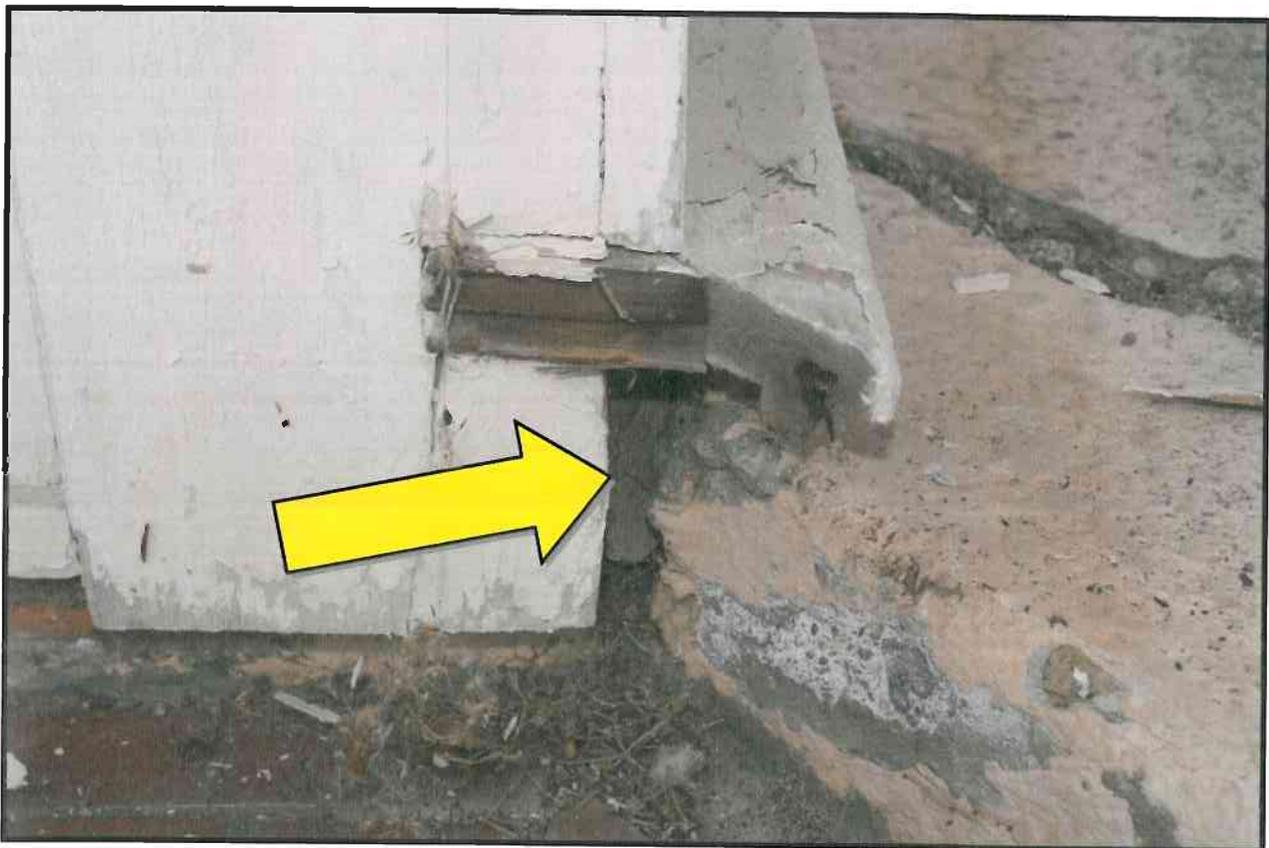
Photo D - Photo showing new concrete patio slab poured and encasing wood sill for added window
