Facilities Condition Assessment **Qualcomm Stadium**

Facilities Condition Assessment
AECOM
San Diego, California
April 2011

Qualcomm Stadium Facilities Condition Assessment

Qualcomm Stadium Facilities Condition Assessment
Introduction and Methodology

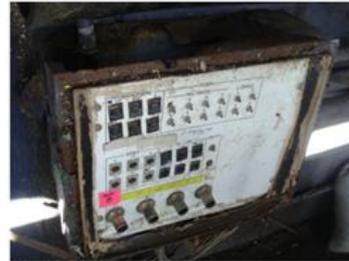
Deteriorated Box

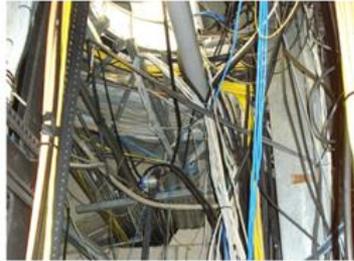
Fiber Patch Panels Uncapped

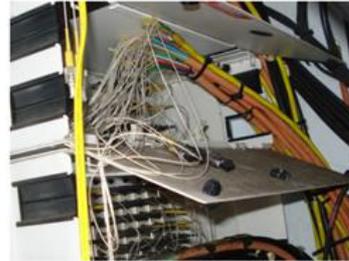
Improper Fiber Termination Example

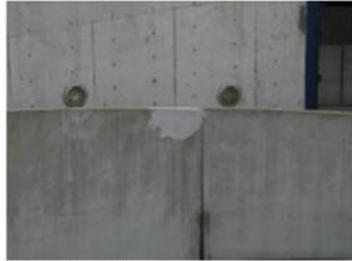
Patched Guardrail

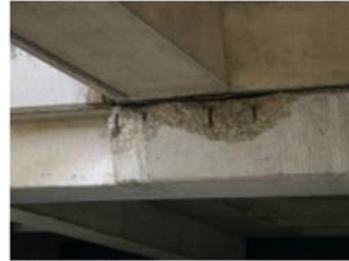
Broken Concrete

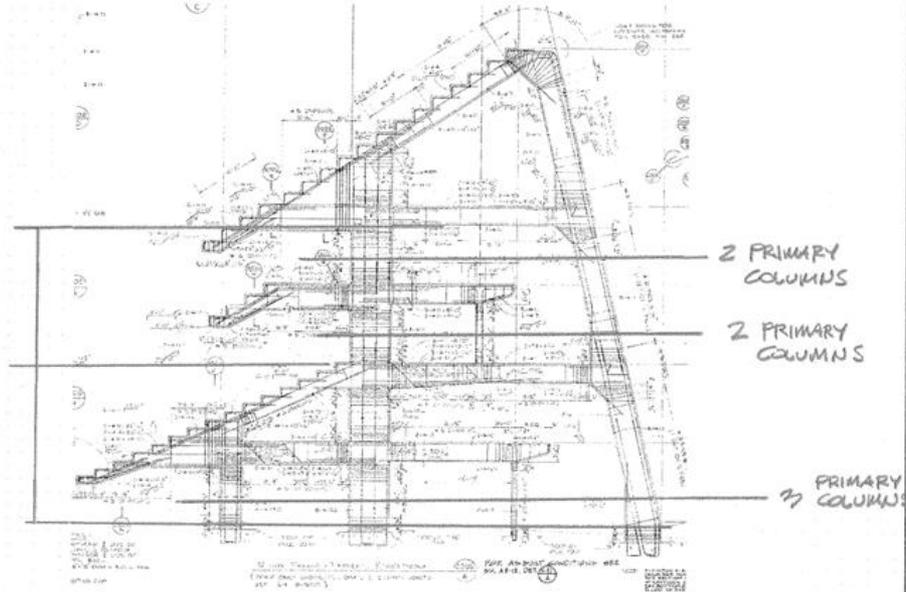
CHECK STORY STIFFNESS - CREATE RISA MODEL USE 40% MEMBER SECTION PROPERTIES.

BASED ON RISA MODEL UPPER LEVEL FRAME STIFFNESS = 212 k/11 WHILE THE FRAME BELOW W/ THE ADDER COLUMNS HAS A STIFFNESS = 689 k/11

$212/689 = 30\%$ ∴ DOESN'T COMPLY HOWEVER THIS CRITERIA IS MORE APPROPRIATE TO MULTI STORY BUILDINGS AND CAN BE PROBLEMATIC IN BUILDINGS 5 TO 15 STORIES IN HEIGHT. WE ONLY HAVE 2 LEVELS (EFFECTIVE) AND THE ASCE 7-10 WOULD ALLOW A 2 STEP STATIC CALL

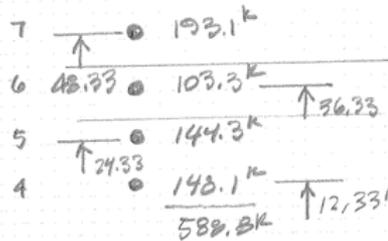
SHEAR STRESS CHK - 3.9.3.2 (SEE MSSJ-16)

- V_0 6'-1" x 1'-4" COLUMN

$V = \frac{446.4k}{2(73 \times 16)} = 191 \text{ PSL} > 100 \text{ PSL}$

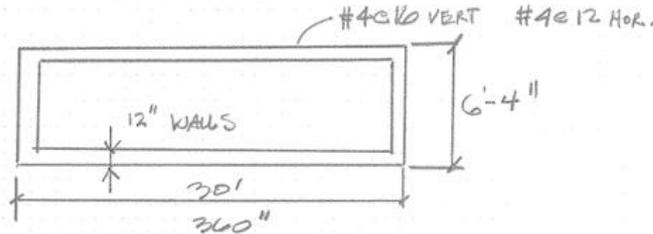
CHK SHEAR WALL SHEAR -

@ MOST CRITICAL WALLS - 8 FRAMES @ 588K/FRAME = 4704 K
 $V = .853(4704) = 4013 \text{ KIPS}$

$$V_{AVE} = \frac{4013 \text{ k}}{(4)(360" \times 12" \times 2)} \times 1000 = 116 \text{ PSL} > 100 \text{ PSL}$$

$$2\sqrt{3000 \text{ PSL}} = 109.5 \text{ PSL}$$
