Exhibit B - 8: Buildings Suffering from Defective Design

# Grantville Redevelopment Project Area

## Parcels exhibiting Defective Design

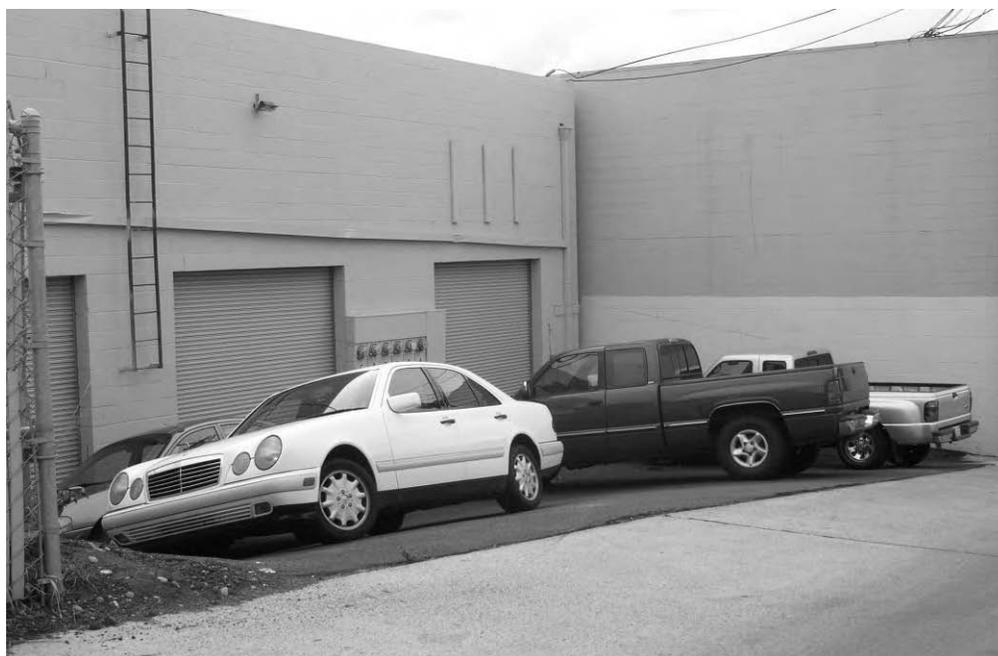
#### **Parcel Number – 458 521 22**

This building footprint nearly covers this entire parcel, leaving inadequate area for deliveries and parking.

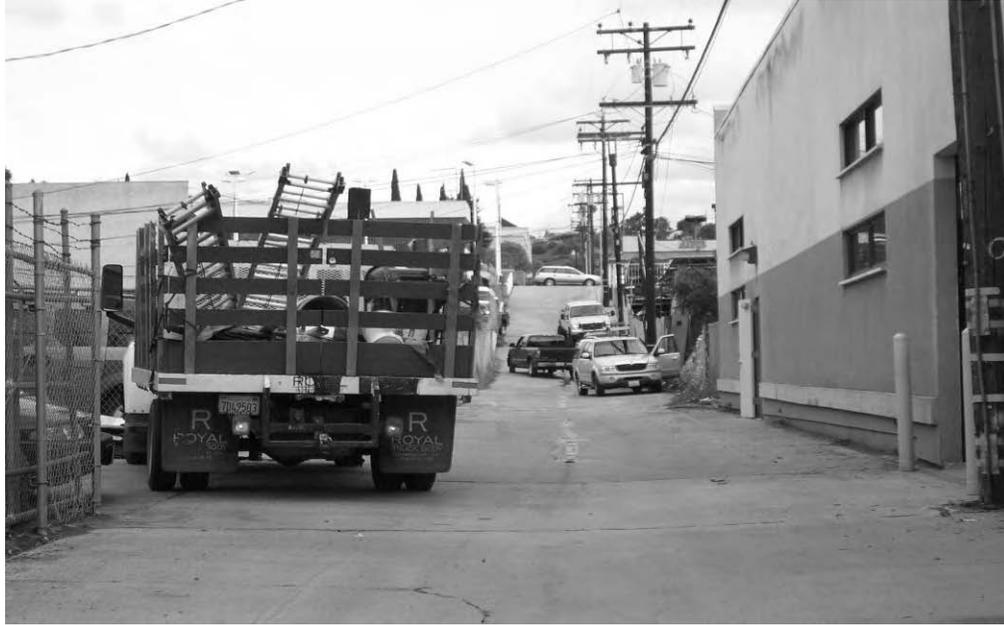
**Parcel Number – 458 522 11**

An auto body shop with alley-only access to its property uses the alley for long-term parking and not as a service entrance. This practice results in the alley being too congested for other vehicle access.

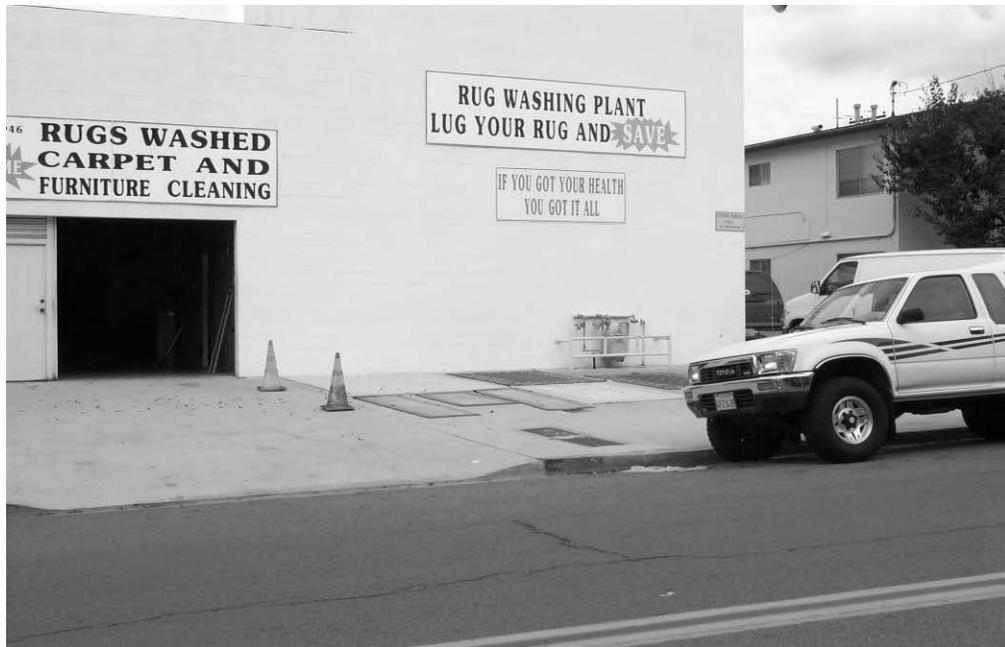
**Parcel Number – 458 522 18**

This property on Vandever Avenue lacks adequate landscaping in the front and uses the sidewalk area for drying carpets because of excess debris storage in the rear of the property. The overall effect detracts from the visual appearance of the business as well as surrounding properties in addition to inhibiting vehicle and pedestrian access to the property.

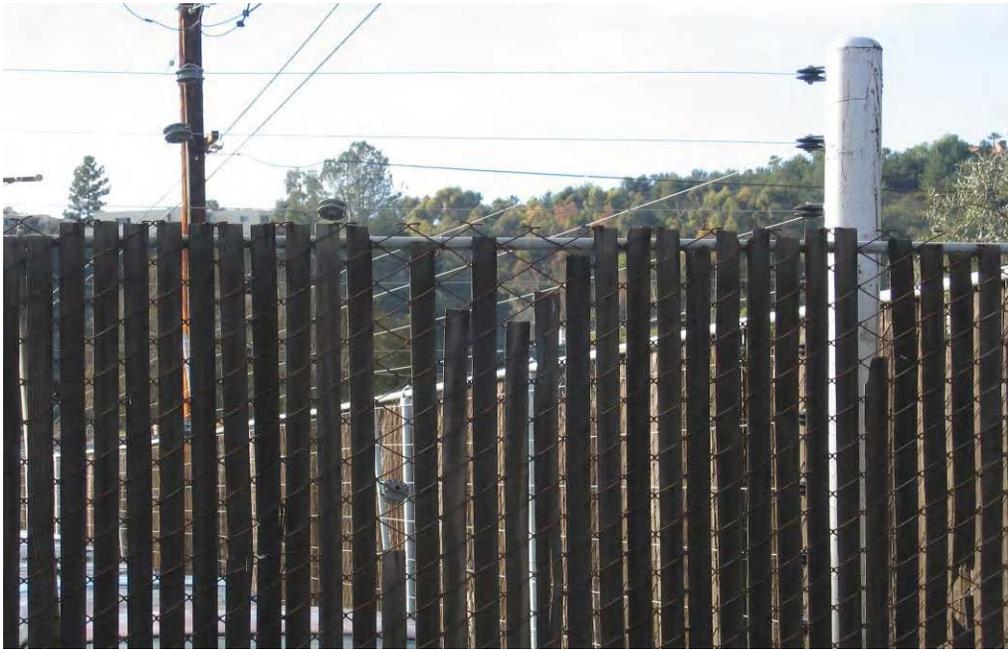
**Parcel Number – 458 510 03**

This car storage facility has electrified fencing, which is a violation of the City’s zoning code.

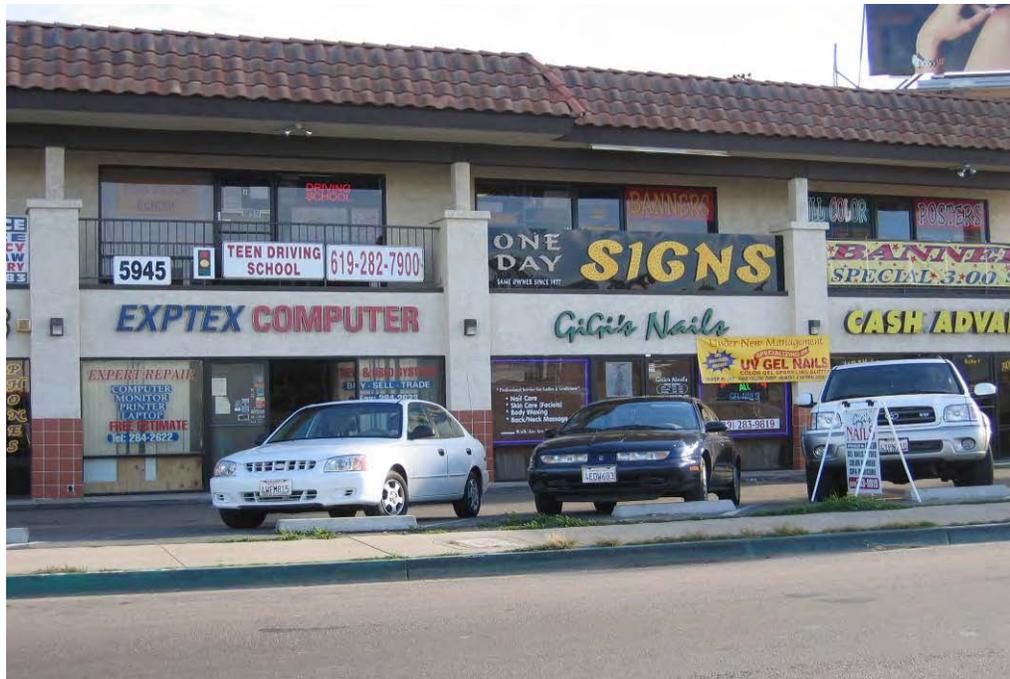
**Parcel Number – 461 190 04**

This commercial property on Mission Gorge Road displays excessive signage on the building and the public right-of-way, which are both a violation of the zoning code as well as being visually detracting.

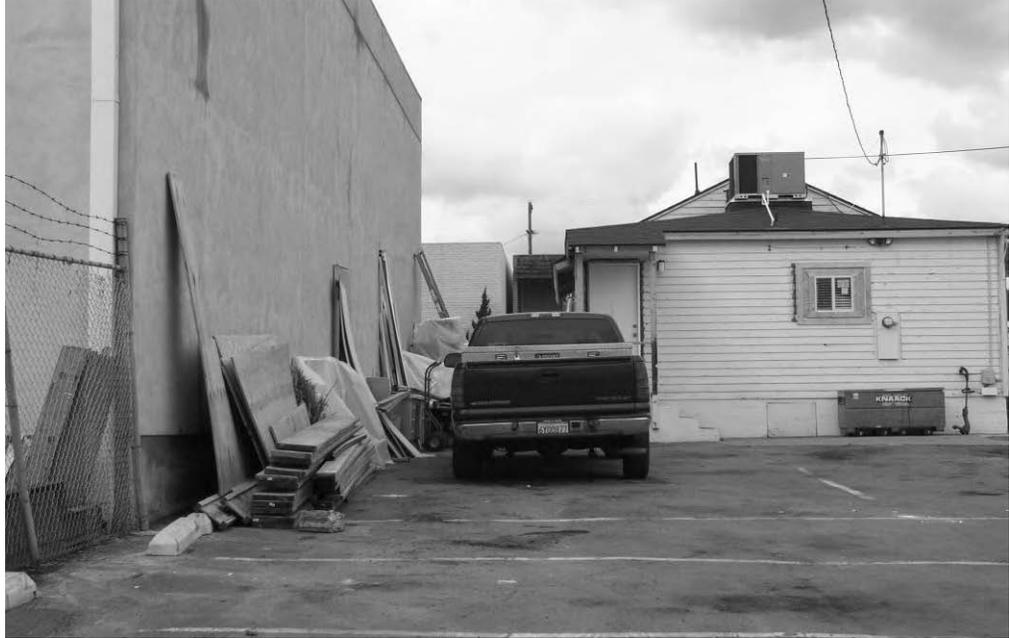
**Parcel Number – 458 522 03**

This residential building has been converted to a construction office and storage area through a series of substandard additions that have fallen into disrepair.

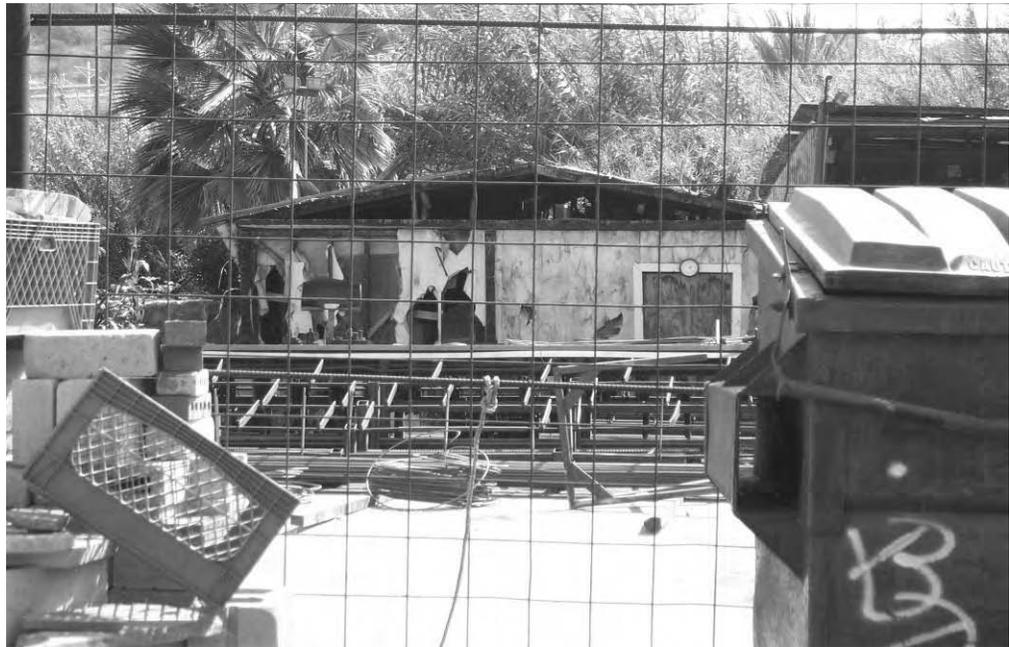
**Parcel Number – 461 320 11**

This dilapidated residential structure has been converted to an industrial storage facility for steel manufacturing.

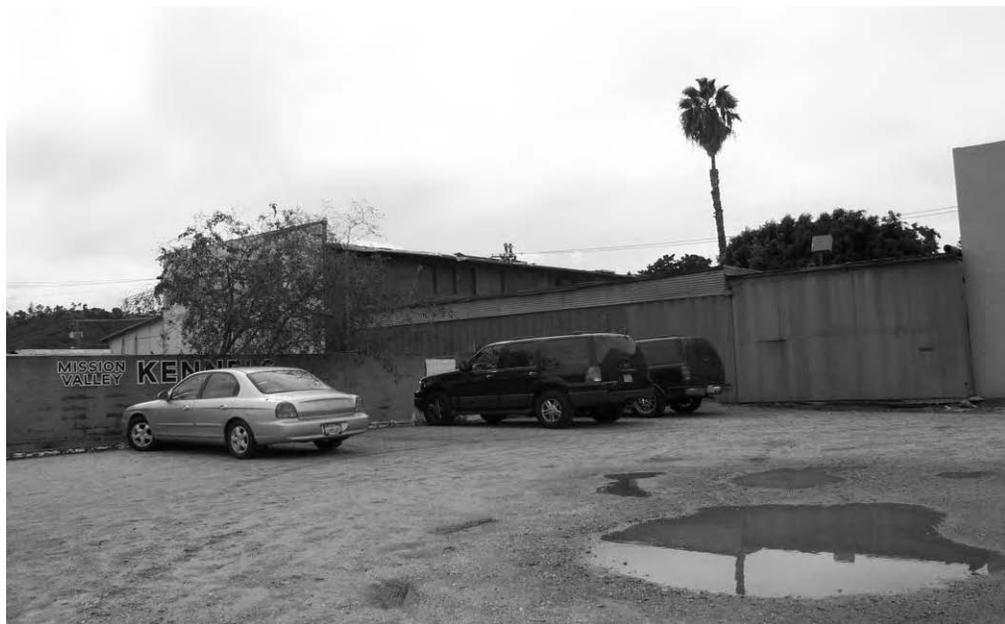
### **Parcel Number – 461 160 01**

This is a rear view of a building (to the right) that has constructed a series of additions using wood, corrugated metal and stucco creating a substandard addition that occupies most of the property.

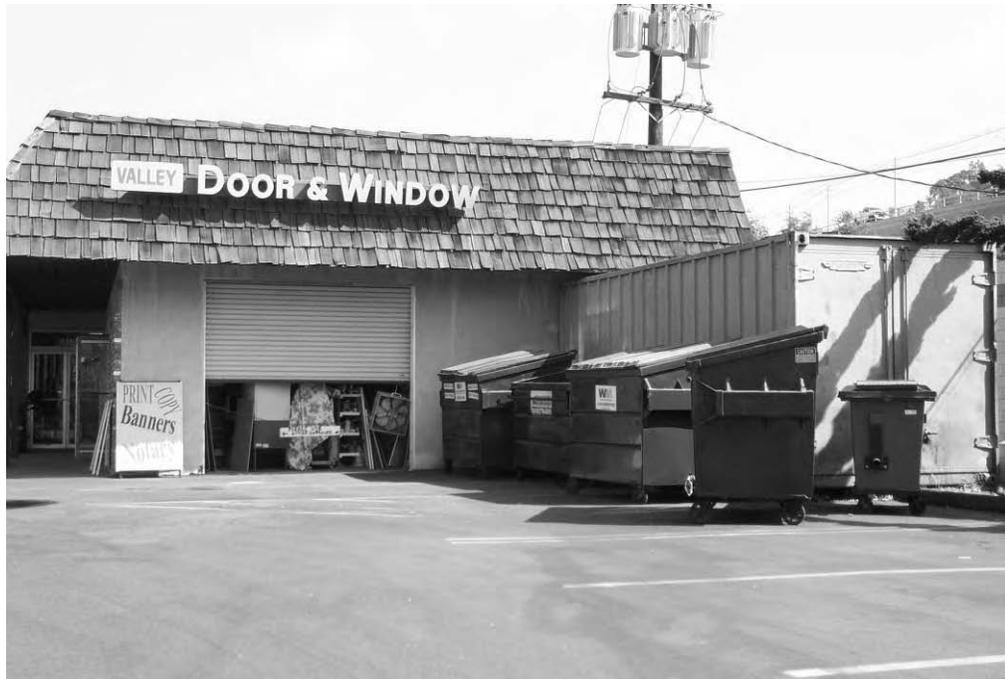
**Parcel Number – 461 320 05**

This manufacturing business on Mission Gorge Road has a metal storage container occupying three parking spaces that is illegally attached to the front of the building.

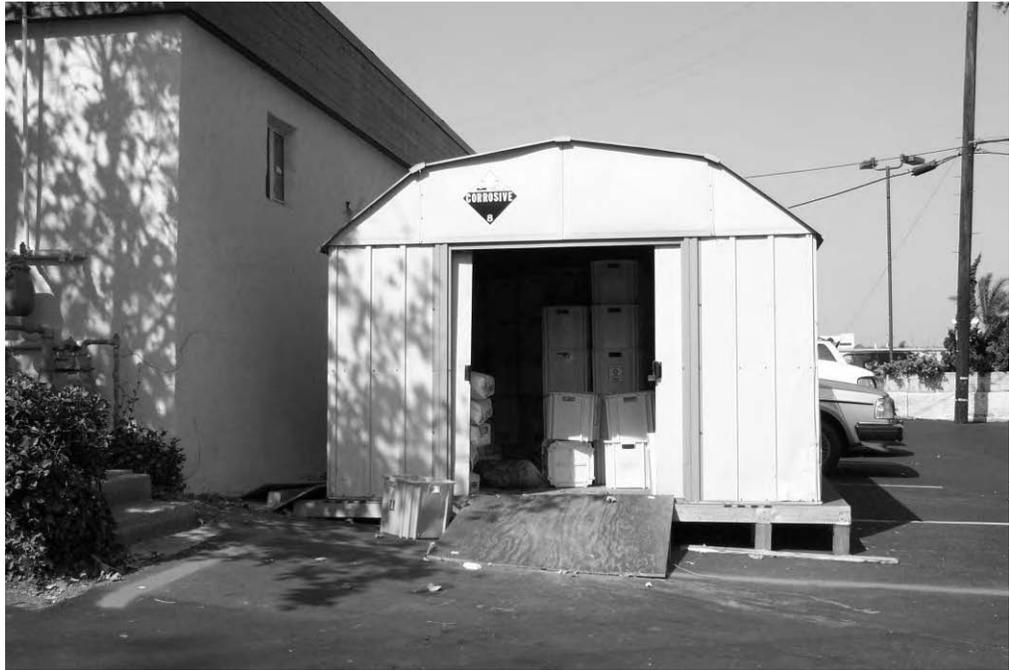
**Parcel Number – 461 320 03**

Chemical storage shed off Mission Gorge Road using substandard building materials for a commercial area and occupying a parking space.

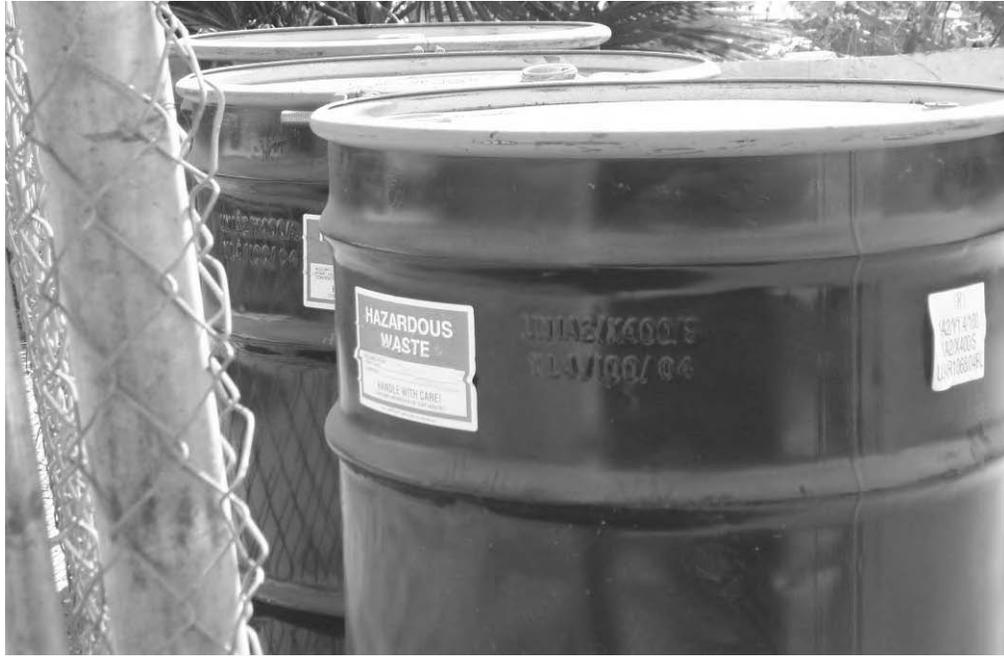
**Parcel Number – 461 320 20**

Outdoor storage is unsightly as well as dangerous, These hazardous waste containers are being stored outside the fenced area along Mission Gorge Road.

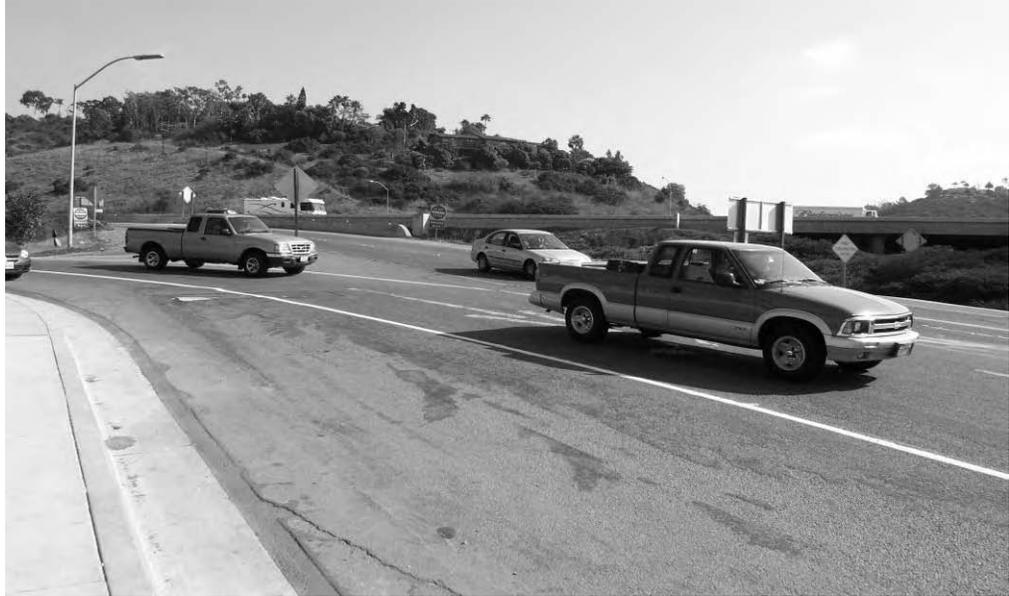
**Parcel Number – 461 320 21**

The eastbound Interstate 8 exit to Mission Gorge Road has a dangerous merge with Alvarado Canyon Road to the left. As vehicles are exiting the freeway on the right, vehicles on the left are merging across four lanes of traffic at the busy Mission Gorge Road/Fairmont Avenue Intersection to make a left turn.

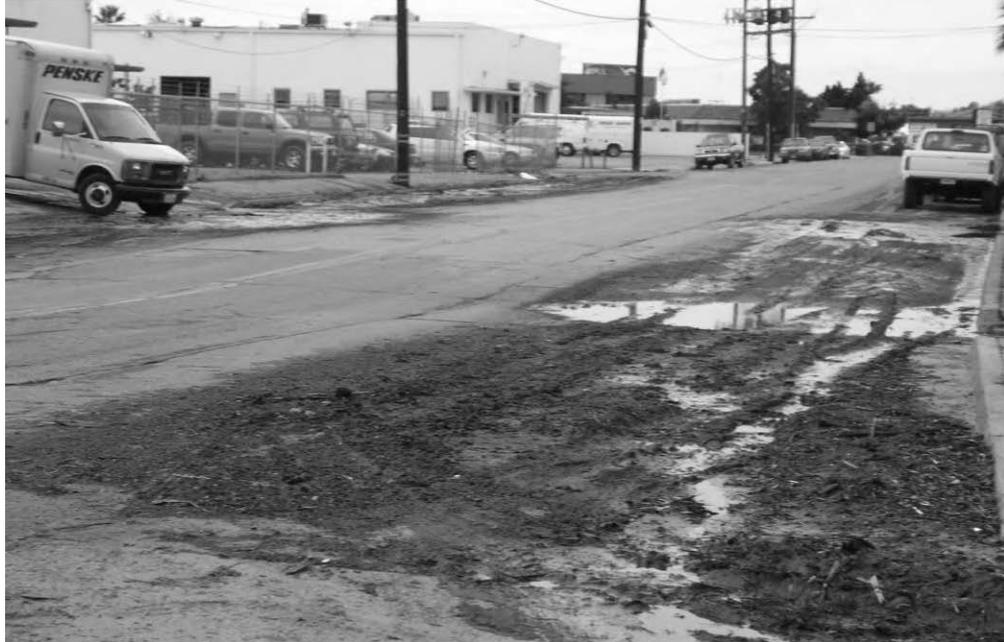
**Parcel Number – 461 210 05**

This is the remaining debris after City work crews cleaned mud and debris from the street with a tractor.
