MAINTENANCE ACTIVITY REPORT

Site Name/Facility:	Upper Alvarado channel
PEIR Map No:	Map 64
Date:	February 2011
Preparer Name:	Rudy Bilan, City of San Diego
Instructions: This form must be completed following any work done at a storm water facility. Attach additional sheets if needed.	
Description of Work (e.g., routine, re-occurring; also note general frequency maintenance at this site): Emergency maintenance to remove accumulated trash/debris, vegetation, and sediment within concrete-lined and earthen drainage channel which runs upstream from the west end of Map 59 towards a double-box culvert next to 4580 Alvarado Road.	
Street Name: Alvarado Ct Latitude: N 32°46'38.57" Longitude: W 117°03'49.15"	Work Orientation from Street (N, S, E, W): Commercial (N), Residential (S), SDSU Dormitory (W), Open Space (E) Location Between: Alvarado Rd (N), Cleo St (S), College Av (W)____ Reservoir Dr (E)
Maintenance Facility Type: <input checked="" type="checkbox"/> Stream <input type="checkbox"/> Roadside Ditch <input type="checkbox"/> Spillway <input type="checkbox"/> Culvert <input type="checkbox"/> Detention Basin <input type="checkbox"/> Other: _____	Additional Description: Constructed chan

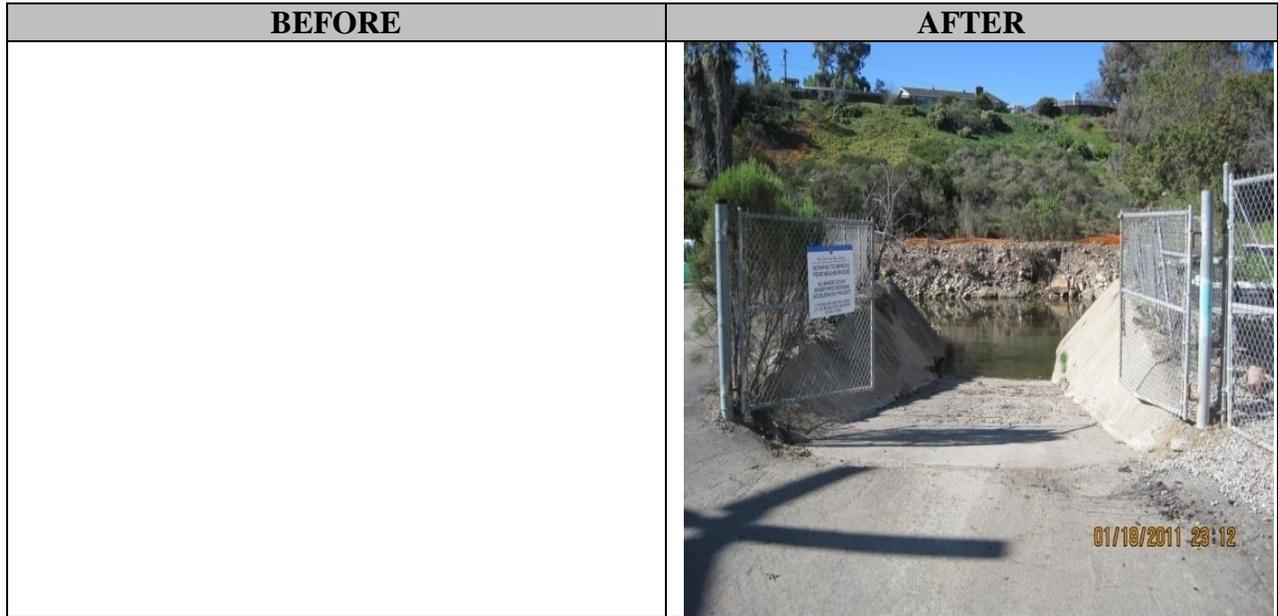
PHOTO NOTES: View of concrete access ramp about 280 feet from west end of Map 64. Concrete-lined & earthen channel. Looking at side profile of channel from north side.

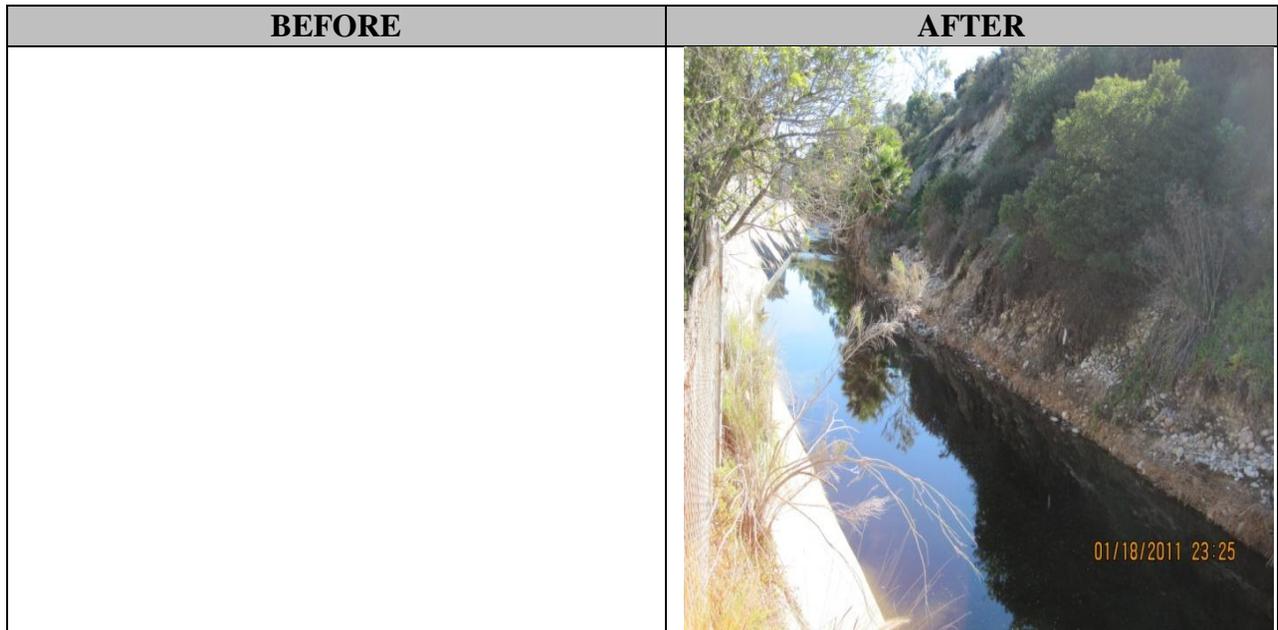
PHOTO NOTES: View from east side of access ramp. Looking upstream in eastern direction.

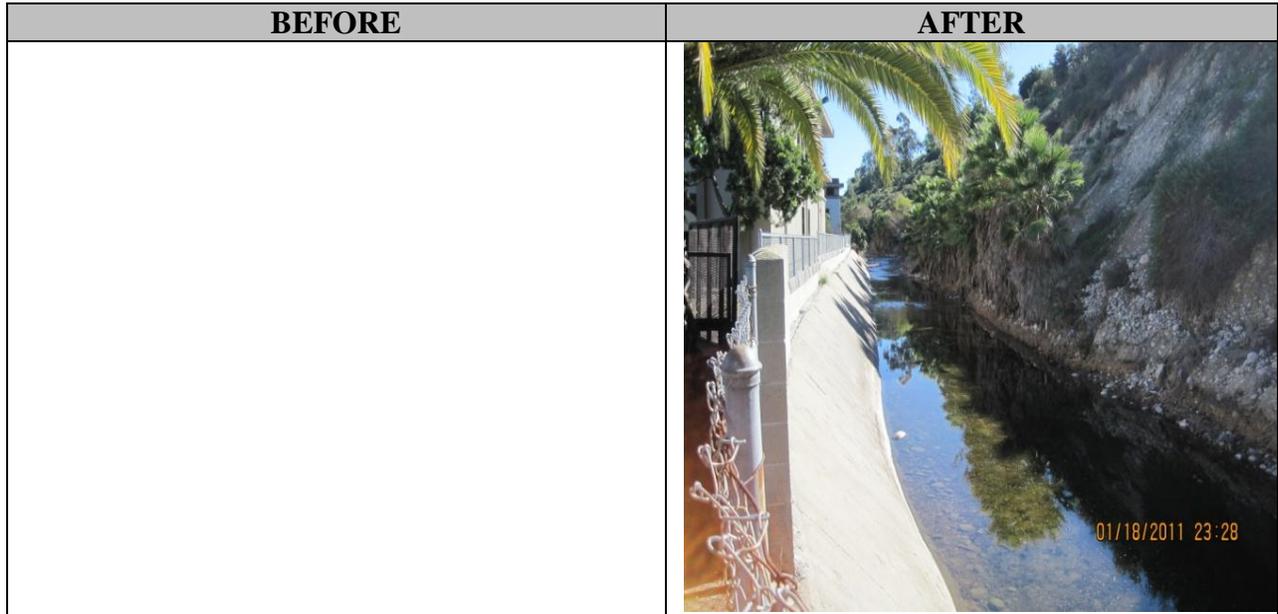
PHOTO NOTES: View from midpoint of parking area at 6363 Alvarado Court. Looking upstream in eastern direction.

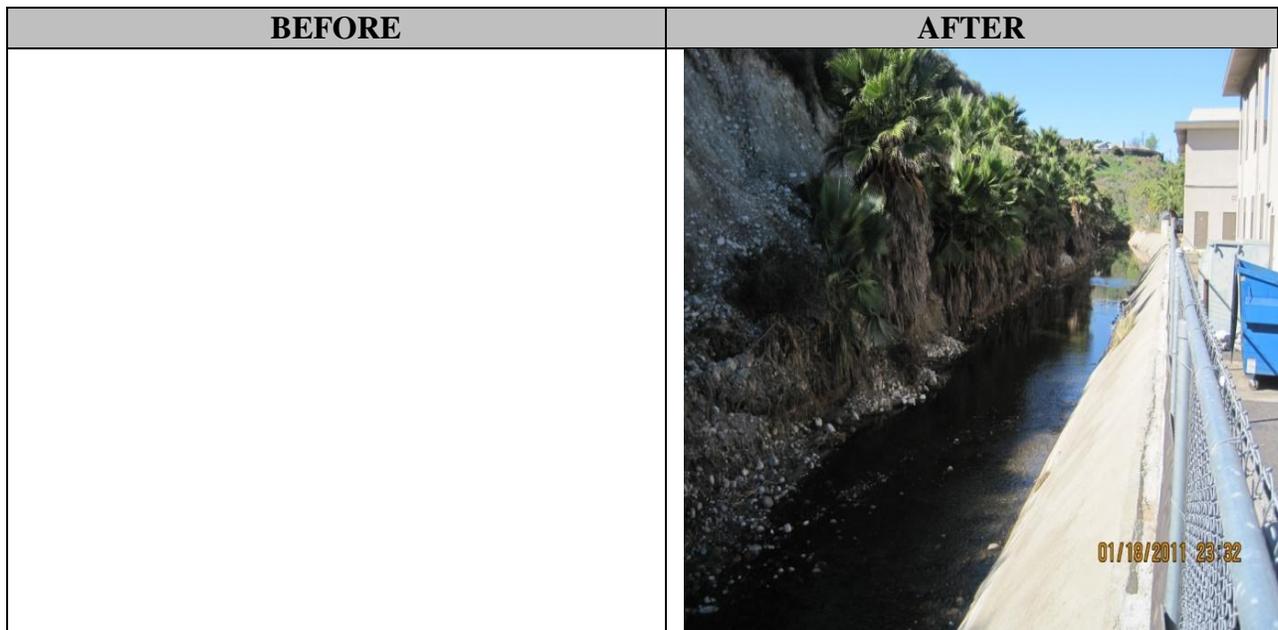
PHOTO NOTES: View from midpoint between 6363 and 6367 Alvarado Court. Looking downstream towards west end of Map 64.

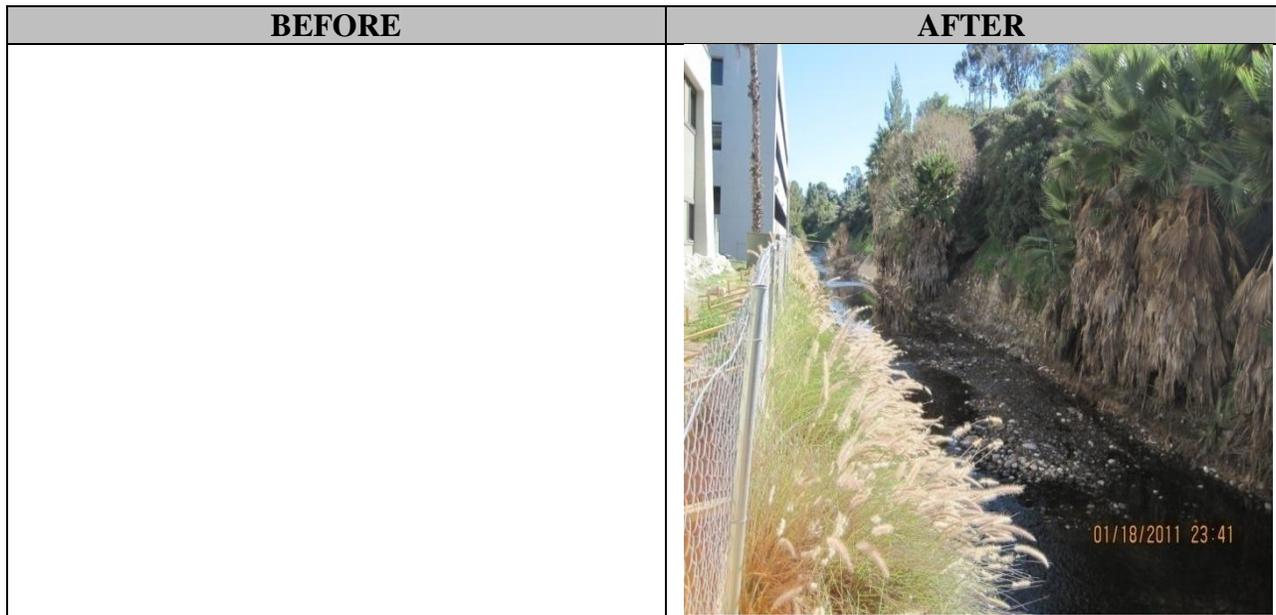
PHOTO NOTES: View from midpoint of 6367 Alvarado Court. Looking upstream in eastern direction.

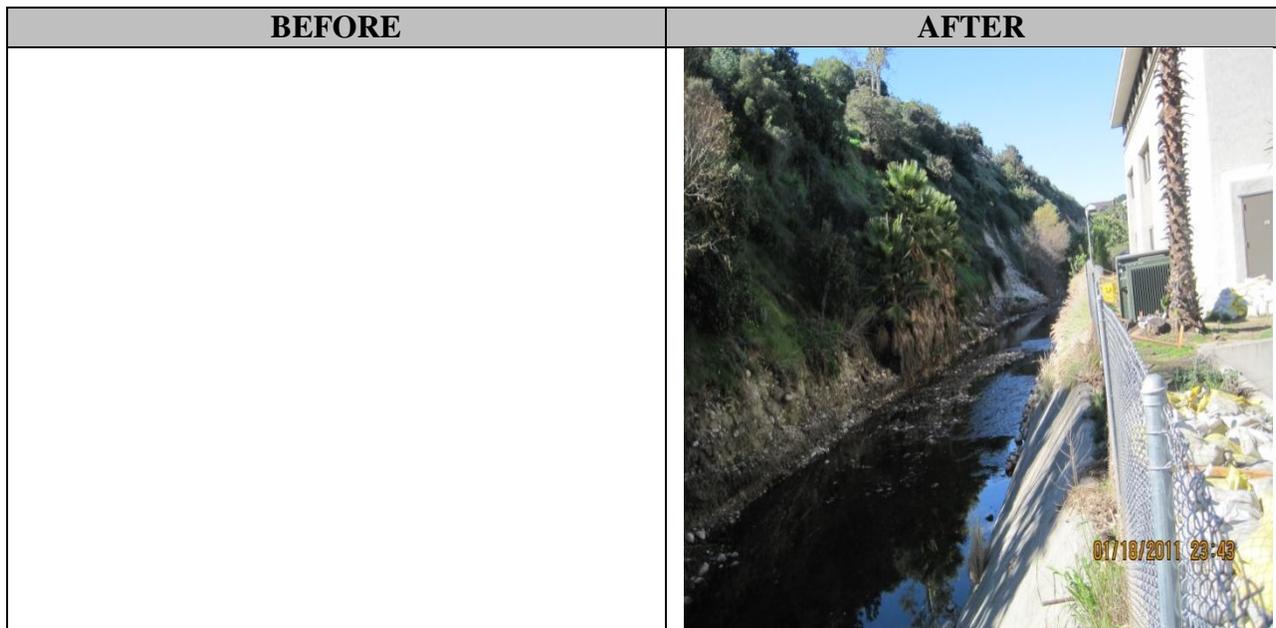
PHOTO NOTES: View from midpoint between 6367 and 6386 Alvarado Court. Looking downstream in western direction.

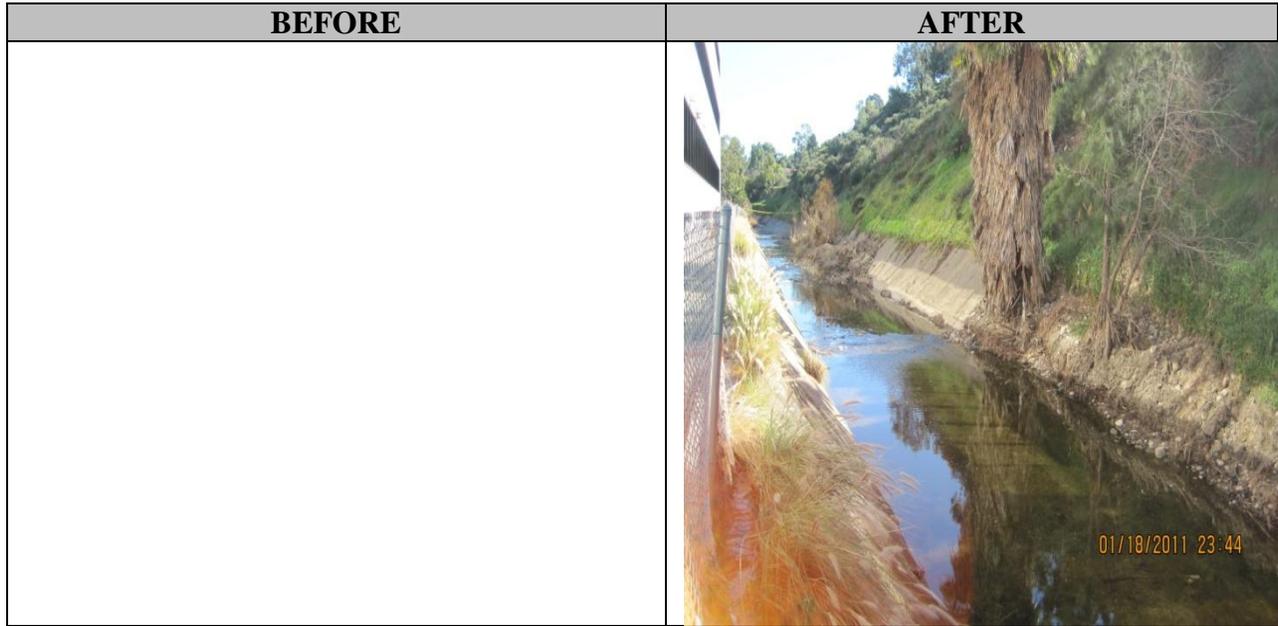
PHOTO NOTES: View from midpoint between 6367 and 6386 Alvarado Court. Looking upstream towards east end of Map 64.

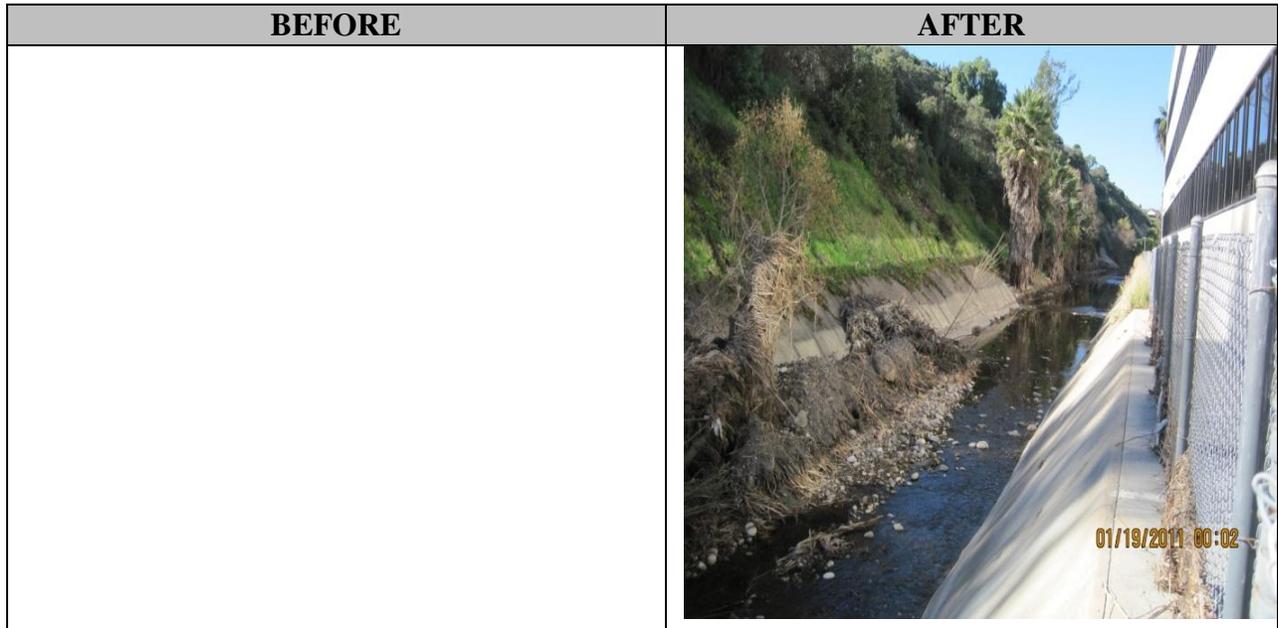
PHOTO NOTES: View from north side of channel at east end of bldg at 6386 Alvarado Court. Looking downstream in western direction.

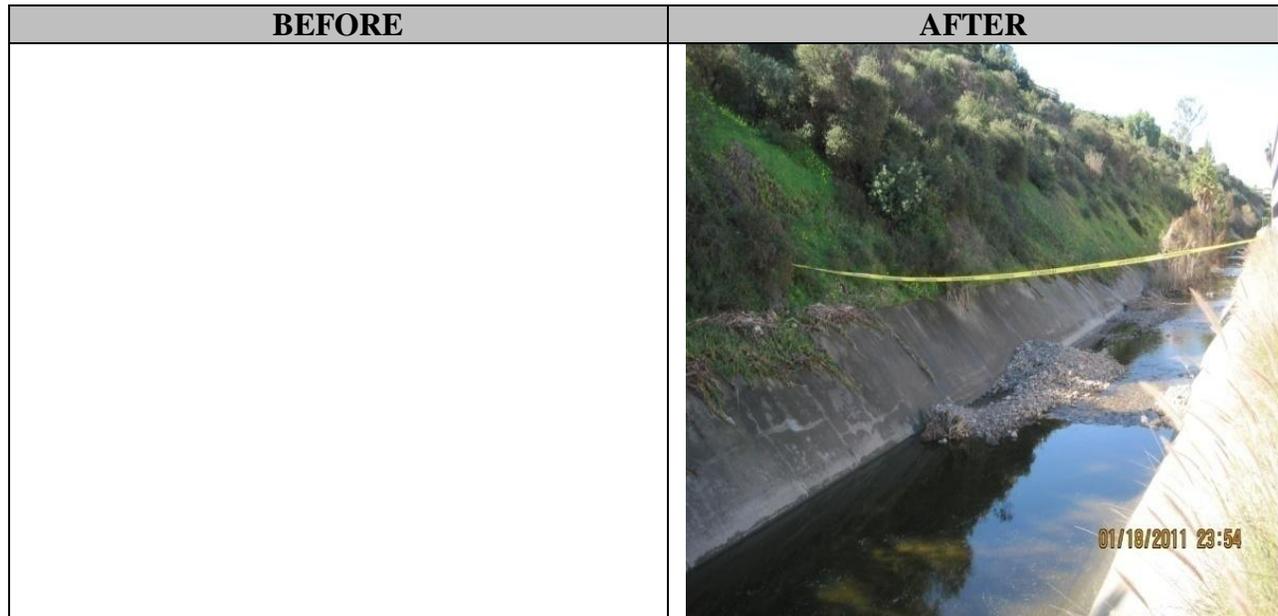
PHOTO NOTES: View from north side of channel near east end of 6386 Alvarado Court. Looking downstream in western direction.
