Channel: Washington

MMP Map # 84

Channel Maintenance Prioritization Summary Sheet

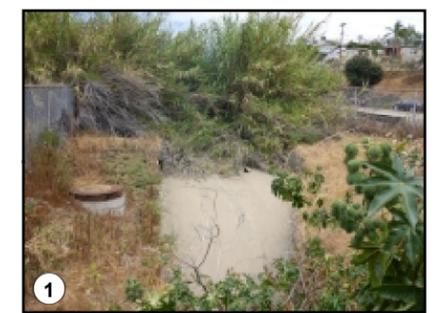
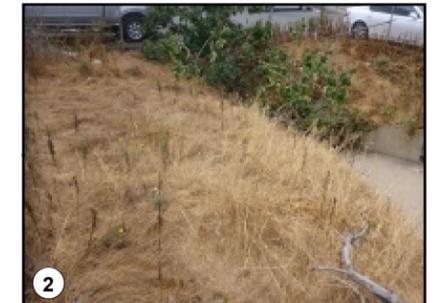
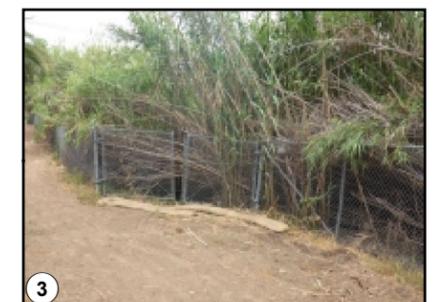
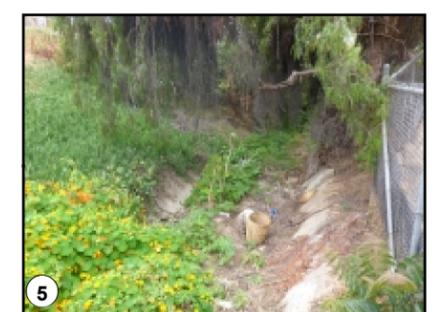
- Channel Prioritization Score: **80.3 out of 100**
 - Flood Hazard Score: **71.3 out of 75**
 - Water Quality Score: **4 out of 10**
 - Community Input Score: **5 out of 10**
 - Aesthetics Score: **0 out of 5**
- Capacity Prior to Maintenance: **Less than 2-year storm event**
- Capacity After Maintenance (As-built Capacity) : **100-year storm event**
- Clogging Potential: **HIGH**
- Approximate Vegetation Coverage: **HIGH**
- Surrounding Area: **Residential**
- Infrastructure Failures: **None**
- Site Evaluation Date: **May 5, 2015**
- Notes/Comments: **Based on site photos taken by the City of San Diego, heavy vegetation exists in the downstream end of the channel. A high risk of vegetation clogging the downstream culvert exists.**

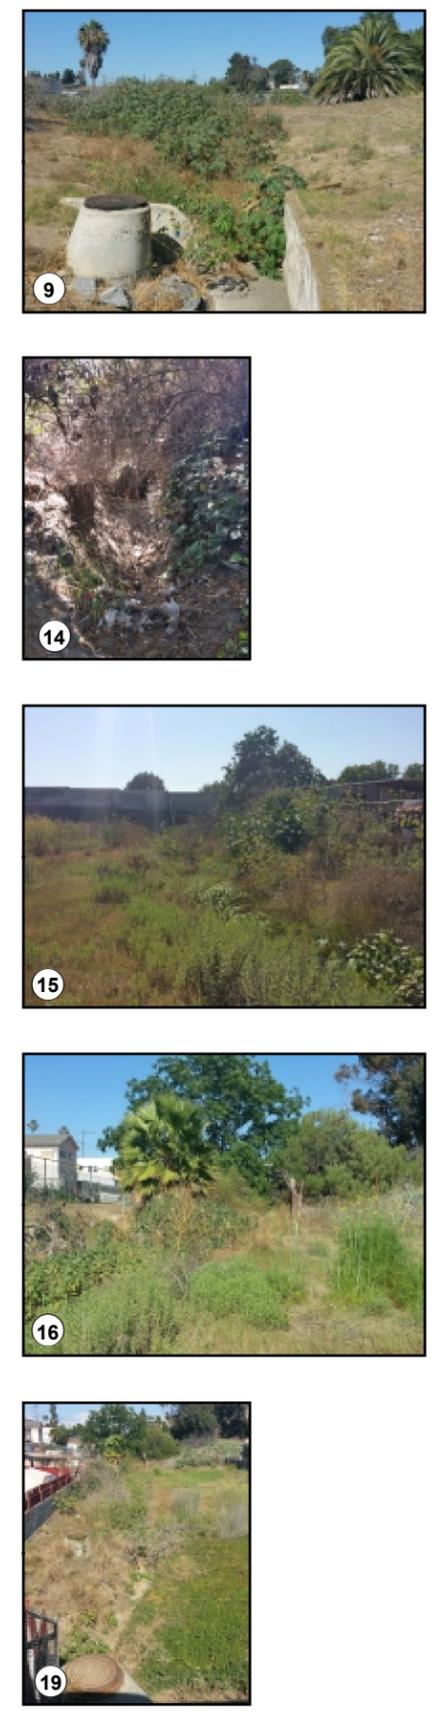
- **Channel Prioritization Score:**
57.4 out of 100
 - Flood Hazard Score:
54.4 out of 75
 - Water Quality Score:
3 out of 10
 - Community Input Score:
0 out of 10
 - Aesthetics Score:
0 out of 5
- **Capacity Prior to Maintenance:**
Less than 2-year storm event
- **Capacity After Maintenance (As-built Capacity):**
Less than 2-year storm event
- **Clogging Potential:** MEDIUM
- **Approximate Vegetation Coverage:** HIGH
- **Surrounding Area:** Residential
- **Infrastructure Failures:**
None
- **Site Evaluation Date:**
July 17, 2015
- **Notes/Comments:**

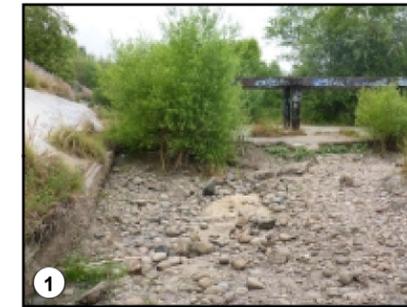
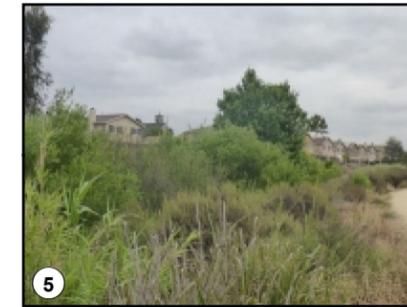
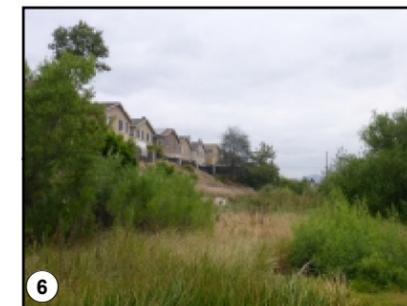
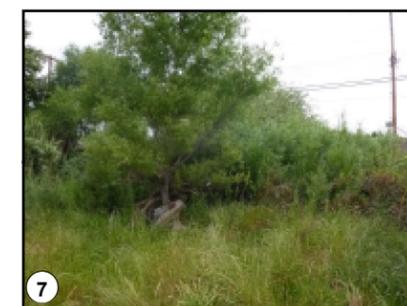
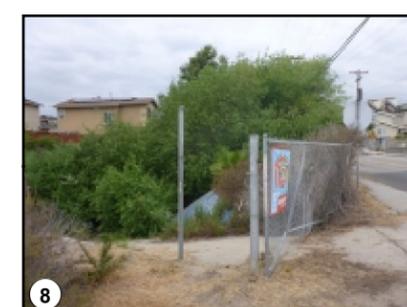
- Channel Prioritization Score: **72.0 out of 100**
 - Flood Hazard Score: **65.0 out of 75**
 - Water Quality Score: **2 out of 10**
 - Community Input Score: **5 out of 10**
 - Aesthetics Score: **0 out of 5**
- Capacity Prior to Maintenance: **5-year storm event**
- Capacity After Maintenance (As-built Capacity) : **25-year storm event**
- Clogging Potential: **HIGH**
- Approximate Vegetation Coverage: **HIGH**
- Surrounding Area: **Residential**
- Infrastructure Failures: **None**
- Site Evaluation Date: **May 5, 2015**
- Notes/Comments: **Moderate erosion in west end of channel near the foot bridge**

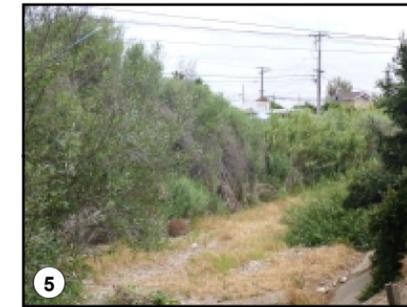
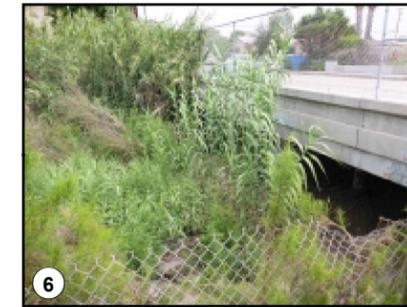
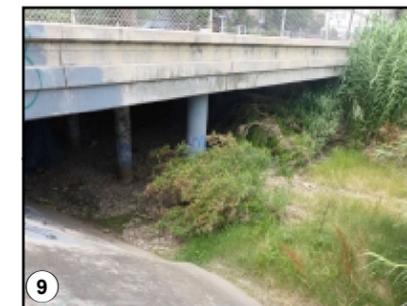
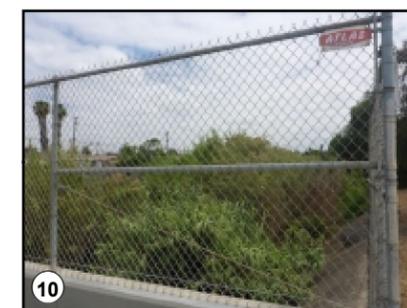
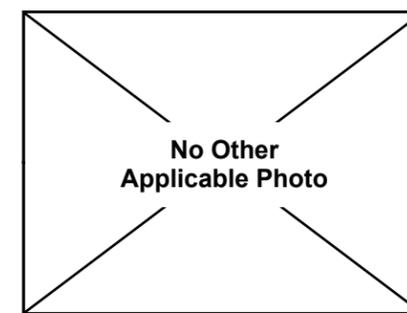
- Channel Prioritization Score: **71.8 out of 100**
 - Flood Hazard Score: **63.8 out of 75**
 - Water Quality Score: **3 out of 10**
 - Community Input Score: **5 out of 10**
 - Aesthetics Score: **0 out of 5**
- Capacity Prior to Maintenance: **10- to 25-year storm event**
- Capacity After Maintenance (As-built Capacity) : **50- to 100-year storm event**
- Clogging Potential: **HIGH**
- Approximate Vegetation Coverage: **HIGH**
- Surrounding Area: **Residential**
- Infrastructure Failures: **NONE**
- Site Evaluation Date: **May 5, 2015**
- Notes/Comments: **A high risk of vegetation flowing downstream and clogging the culvert exists. It was noted on the O&M Channel Maintenance Inspection Form completed for the channel by the City of San Diego that there is broken gunite near the foot bridge to the park.**

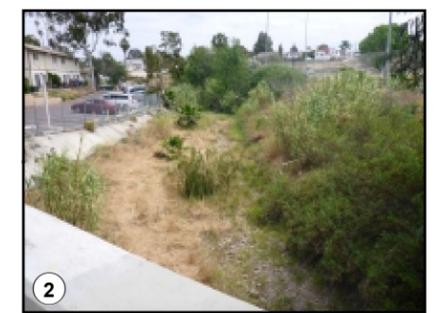
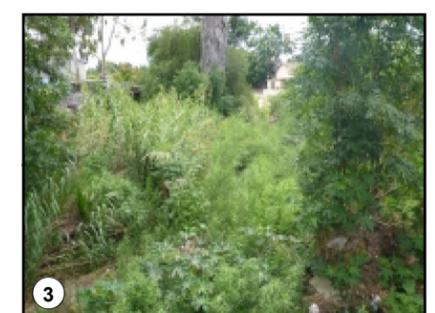
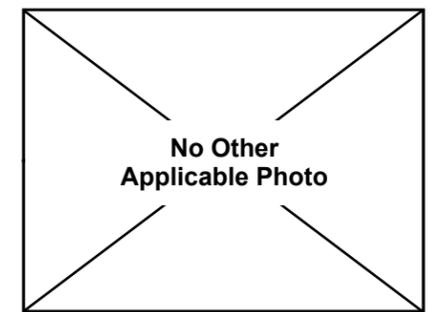
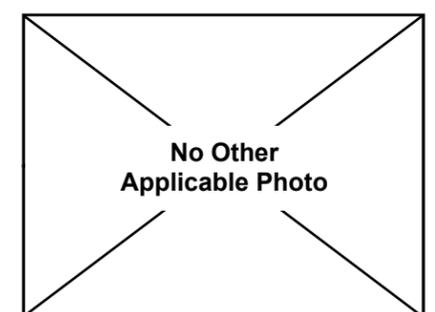
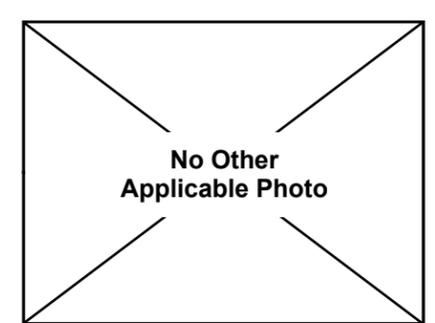
- Channel Prioritization Score: **64.3 out of 100**
 - Flood Hazard Score: **56.3 out of 75**
 - Water Quality Score: **3 out of 10**
 - Community Input Score: **5 out of 10**
 - Aesthetics Score: **0 out of 5**
- Capacity Prior to Maintenance: **2- to 5-year storm event**
- Capacity After Maintenance (As-built Capacity) : **10- to 25-year storm event**
- Clogging Potential: **MEDIUM**
- Approximate Vegetation Coverage: **HIGH**
- Surrounding Area: **Residential**
- Infrastructure Failures: **None**
- Site Evaluation Date: **May 5, 2015**
- Notes/Comments: *It was noted on the O&M Channel Maintenance Inspection Form that there is heavy vegetation in the majority of the channel reach. A high risk of vegetation flowing downstream and clogging the culvert exists.*
