**SUMMARY OF FINDINGS FOR THE
ANNUAL DRAINAGE CHANNEL FIELD
ASSESSMENT AND MAINTENANCE PRIORITIZATION
PROJECT (PHASE 1)
FOR
THE CITY OF SAN DIEGO – MASTER STORM WATER
SYSTEM MAINTENANCE PROGRAM (MMP) MAP 92:
35TH ST & MARTIN AVE**

**Job Number 17204-D
August 4, 2015**

Prepared For:
City of San Diego
2781 Caminito Chollas
San Diego, California 92105

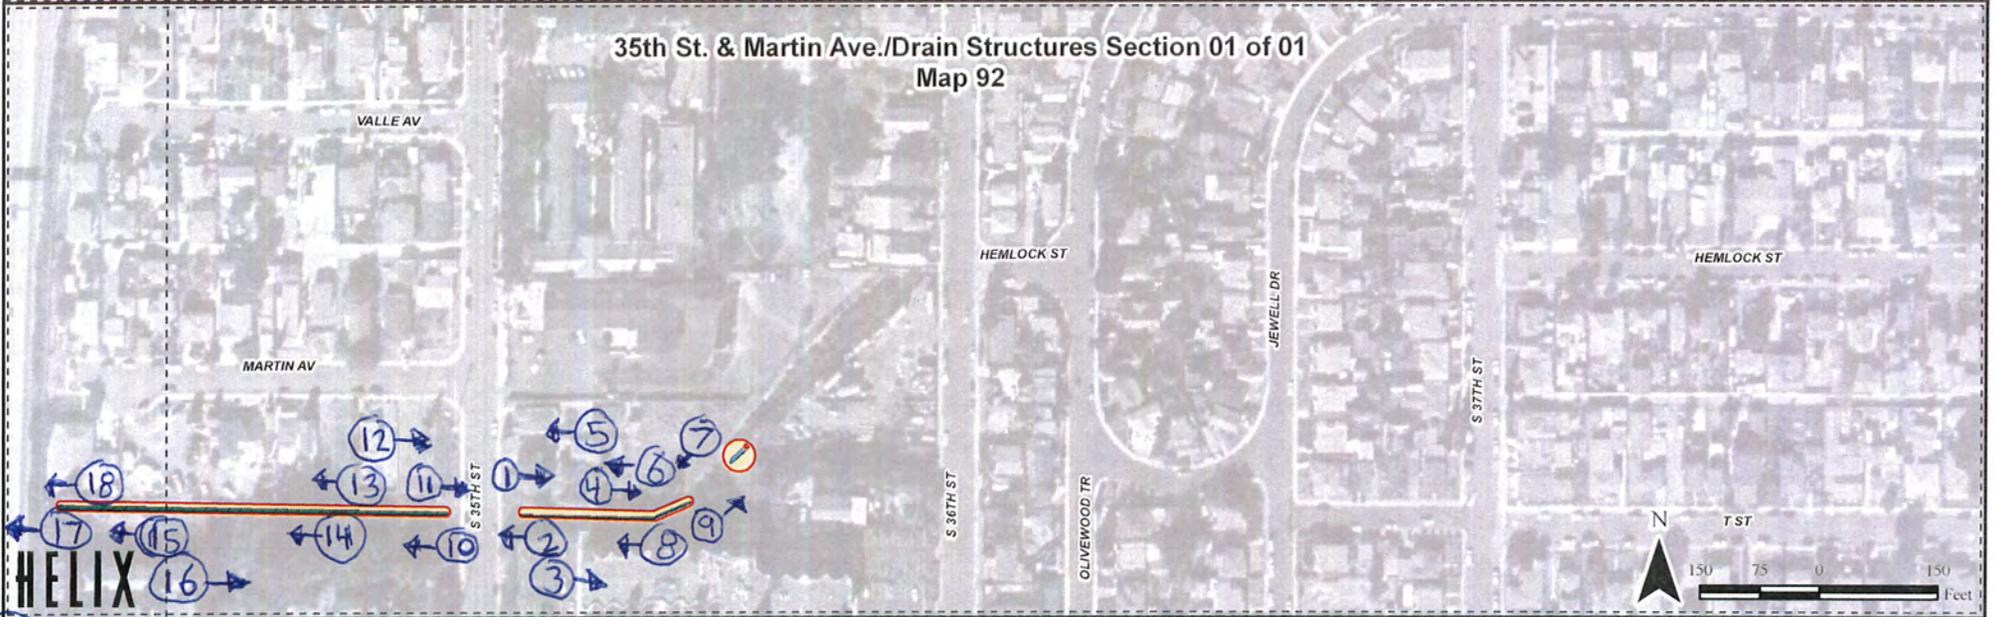
35th St. & Martin Ave./Drain Structures Section 01 of 01
Map 92

Sediment built up after out fall on East side of channel.
