**SUMMARY OF FINDINGS FOR THE
ANNUAL DRAINAGE CHANNEL FIELD
ASSESSMENT AND MAINTENANCE PRIORITIZATION
PROJECT (PHASE 1)
FOR
THE CITY OF SAN DIEGO – MASTER STORM WATER
SYSTEM MAINTENANCE PROGRAM (MMP) 4300
MISSION BAY DRIVE**

**Job Number 17204-D
August 4, 2015**

August 4, 2015

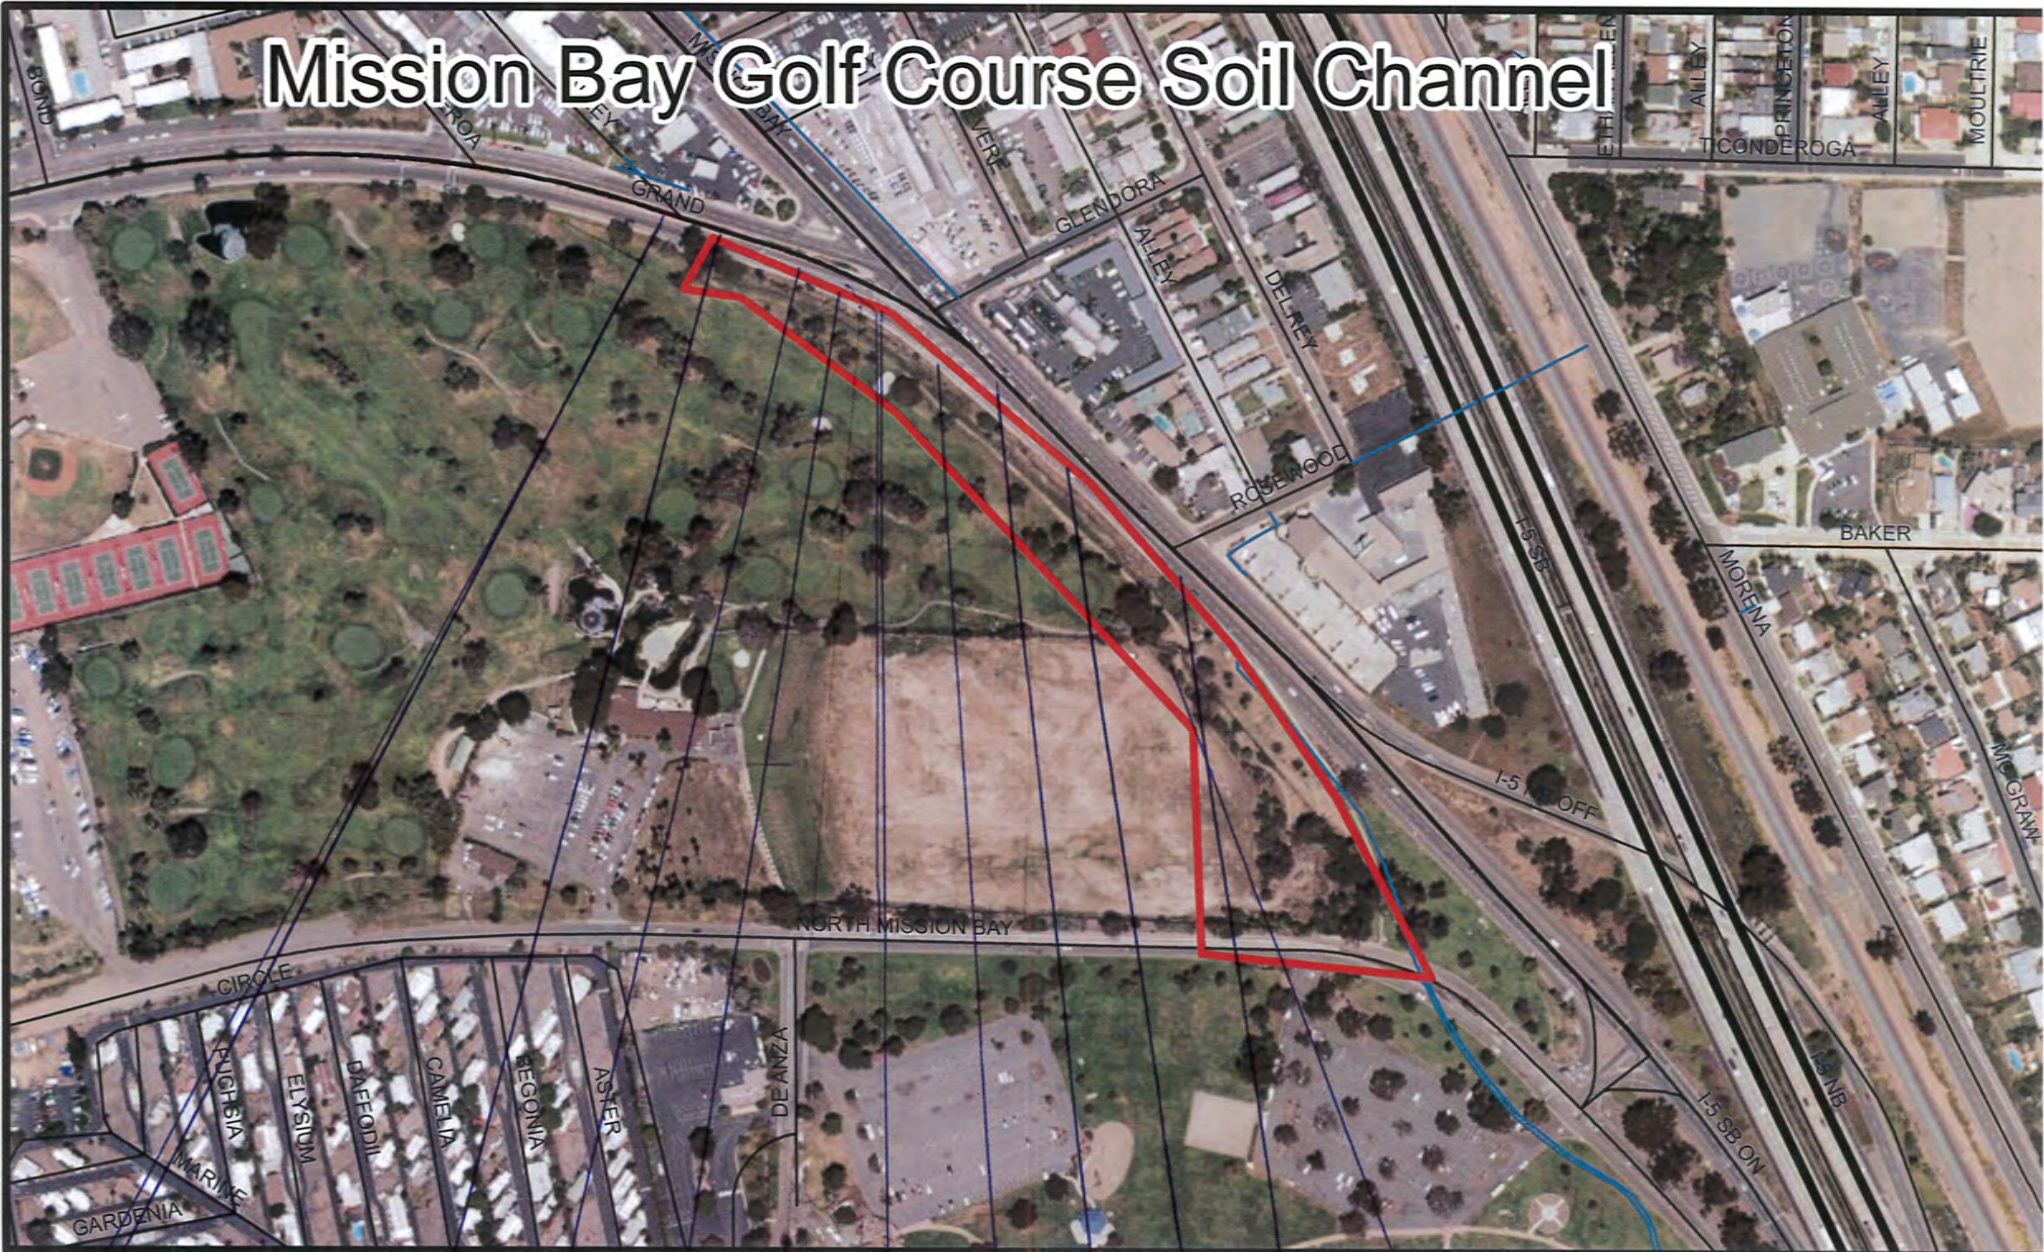
Mission Bay Golf Course Soil Channel

11 10 9 8 7 6 5 4 3 2 1

PHOTOS 1-10 TAKEN LOOKING

NORTHWEST

PHOTO 11 TAKEN
LOOKING
SOUTHEAST

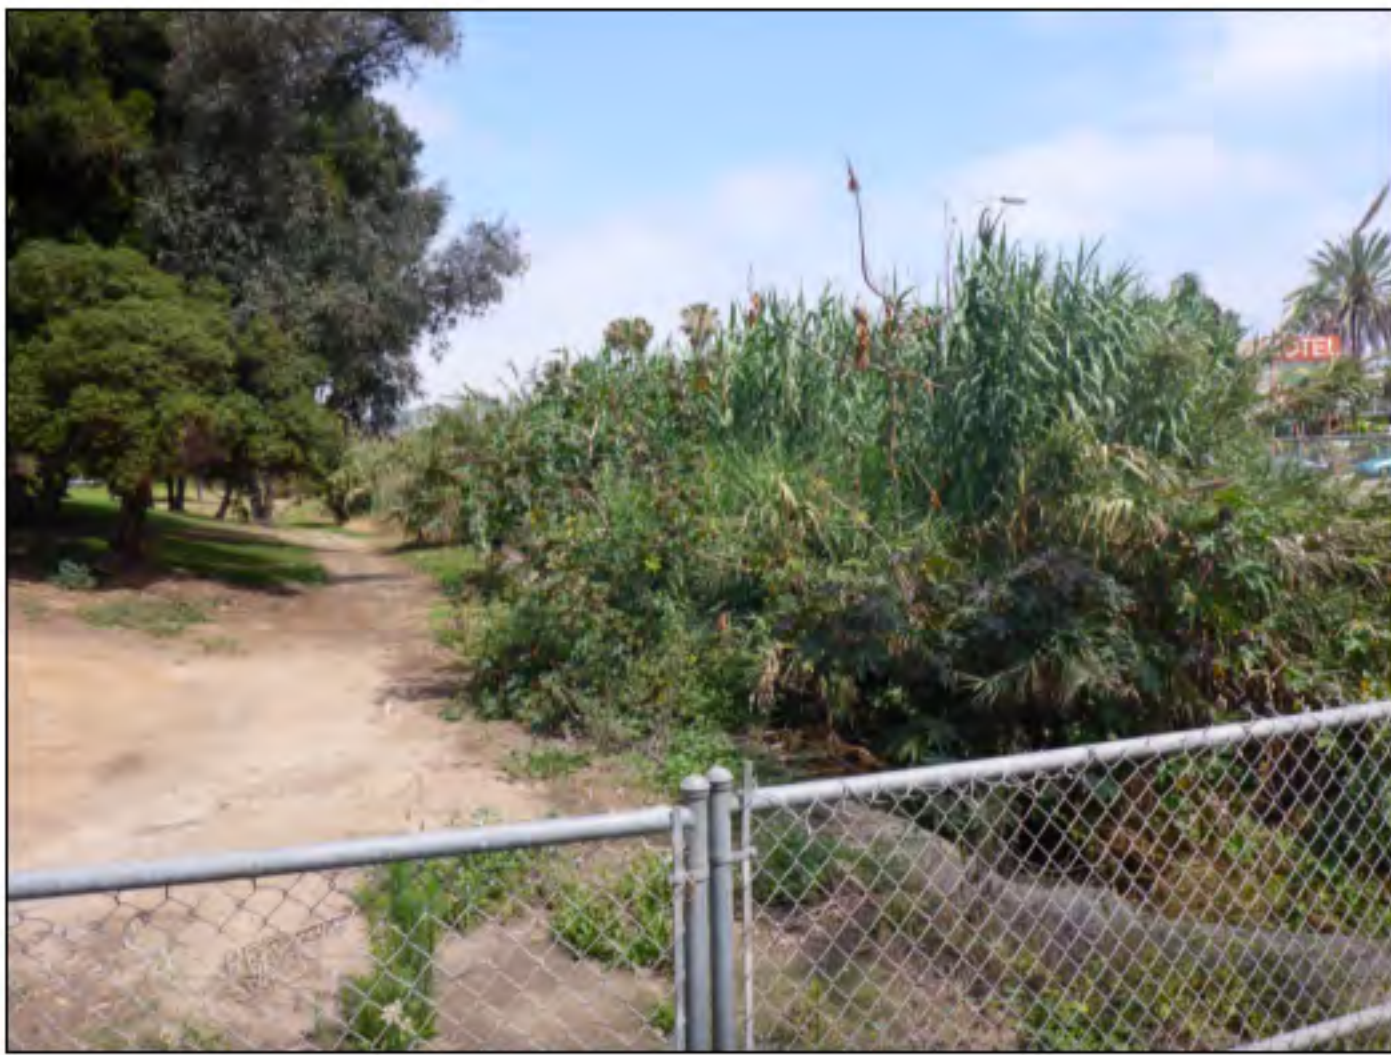
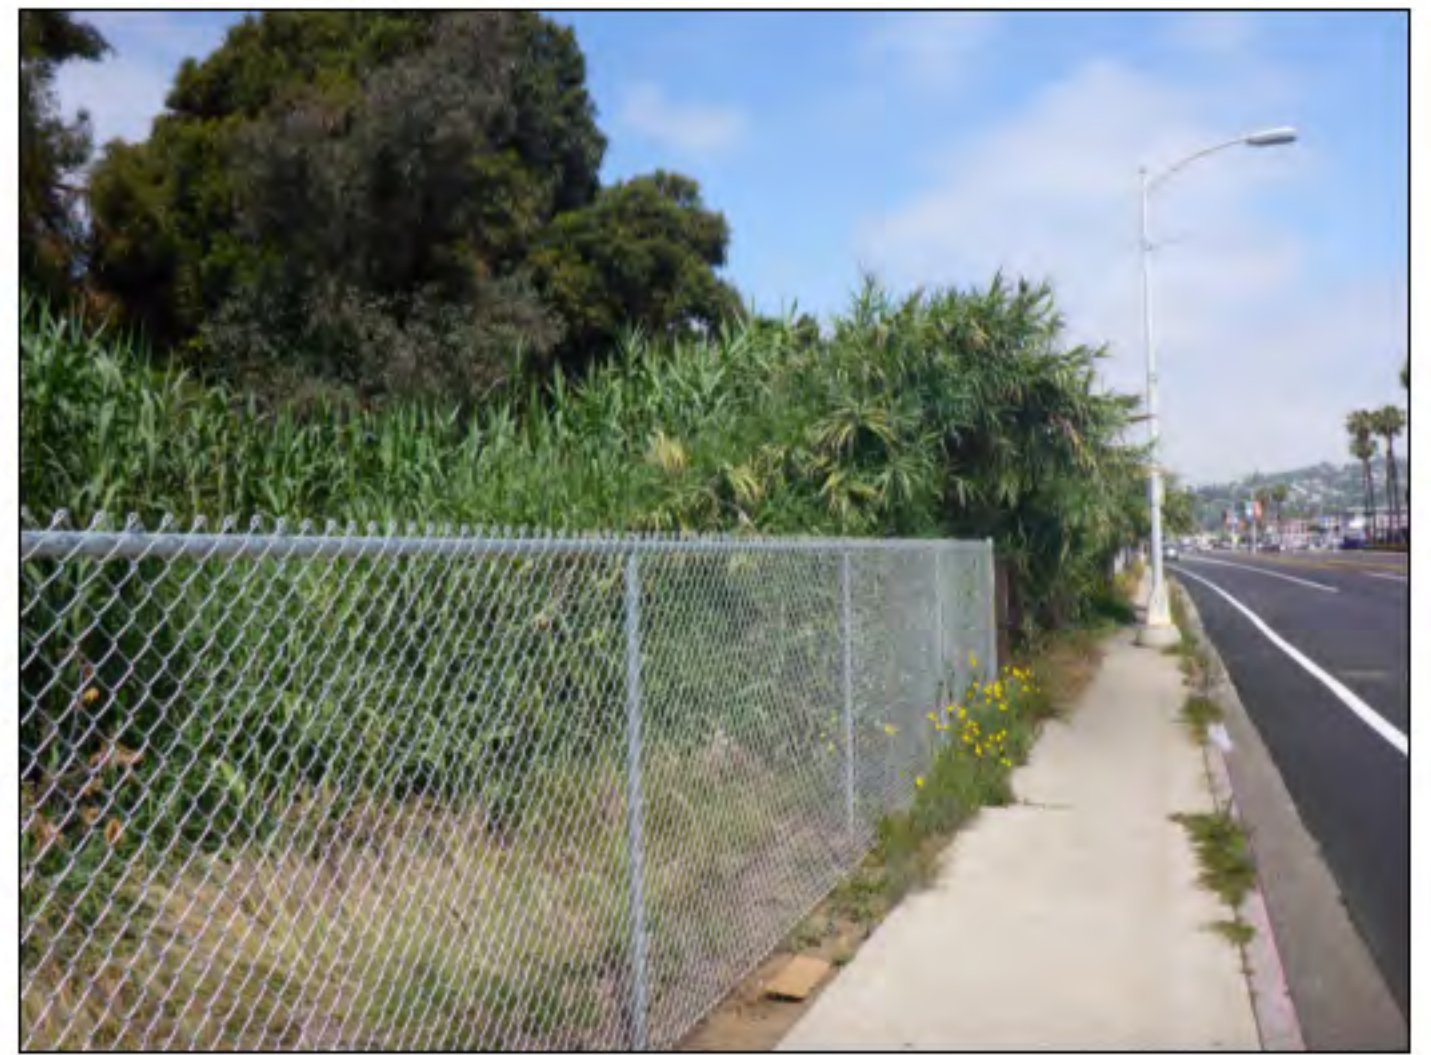
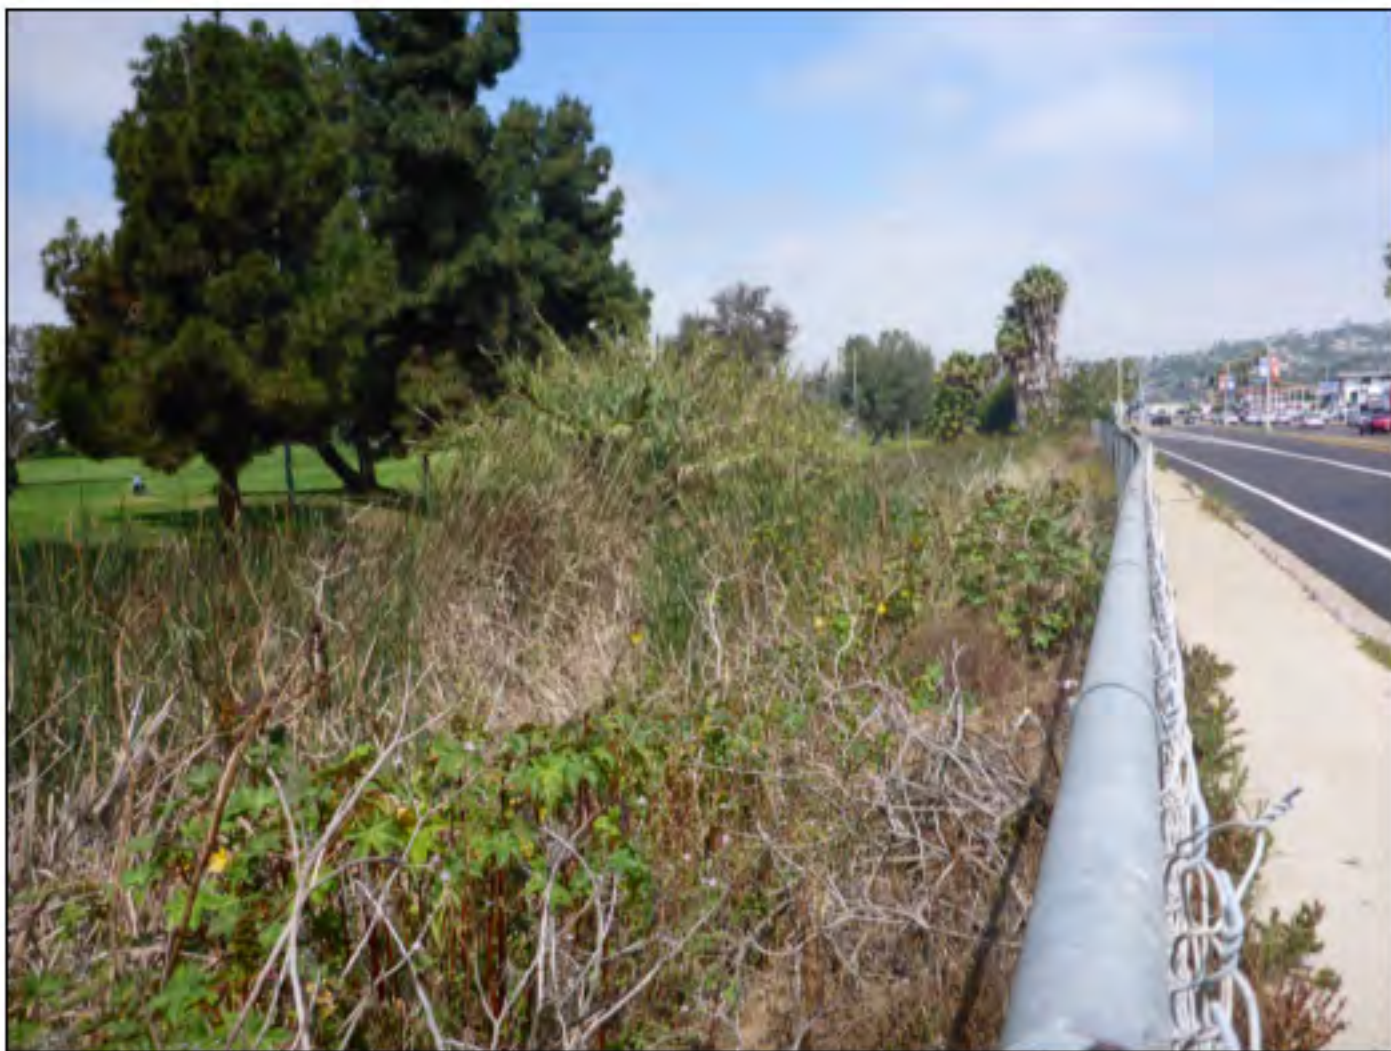
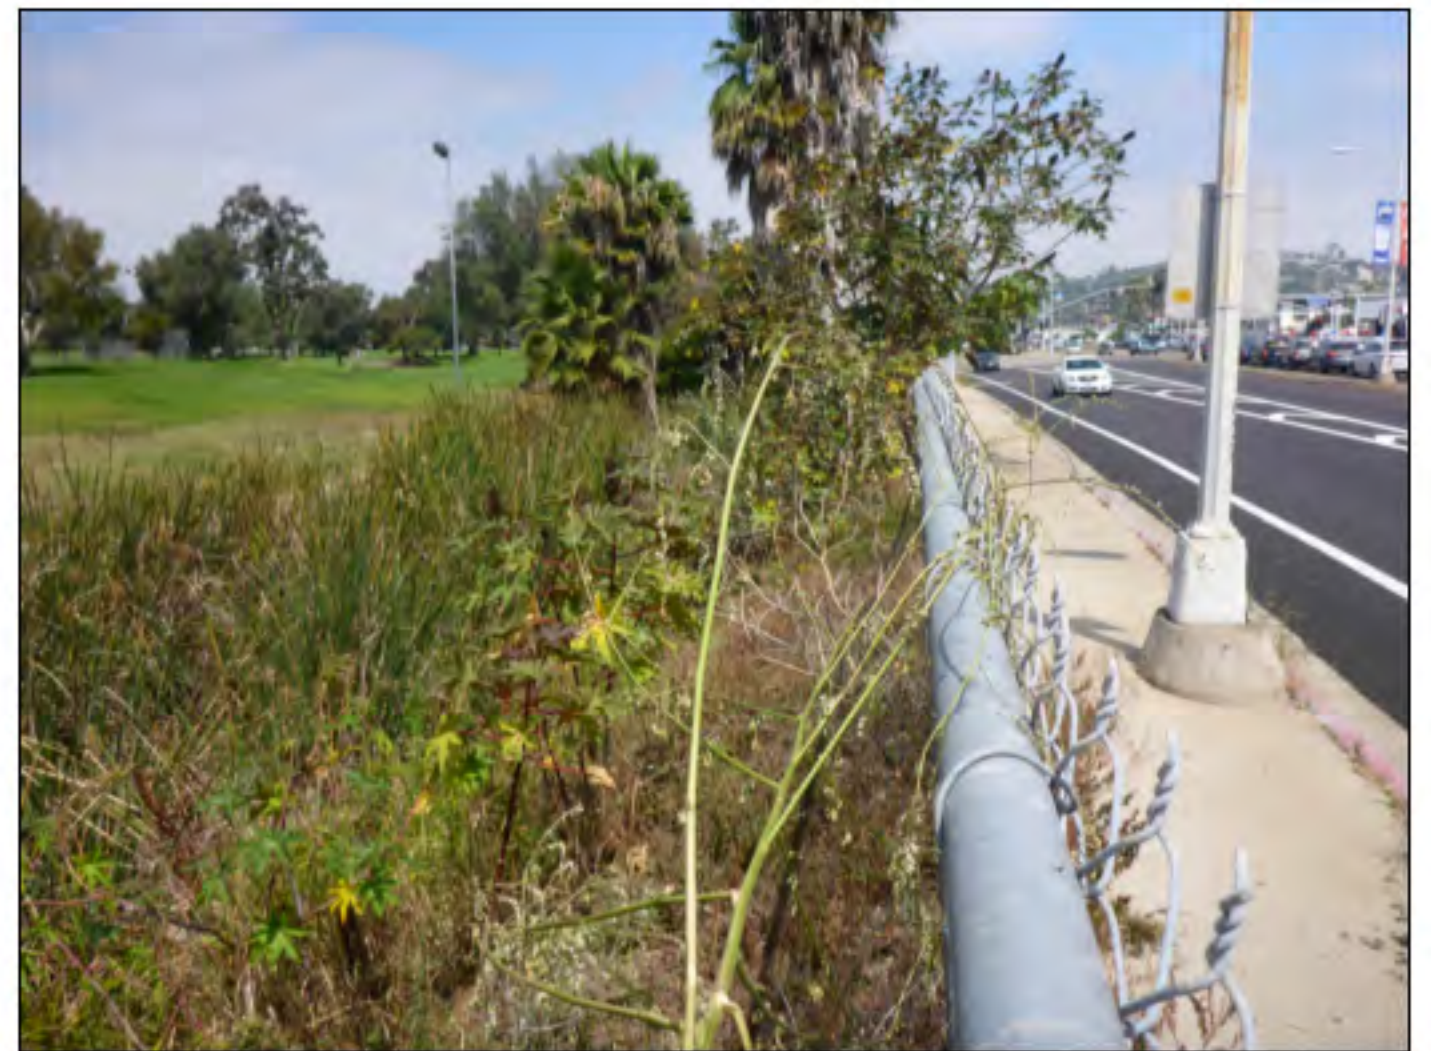
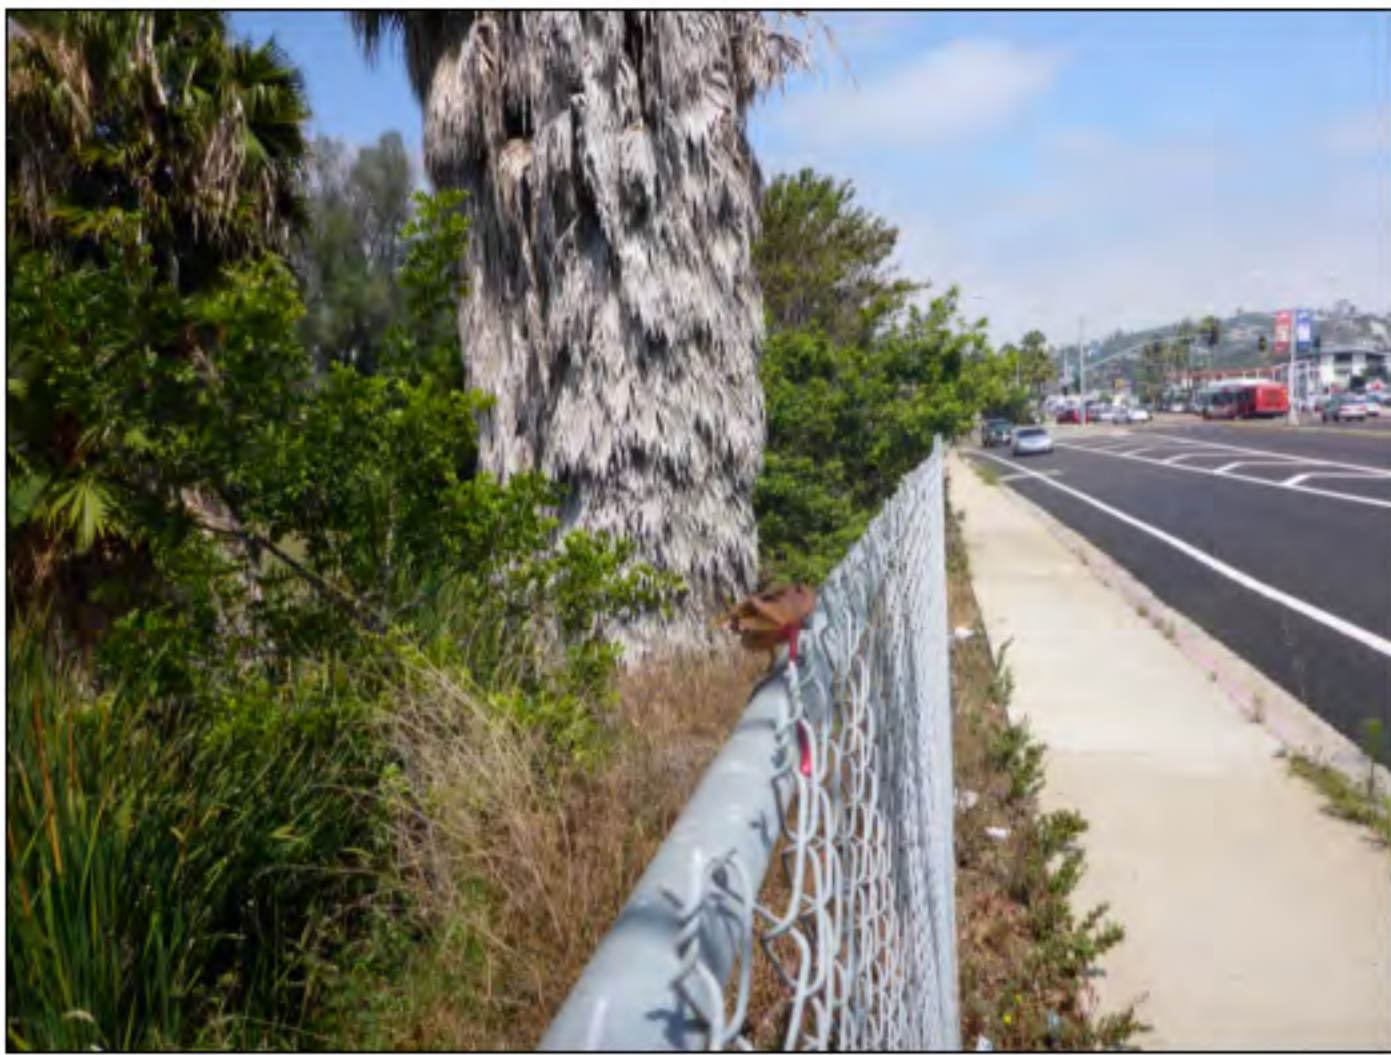
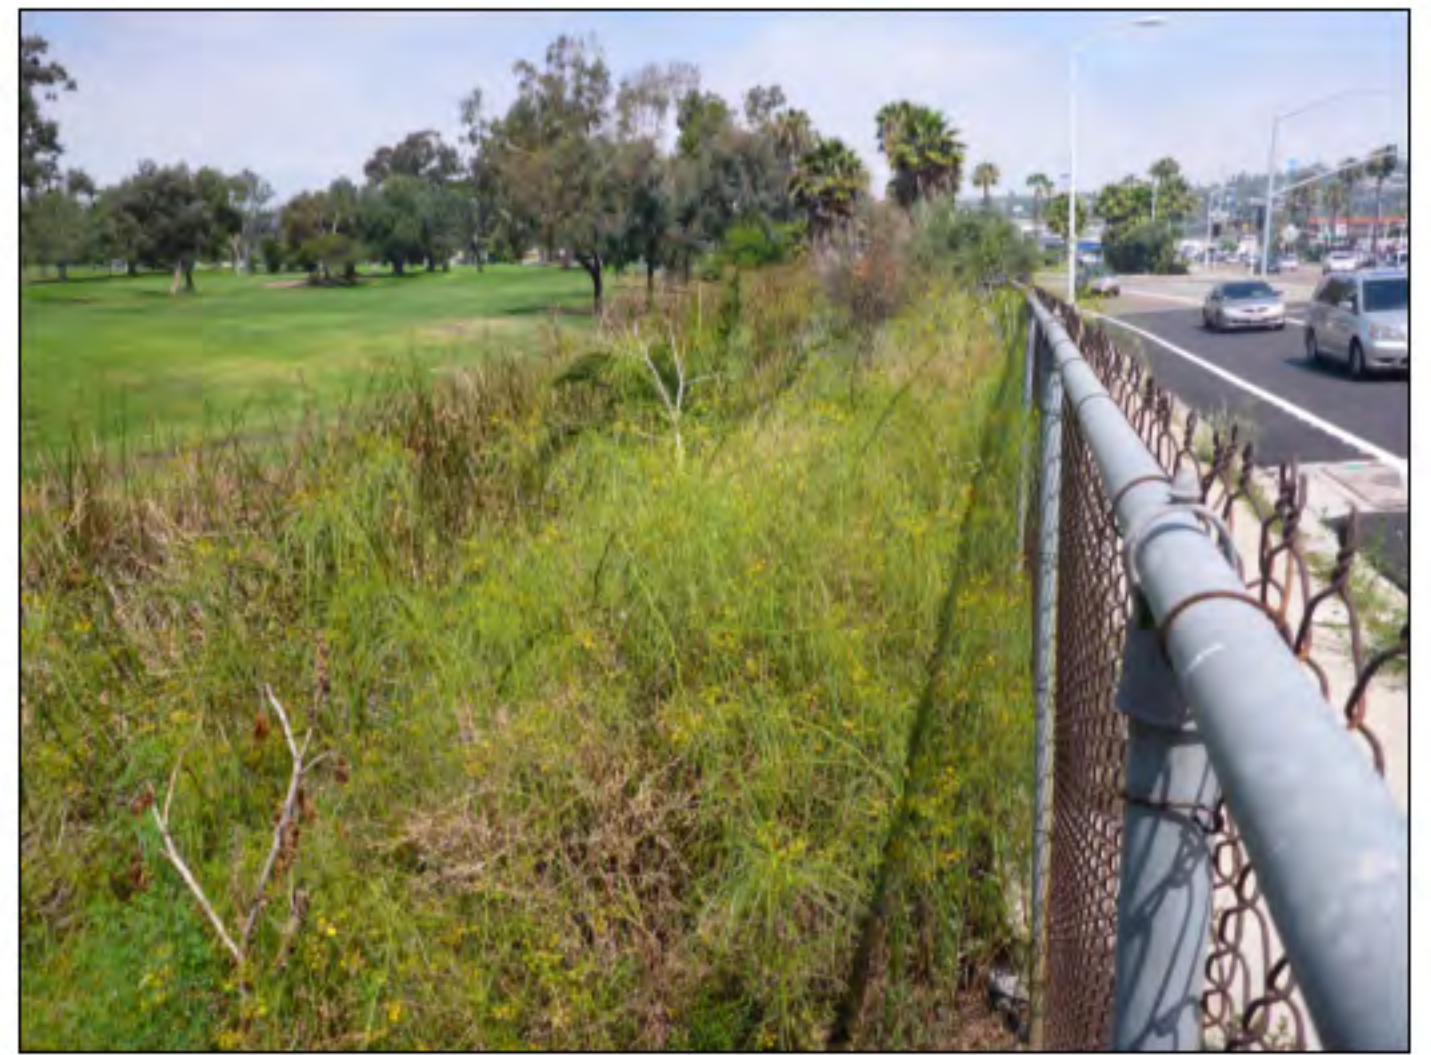
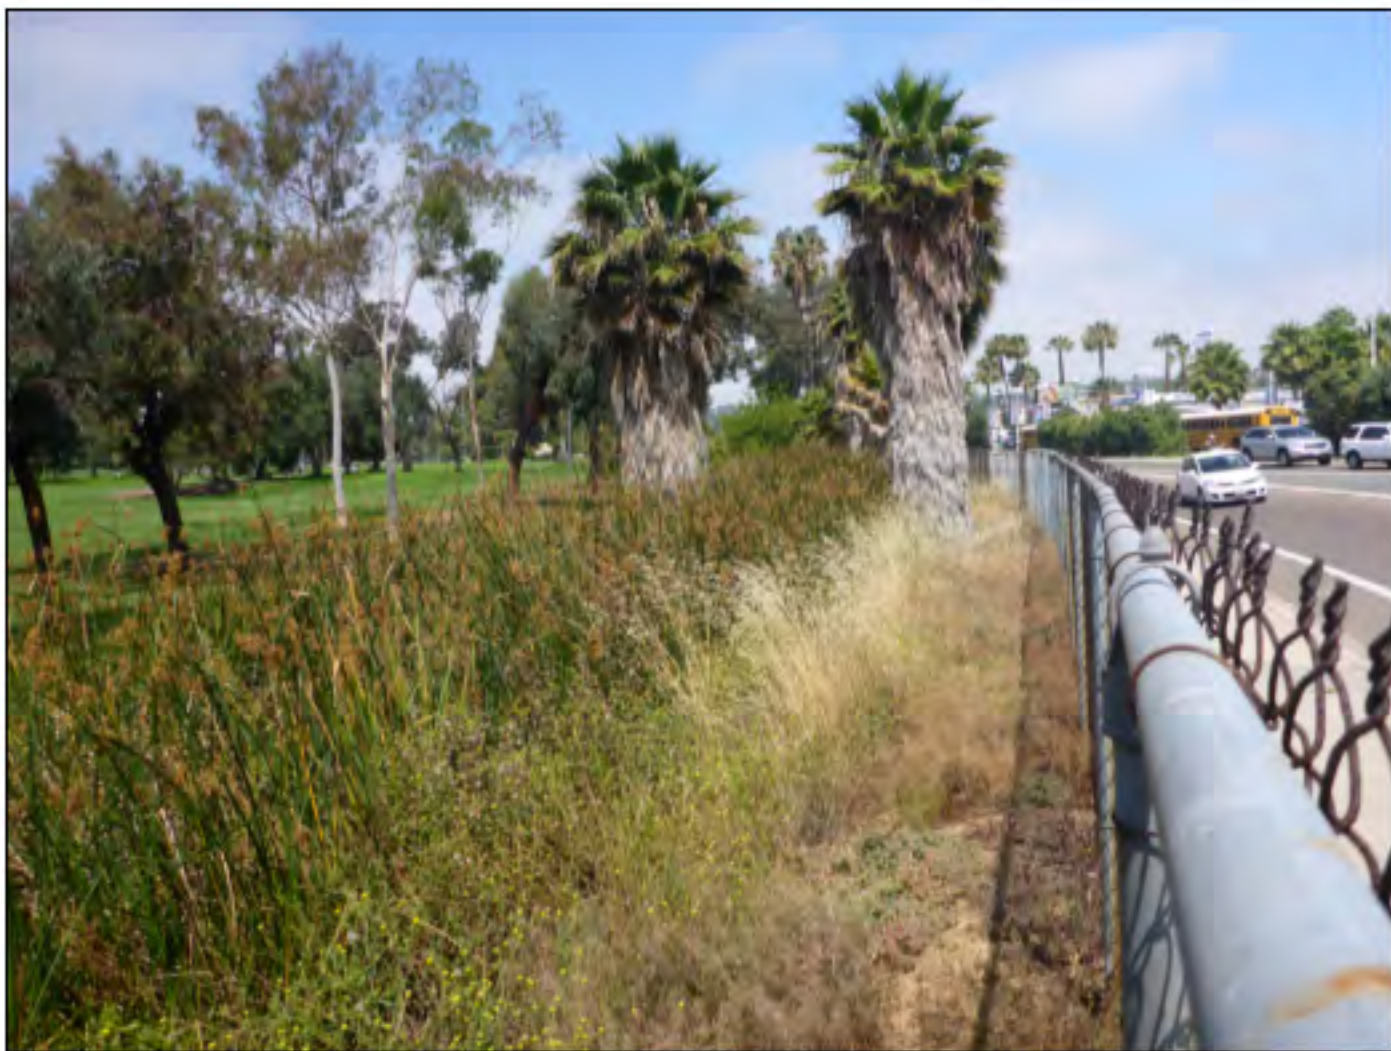
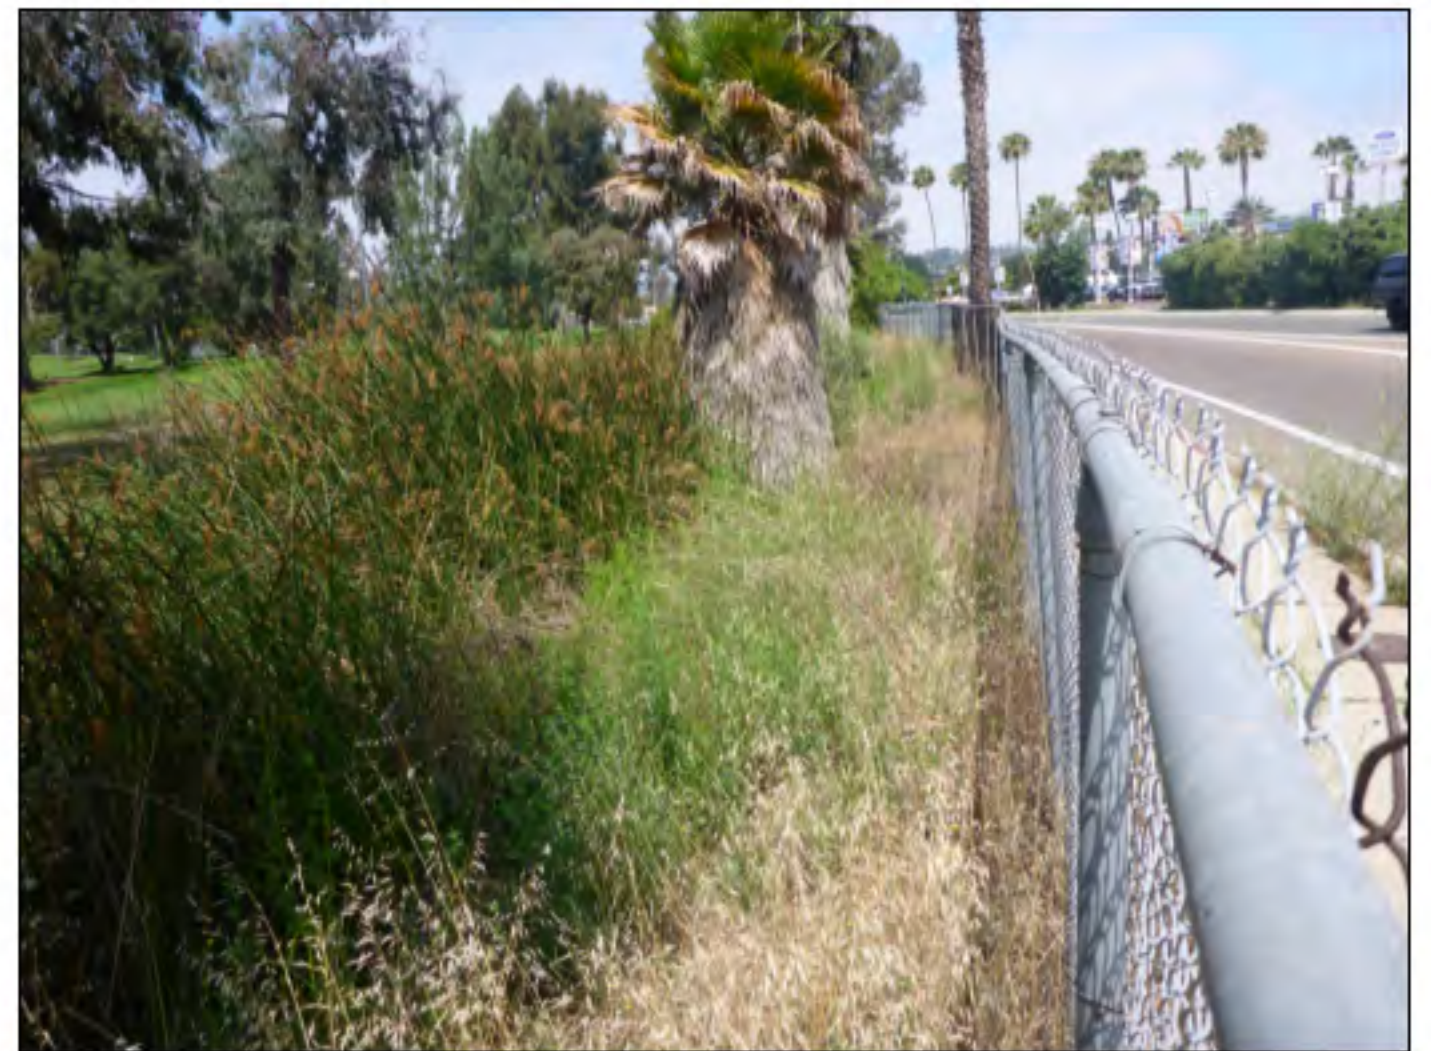
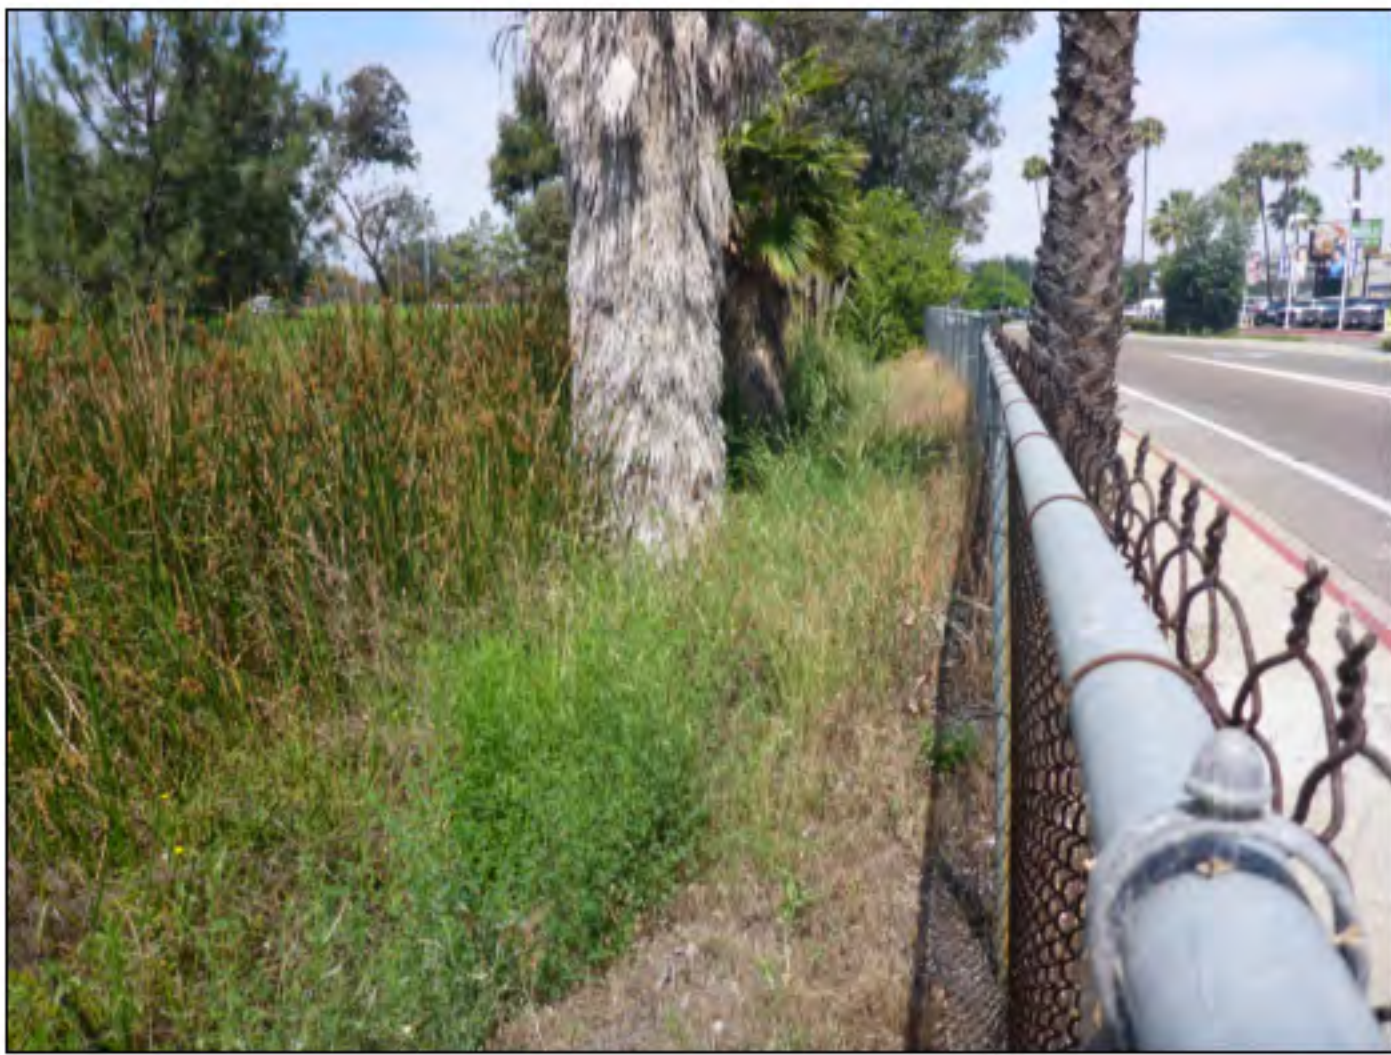
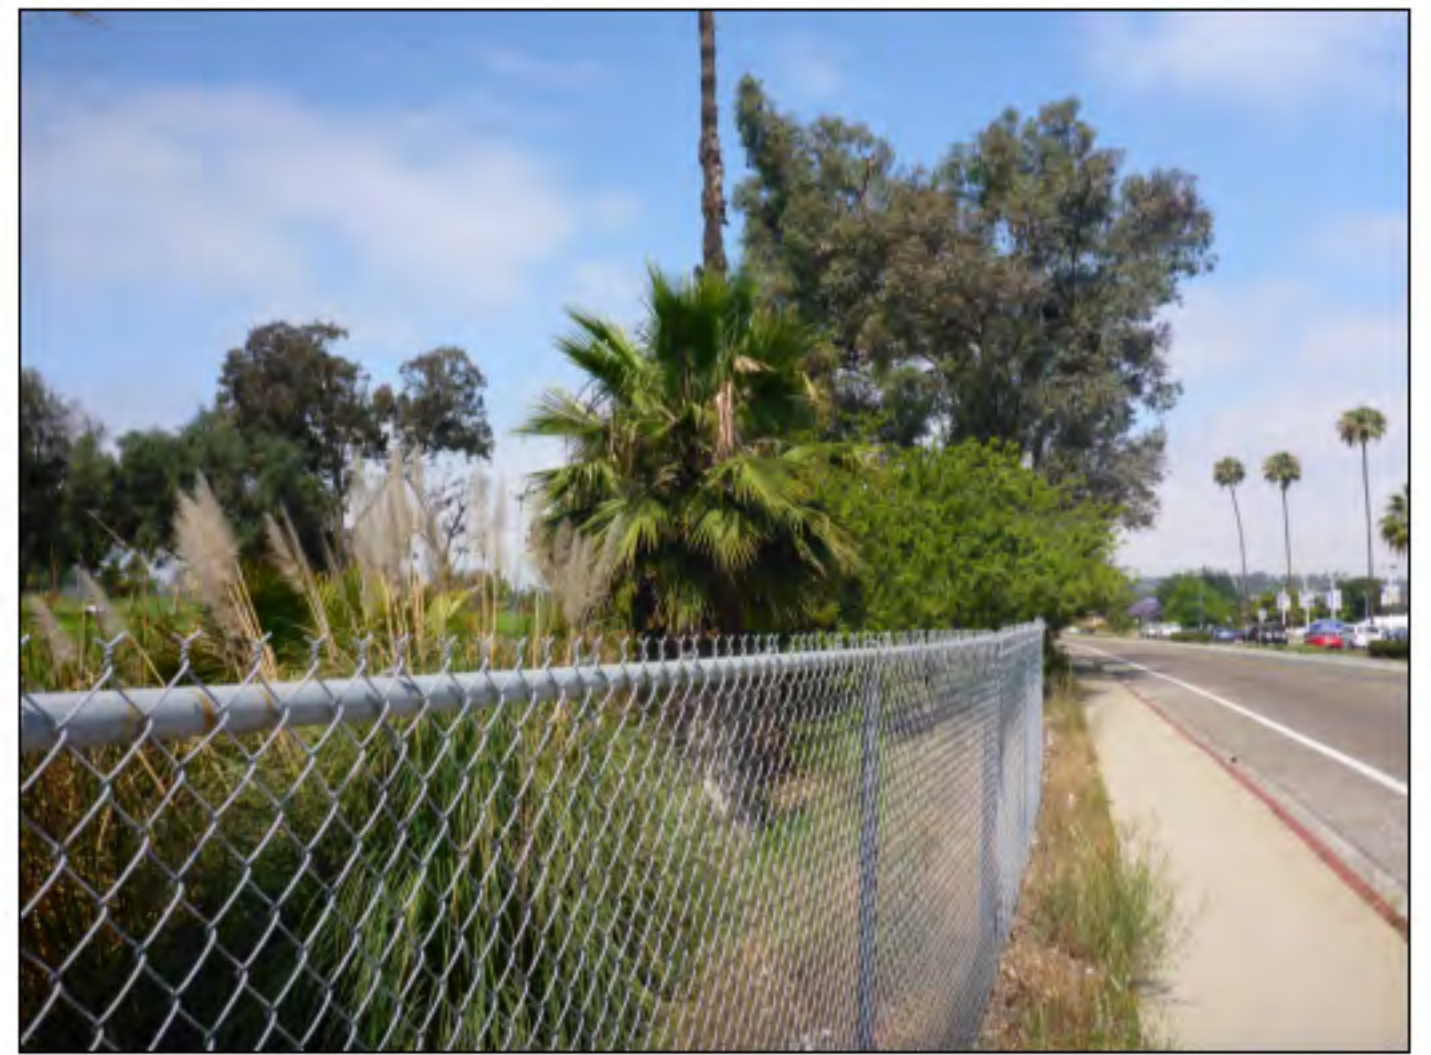
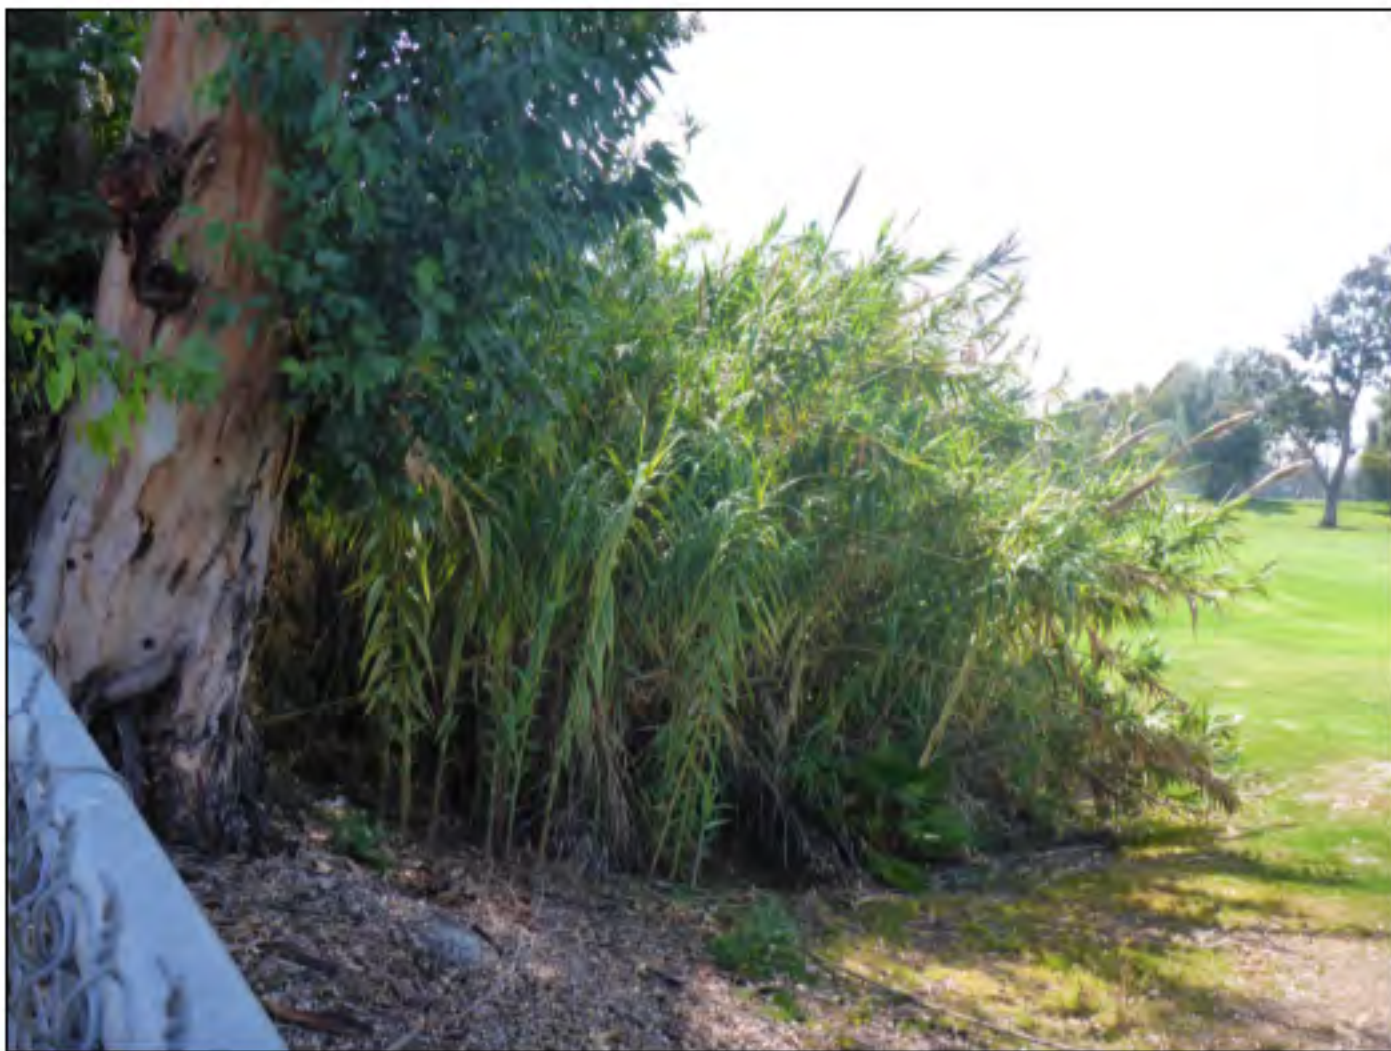
- Based on site photos taken by the City of San Diego, heavy vegetation exists in the channel. A high risk of vegetation flowing downstream and clogging the culvert exists.

| Item | Condition | Comments |
|---|---|--|
| 3. Trash/Debris | (1) 2 3 N/A | Type of trash and source: <i>veg. & sediment & trees</i> |
| 6. Vegetation | (1) 2 3 N/A | Approx. Coverage/Density of Vegetation: <i>100%</i> |
| 7. Sediment | 1 (2) 3 N/A | Approx. Depth/Coverage of Sediment: <i>65%</i> |

| Item | Condition | Comments |
|---|---|---|
| 3. Clogging | 1 (2) 3 N/A | Lots of Veg & Palms (may) clog at West End of channel |

It is recommended that this drainage channel be maintained to increase the current capacity of the channel from a 5-year storm event back to a 100-year storm event capacity.
