**SUMMARY OF FINDINGS FOR THE
ANNUAL DRAINAGE CHANNEL FIELD ASSESSMENT
AND MAINTENANCE PRIORITIZATION PROJECT
(PHASE 1)
FOR
THE CITY OF SAN DIEGO –
MASTER STORM WATER SYSTEM MAINTENANCE
PROGRAM (MMP) MAP 47: 7969 AND 7971 ENGINEER
ROAD**

Job Number 17204-D

August 4, 2015

RICK ENGINEERING COMPANY

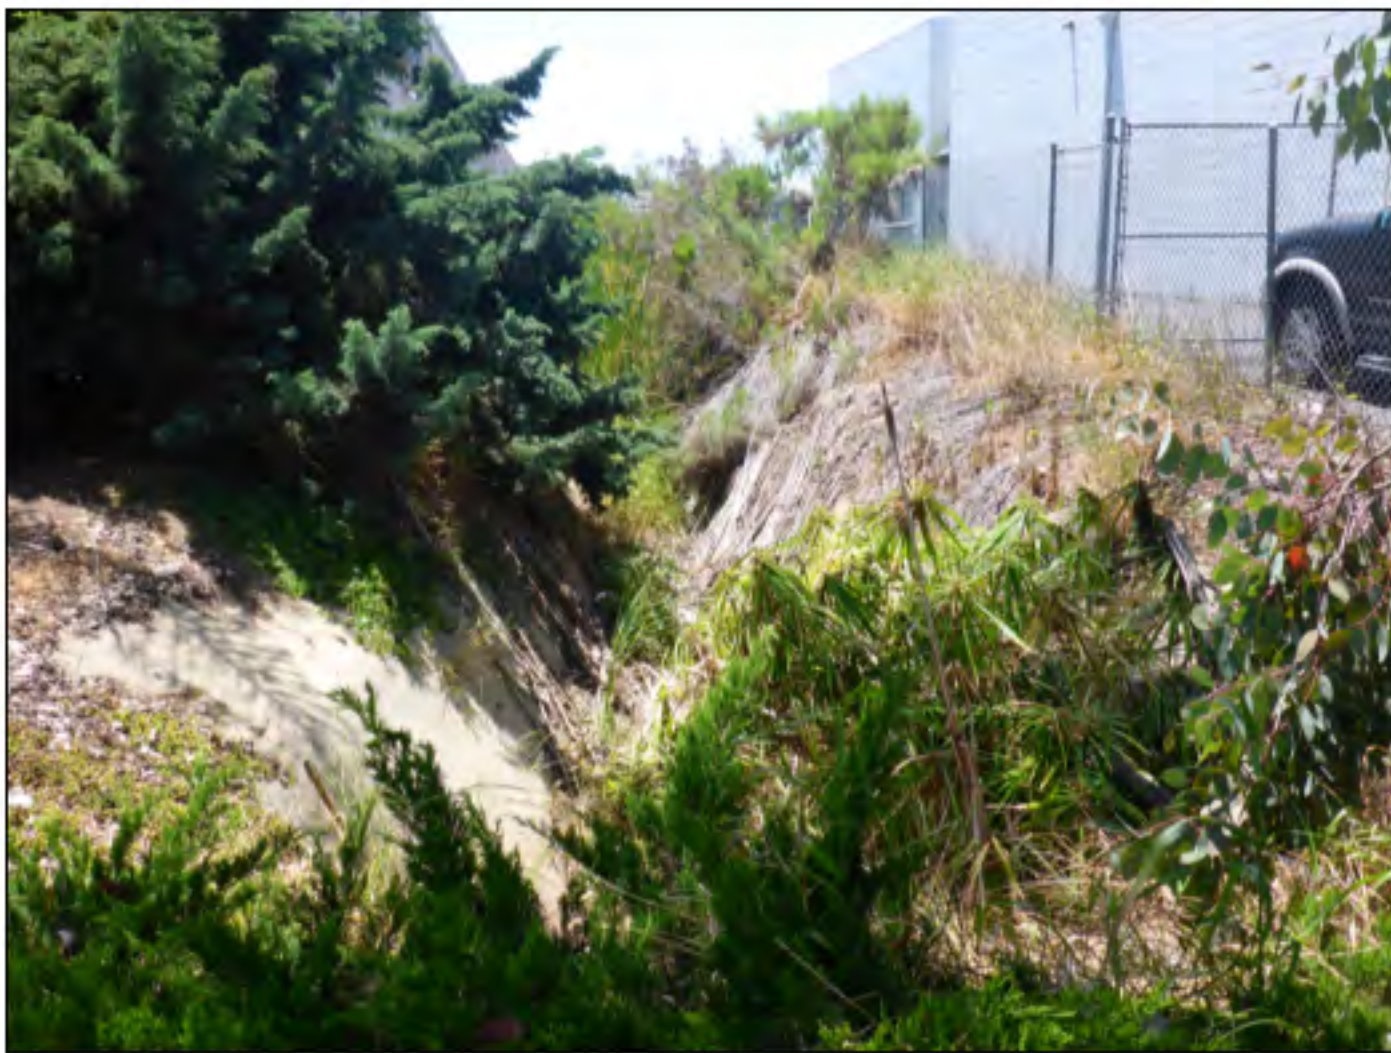
Engineer Road.1 (5-12-2015).JPG

Trash and Palm cuttings Behind
7990 Dagget St in channel

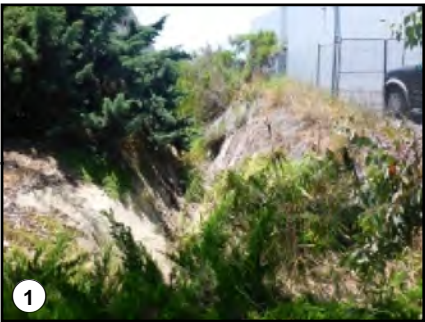
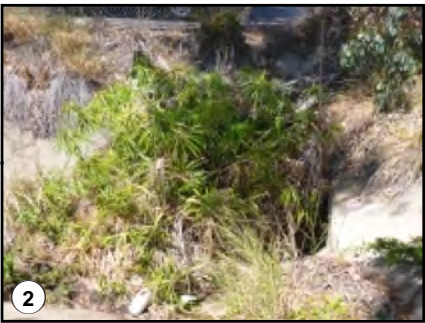
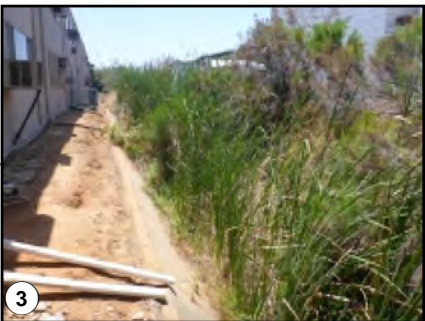
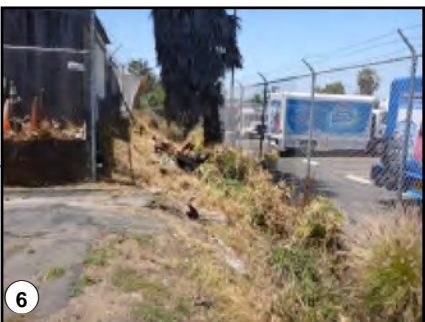
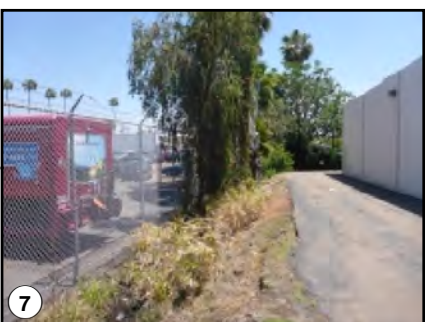
Photos:

- **Channel Prioritization Score:**
89.8 out of 100
 - **Flood Hazard Score:**
73.8 out of 75
 - **Water Quality Score:**
6 out of 10
 - **Community Input Score:**
5 out of 10
 - **Aesthetics Score:**
5 out of 5
- **Capacity Prior to Maintenance:**
Less than 2-year storm event
- **Capacity After Maintenance (As-built Capacity) :**
100-year storm event
- **Clogging Potential:** *HIGH*
- **Approximate Vegetation Coverage:** *HIGH*
- **Surrounding Area:** *Industrial*
- **Infrastructure Failures:**
NONE
- **Site Evaluation Date:**
May 12, 2015
- **Notes/Comments:**
There are trash and palm cuttings behind 7990 Dagget St. in Channel

It is recommended that this drainage channel be maintained to increase the current capacity of the channel from less than a 2-year storm event back to a 100-year storm event capacity.
