**SUMMARY OF FINDINGS FOR THE  
ANNUAL DRAINAGE CHANNEL FIELD  
ASSESSMENT AND MAINTENANCE PRIORITIZATION  
PROJECT (PHASE 1)  
FOR  
THE CITY OF SAN DIEGO – MASTER STORM WATER  
SYSTEM MAINTENANCE PROGRAM (MMP) MAP 67:  
AUBURN CREEK CHANNEL (SECTION 1 OF 4)**

**Job Number 17204-D  
August 4, 2015**

Prepared By:  
**Rick Engineering Company**  
**Water Resources Division**  
5620 Friars Road  
San Diego, California 92110-2596  
(619) 291-0707

August 4, 2015

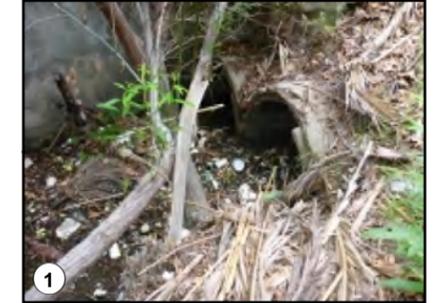
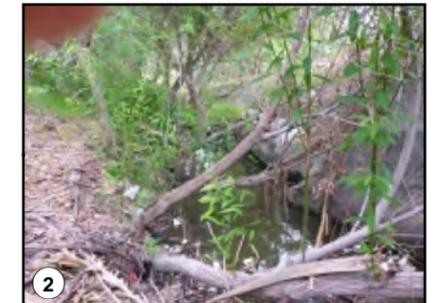
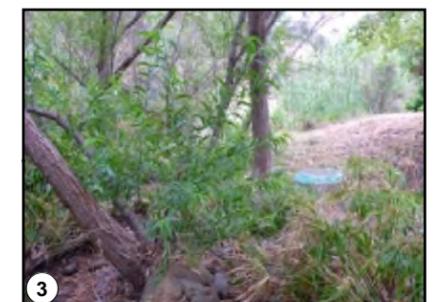
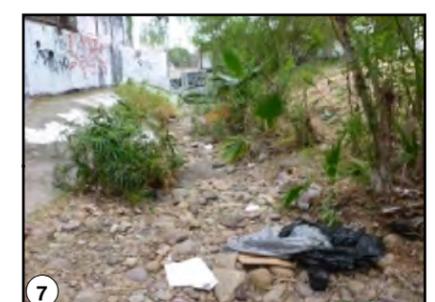
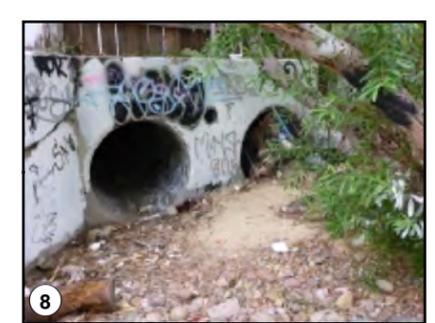
**Photos:**

- **Channel Prioritization Score:**  
*71.5 out of 100*
  - **Flood Hazard Score:**  
*62.5 out of 75*
  - **Water Quality Score:**  
*4 out of 10*
  - **Community Input Score:**  
*5 out of 10*
  - **Aesthetics Score:**  
*0 out of 5*
- **Capacity Prior to Maintenance:**  
*25- to 50-year storm event*
- **Capacity After Maintenance (As-built Capacity):**  
*100-year storm event*
- **Clogging Potential:** *HIGH*
- **Approximate Vegetation Coverage:** *LOW*
- **Surrounding Area:** *Residential*
- **Infrastructure Failures:**  
*Slope Failure*
- **Site Evaluation Date:**  
*May 6, 2015*
- **Notes/Comments:**  
*One of the side slopes in the channel has failed. It is recommended that this be maintained.*

It is recommended that this drainage channel be maintained to increase the current capacity of the channel from a 25- to 50-year storm event back to a 100-year storm event capacity.
