**SUMMARY OF FINDINGS FOR THE  
ANNUAL DRAINAGE CHANNEL FIELD  
ASSESSMENT AND MAINTENANCE  
PRIORITIZATION PROJECT (PHASE 1)  
FOR  
THE CITY OF SAN DIEGO –  
MASTER STORM WATER SYSTEM MAINTENANCE  
PROGRAM (MMP) MAP 69: AUBURN CREEK CHANNEL  
(SECTION 3 OF 4)**

**Job Number 17204-D**

**August 4, 2015**

**Channel Prioritization Assessment Sheet for Auburn Creek Channel (Section 3 of 4) MMP Map 69**

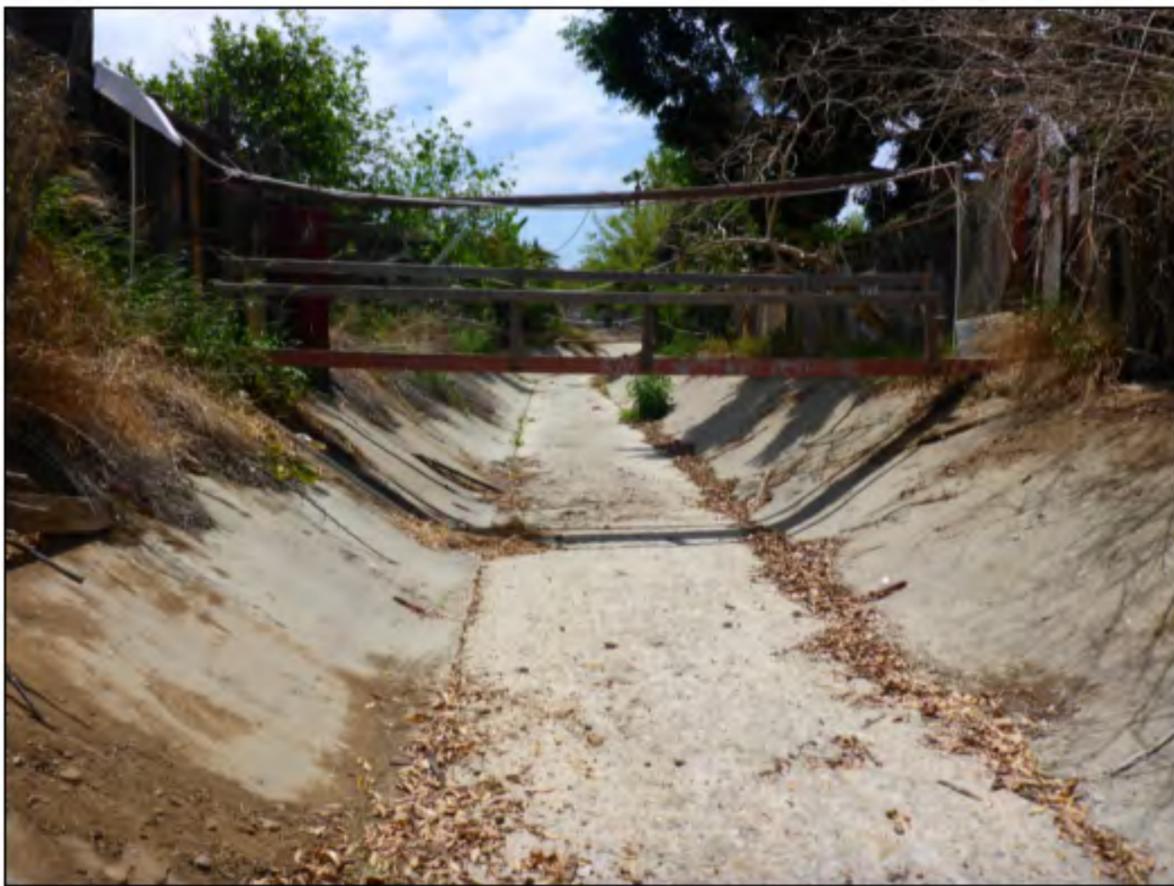
Home Avenue Channel.12 (5-4-2015).JPG

- Based on the site photos taken by the City of San Diego, vegetation has grown down from the top of the channel banks over the concrete side slopes. A high risk of vegetation flowing downstream and clogging the culvert exists.

It is recommended that this drainage channel be maintained to preserve the 100-year storm event capacity. Although the channel currently has 100-year storm event capacity, maintaining it will preserve the 100-year storm event capacity by preventing vegetation from flowing downstream and clogging the culvert.
