**SUMMARY OF FINDINGS FOR THE
ANNUAL DRAINAGE CHANNEL FIELD
ASSESSMENT AND MAINTENANCE PRIORITIZATION
PROJECT (PHASE 1)
FOR
THE CITY OF SAN DIEGO – MASTER STORM WATER
SYSTEM MAINTENANCE PROGRAM (MMP) MAP 70:
AUBURN CREEK CHANNEL (SECTION 4 OF 4)**

**Job Number 17204-D
August 4, 2015**

Prepared For:
City of San Diego
2781 Caminito Chollas
San Diego, California 92105

Prepared By:
Rick Engineering Company
Water Resources Division
5620 Friars Road
San Diego, California 92110-2596
(619) 291-0707

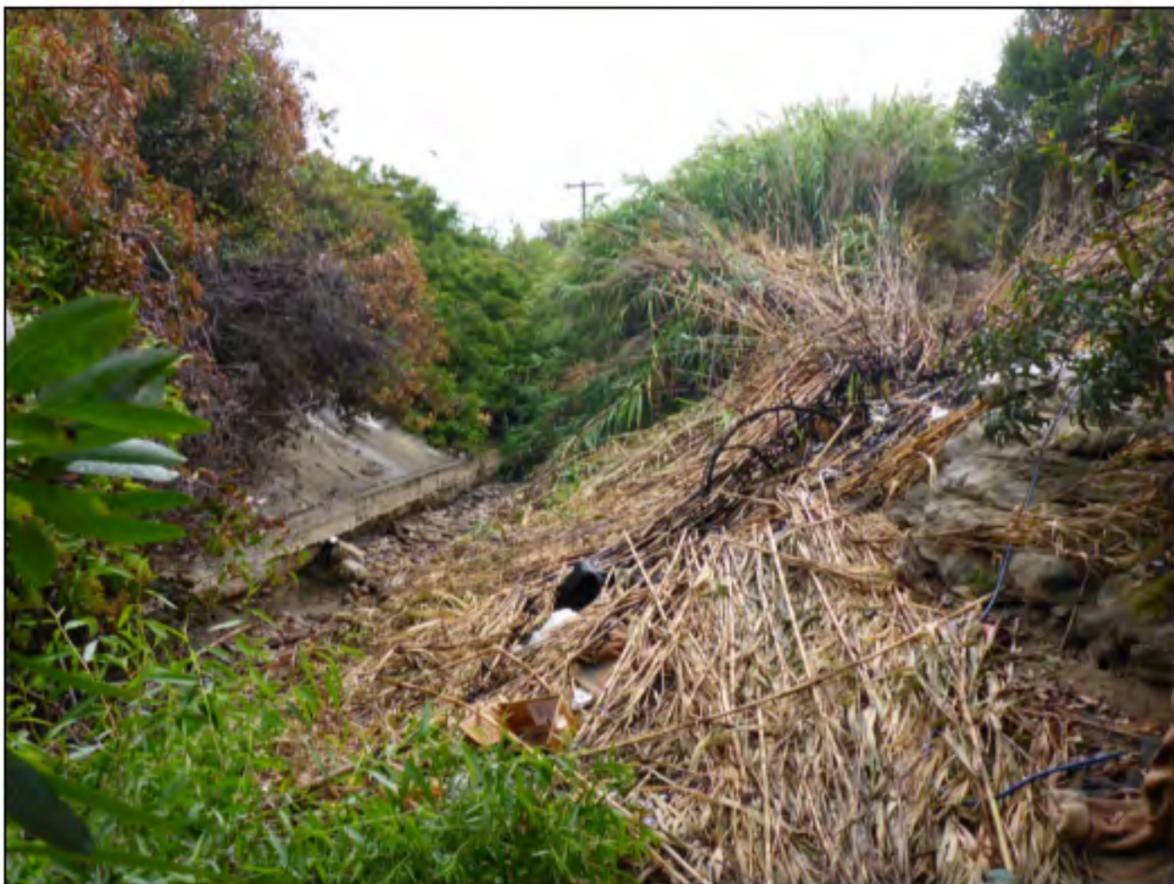
Home Avenue Channel.35 (5-4-2015).JPG

- Based on the O&M Channel Maintenance Inspection Form completed for the channel by the City of San Diego and the site photos taken by the City of San Diego, there is heavy vegetation in the majority of the channel reach. A high risk of vegetation flowing downstream and clogging the culvert exists.
- Based on the site photos taken by the City of San Diego, there appears to be scour occurring at the outlet of the culvert under Fairmont Avenue (site photo 37) and at the toe of the side slope on the right bank (looking downstream) near the middle of the channel reach (site photo 35).

It is recommended that this drainage channel be maintained to increase the current capacity of the channel from a 5-year storm event back to a 100-year storm event capacity.
