**SUMMARY OF FINDINGS FOR THE
ANNUAL DRAINAGE CHANNEL FIELD
ASSESSMENT AND MAINTENANCE PRIORITIZATION
PROJECT (PHASE 1)
FOR
THE CITY OF SAN DIEGO – MASTER STORM WATER
SYSTEM MAINTENANCE PROGRAM (MMP) MAP 71:
CHOLLAS CREEK CHANNEL**

**Job Number 17204-D
August 4, 2015**

Prepared For:
City of San Diego
2781 Caminito Chollas
San Diego, California 92105

Prepared By:
Rick Engineering Company
Water Resources Division
5620 Friars Road
San Diego, California 92110-2596
(619) 291-0707

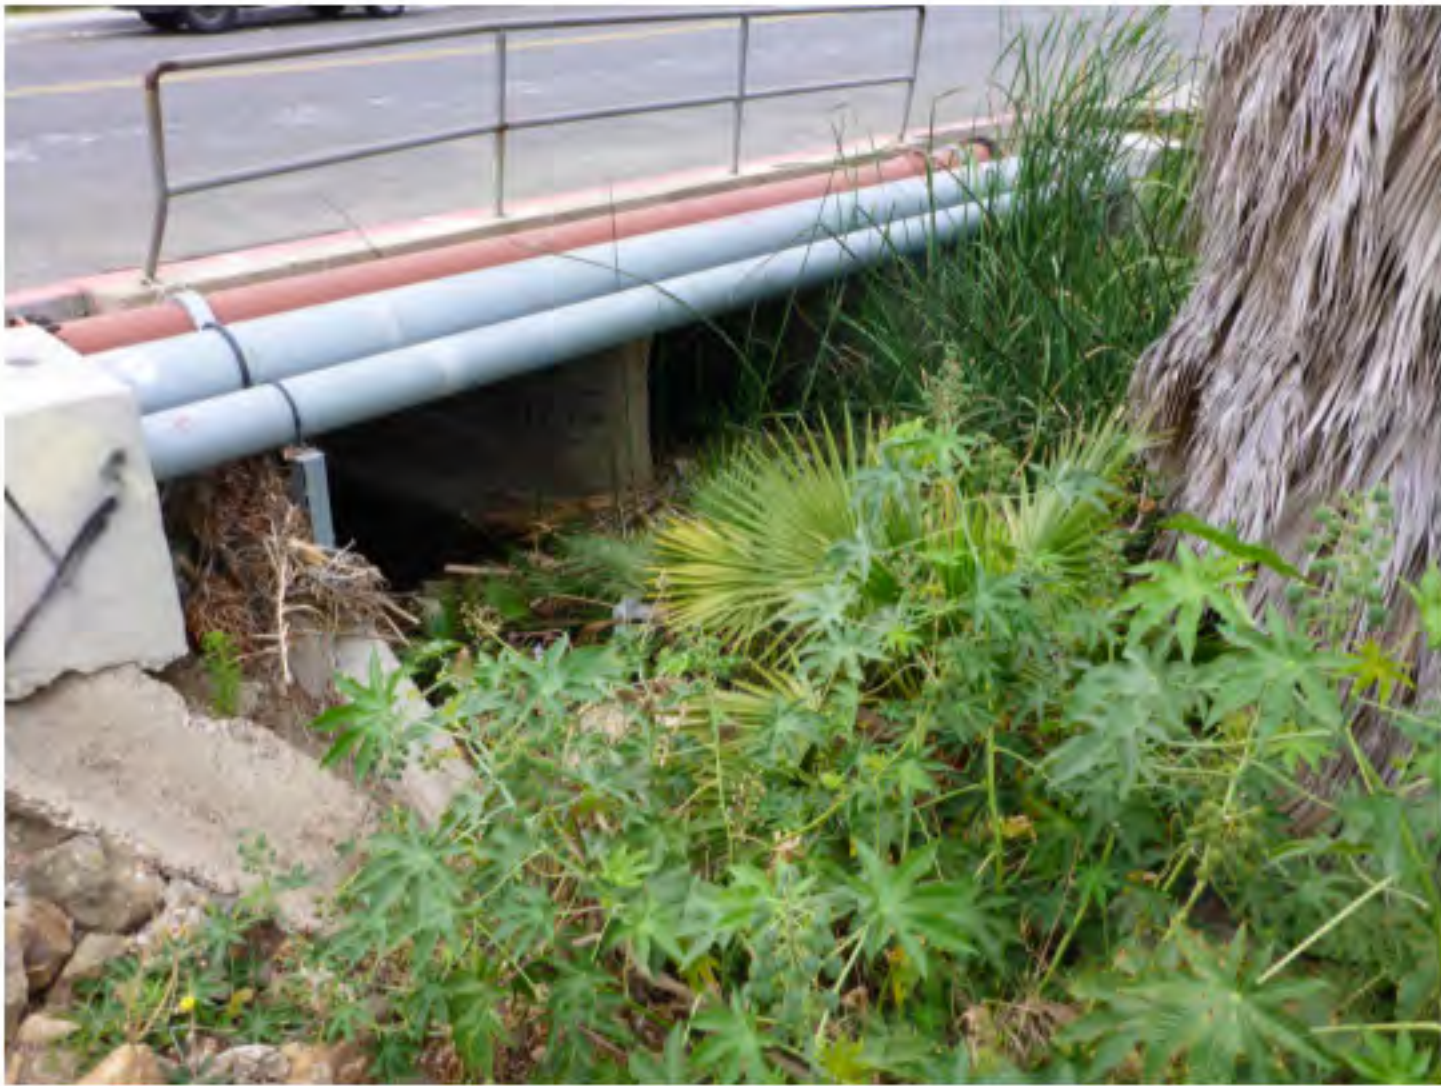
Chollas Creek.1 (5-6-2015)

- It was noted on the O&M Channel Maintenance Inspection Form completed for the channel by the City of San Diego that palm trees line the entire length of the channel. A high risk of vegetation flowing downstream and clogging the culvert exists.
- The available as-builts for the channel show that it is rip-rap lined. The O&M Channel Maintenance Inspection Form completed for the channel by the City of San Diego and the site photos taken by the City of San Diego indicate that sediment and ponded water exist in the channel.

It is recommended that Reach 1 be maintained to improve water quality and aesthetics and to prevent large vegetation from flowing downstream and clogging the culvert. It is recommended that Reach 2 be maintained to increase the current capacity of the channel from less than a 2-year storm event back to a 50-year storm event capacity.

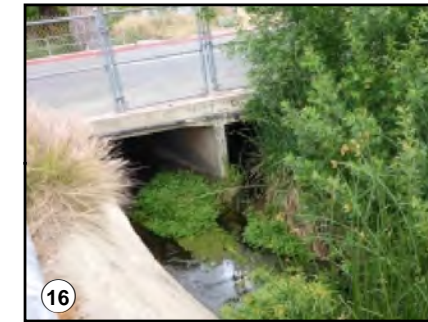
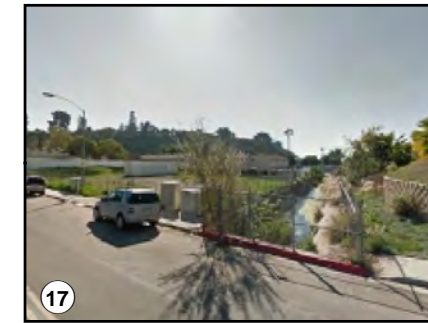
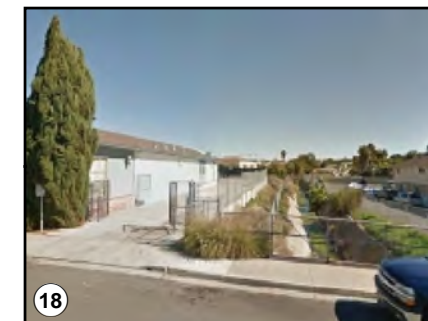
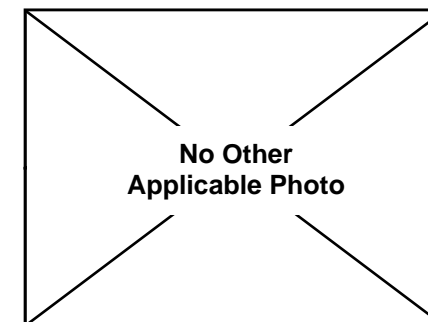
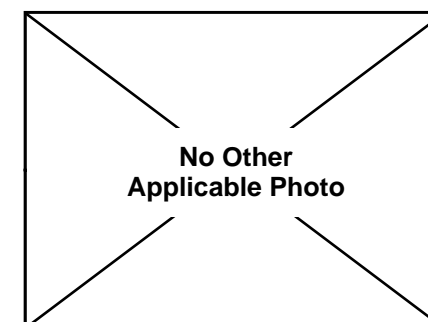
- **Channel Prioritization Score:**
67.8 out of 100
 - **Flood Hazard Score:**
56.3 out of 75
 - **Water Quality Score:**
4 out of 10
 - **Community Input Score:**
5 out of 10
 - **Aesthetics Score:**
2.5 out of 5
- **Capacity Prior to Maintenance:**
100-year storm event
- **Capacity After Maintenance (As-built Capacity):**
100-year storm event
- **Clogging Potential:** *HIGH*
- **Approximate Vegetation Coverage:** *MEDIUM*
- **Surrounding Area:** *Commercial*
- **Infrastructure Failures:**
None
- **Site Evaluation Date:**
May 6, 2015
- **Notes/Comments:**
Based on site photos taken by the City of San Diego, heavier vegetation exists for a small segment of the channel immediately downstream of Roland Boulevard. A high risk of vegetation flowing downstream and clogging the culvert exists.

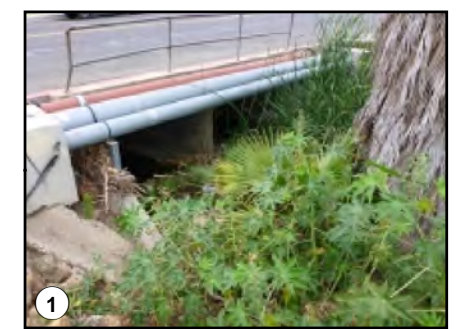
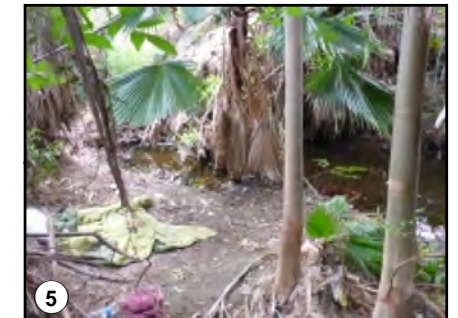
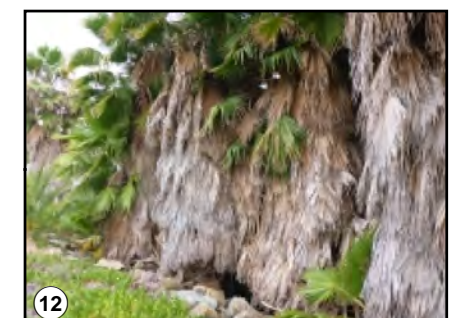
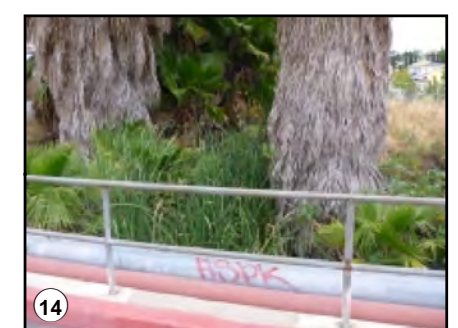
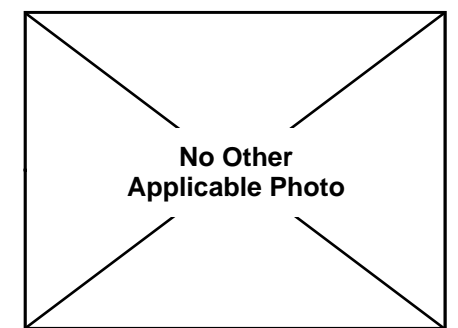
- **Channel Prioritization Score:**
82.3 out of 100
- **Flood Hazard Score:**
68.8 out of 75
- **Water Quality Score:**
6 out of 10
- **Community Input Score:**
5 out of 10
- **Aesthetics Score:**
2.5 out of 5
- **Capacity Prior to Maintenance:**
Less than 2-year storm event
- **Capacity After Maintenance (As-built Capacity):**
50-year storm event
- **Clogging Potential:** *HIGH*
- **Approximate Vegetation Coverage:** *HIGH*
- **Surrounding Area:** *Residential*
- **Infrastructure Failures:**
None
- **Site Evaluation Date:**
May 6, 2015
- **Notes/Comments:**
Palm trees exist along entire reach.
