**SUMMARY OF FINDINGS FOR THE
ANNUAL DRAINAGE CHANNEL FIELD
ASSESSMENT AND MAINTENANCE PRIORITIZATION
PROJECT (PHASE 1)
FOR
THE CITY OF SAN DIEGO – MASTER STORM WATER
SYSTEM MAINTENANCE PROGRAM (MMP) MAP 120:
COTTONWOOD CHANNEL**

**Job Number 17204-D
August 4, 2015**

Job Number 17204-D

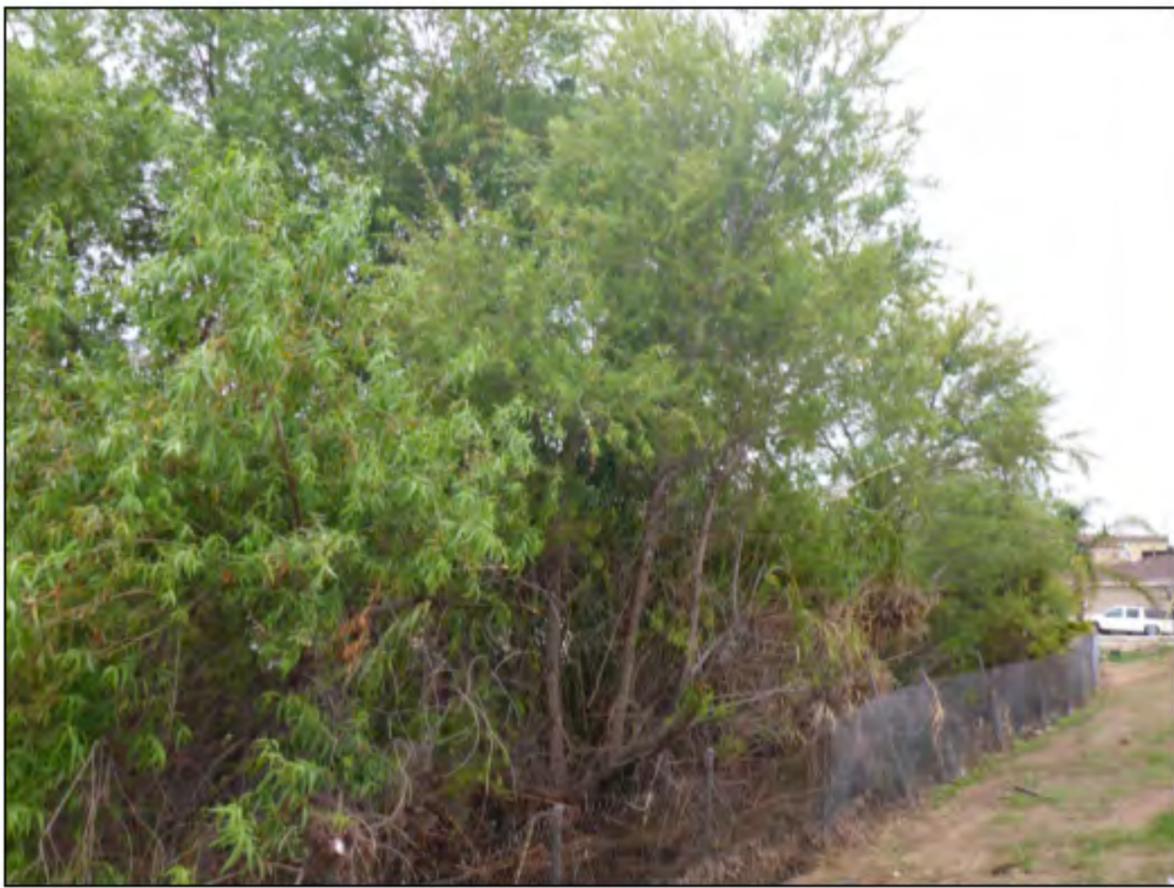
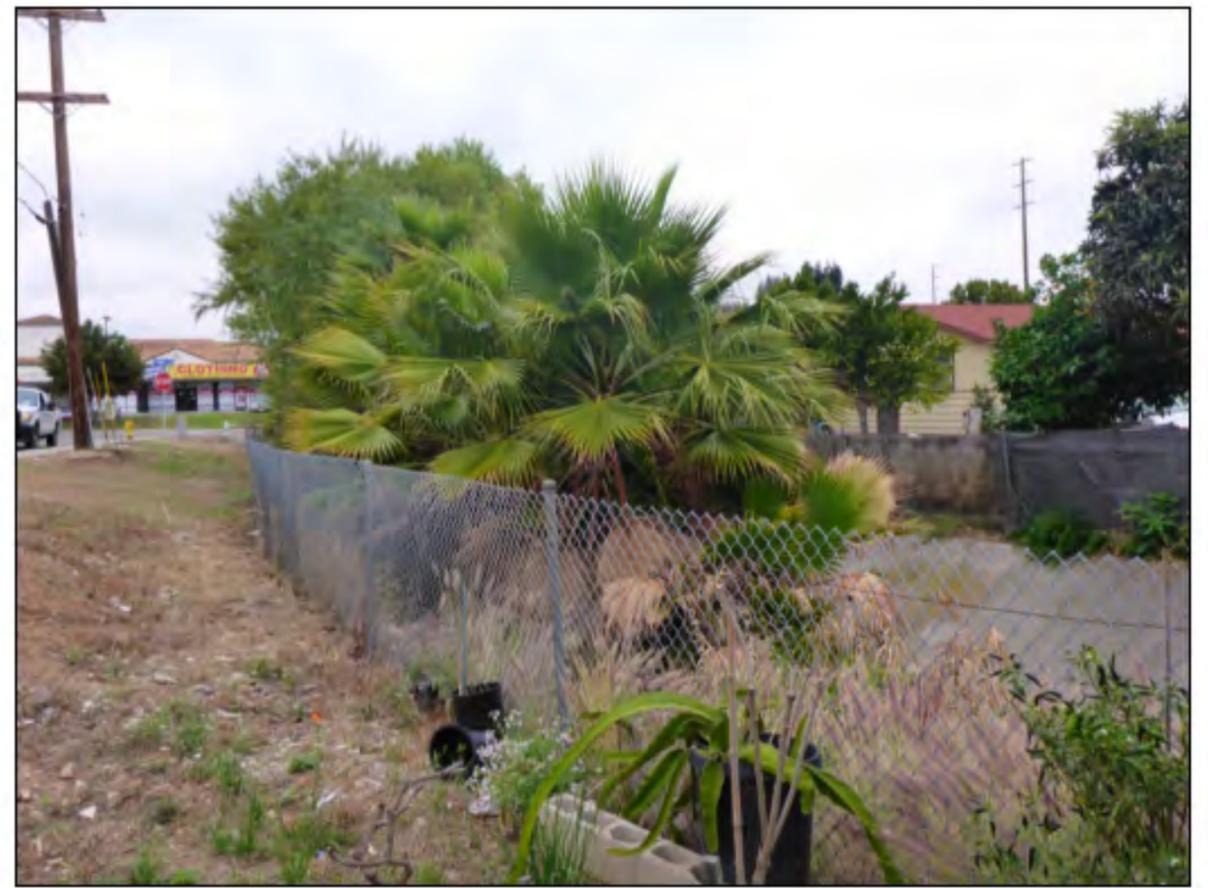
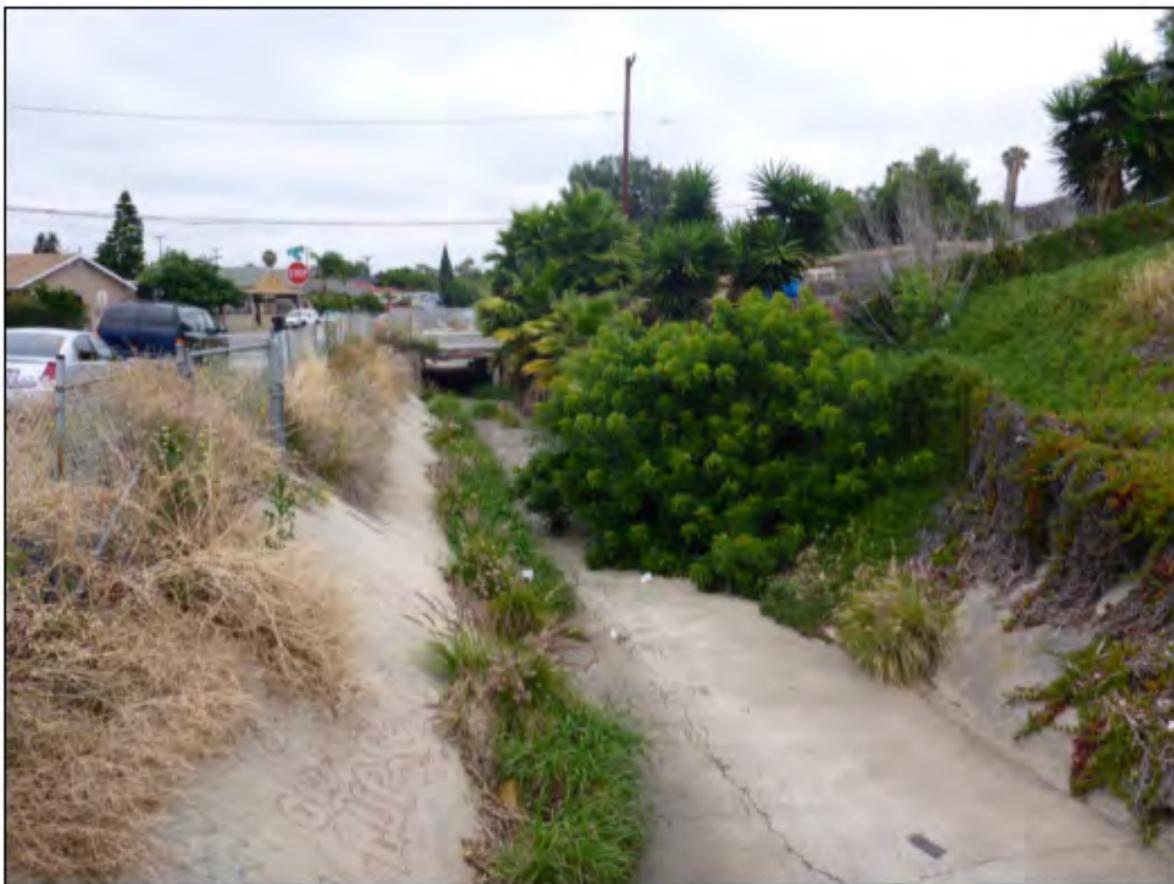
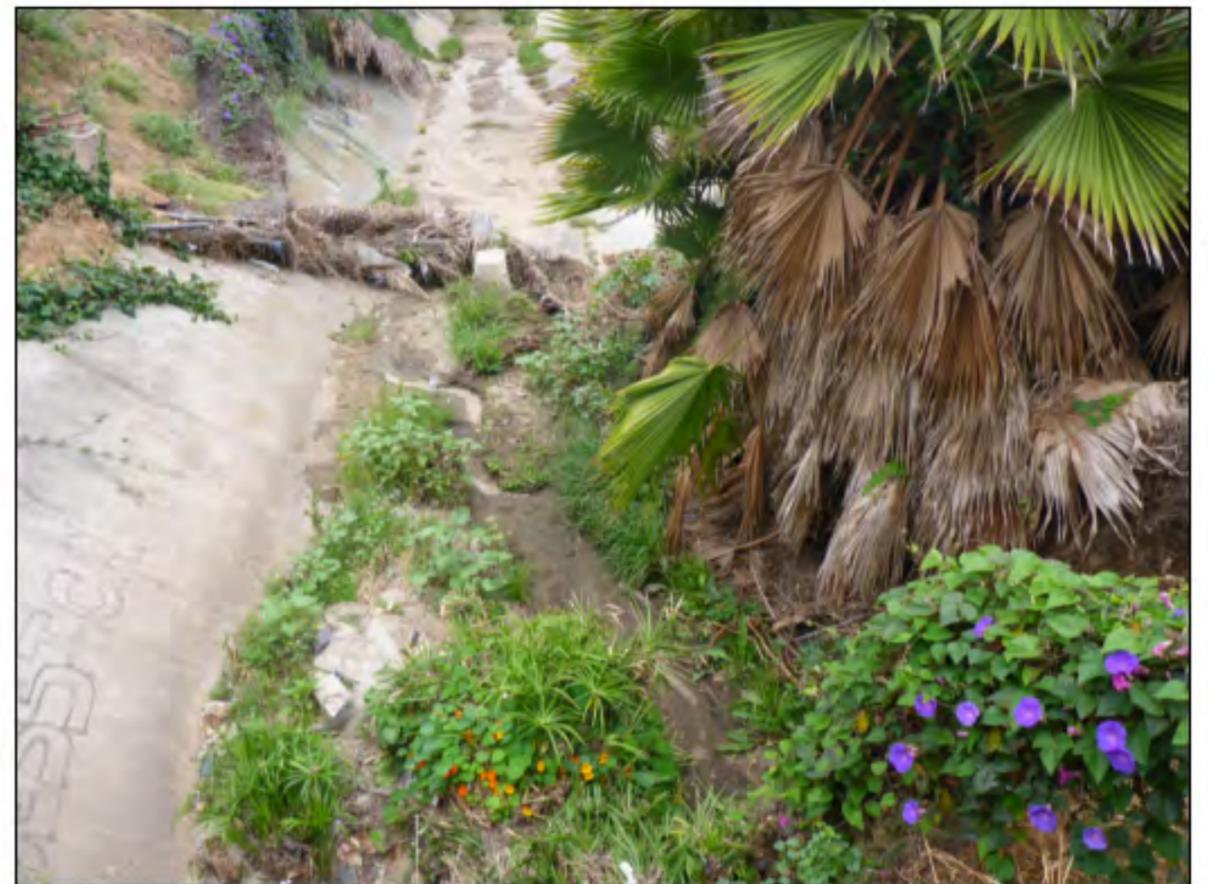
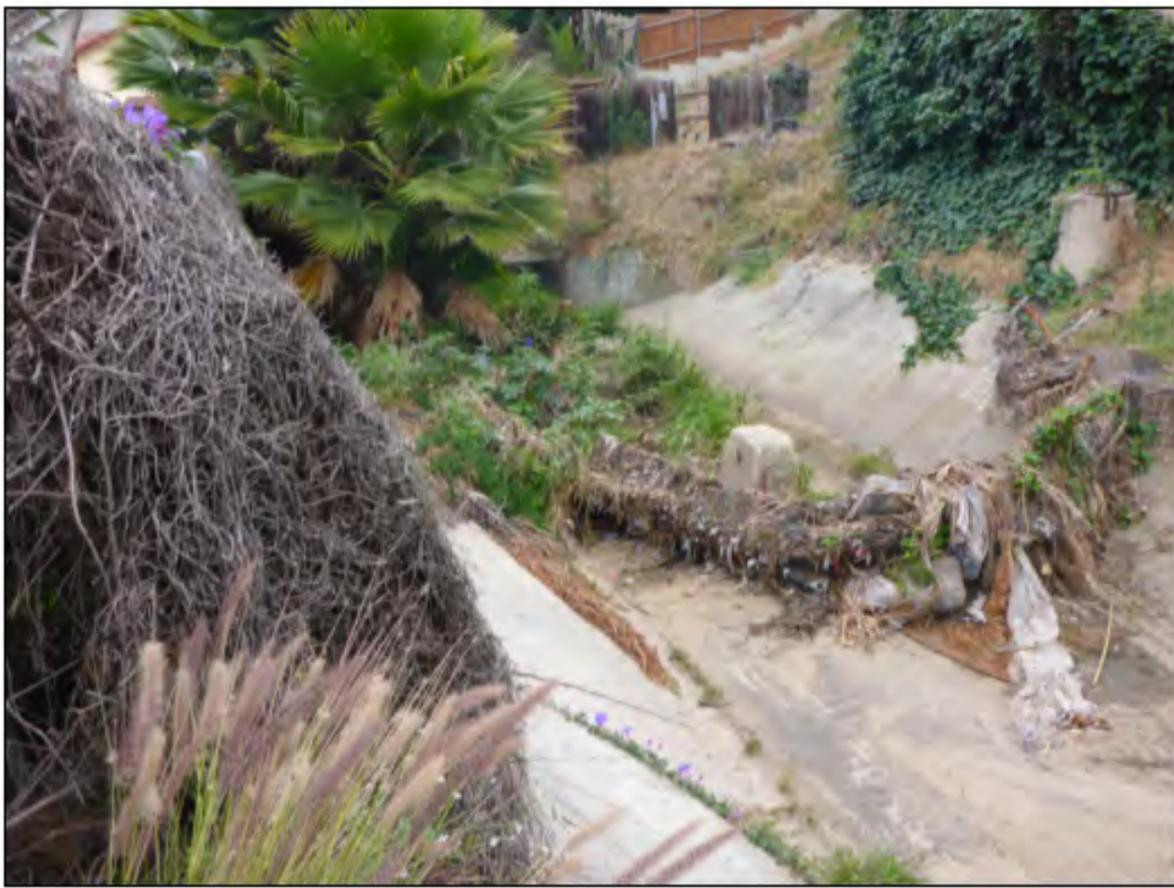
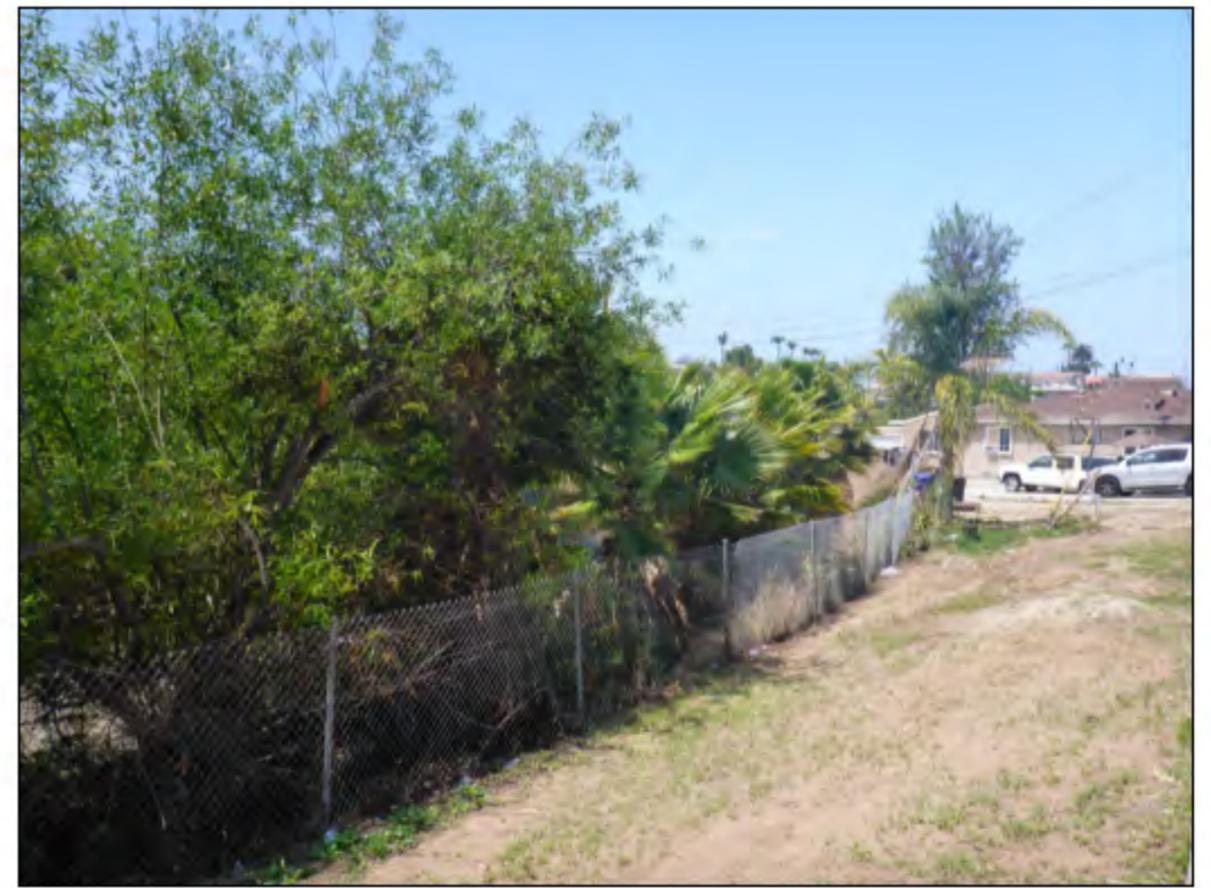
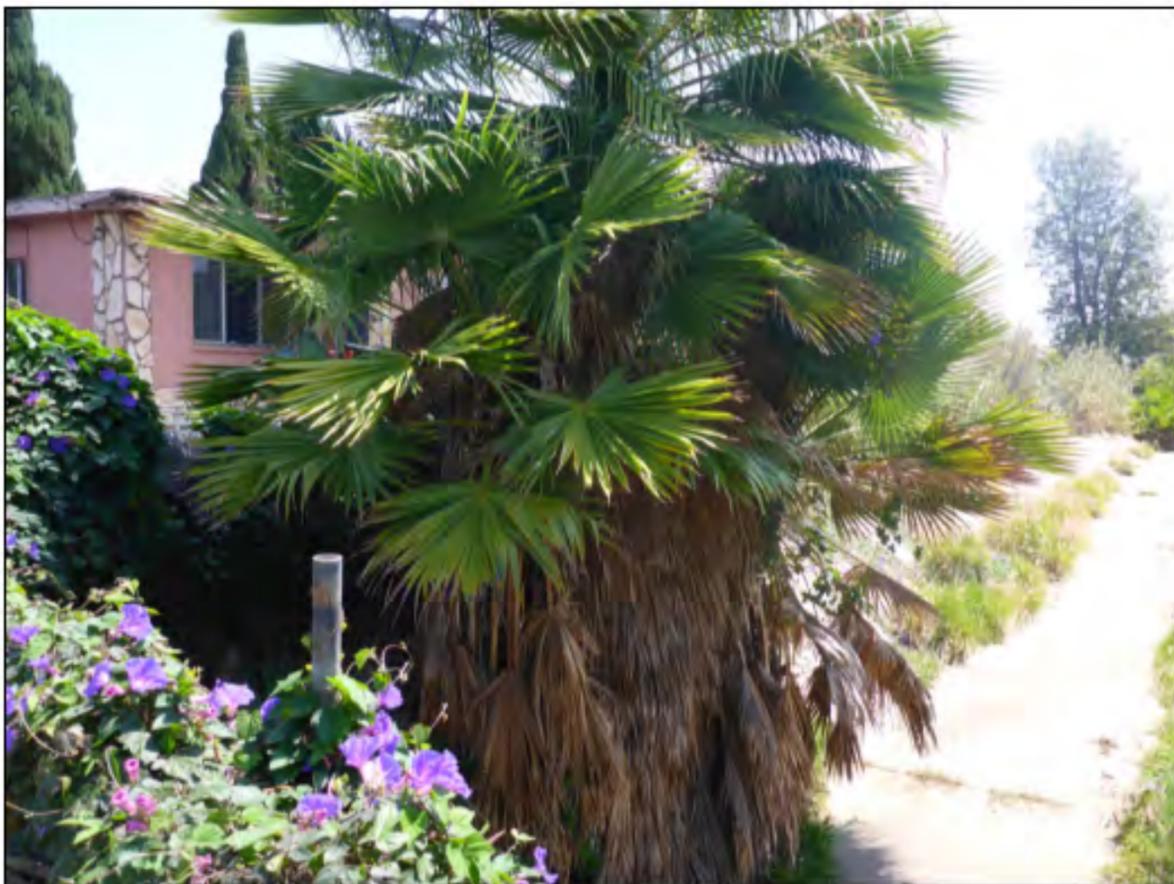
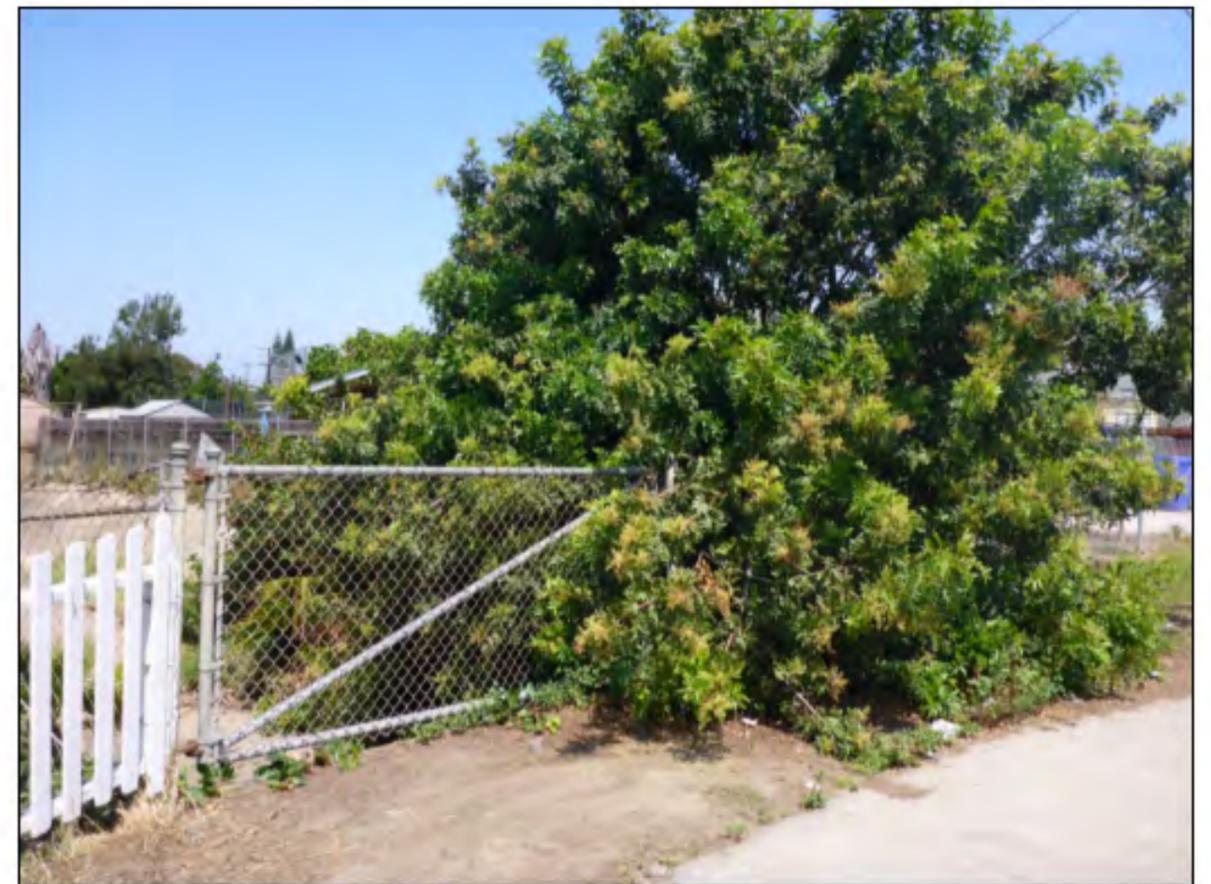
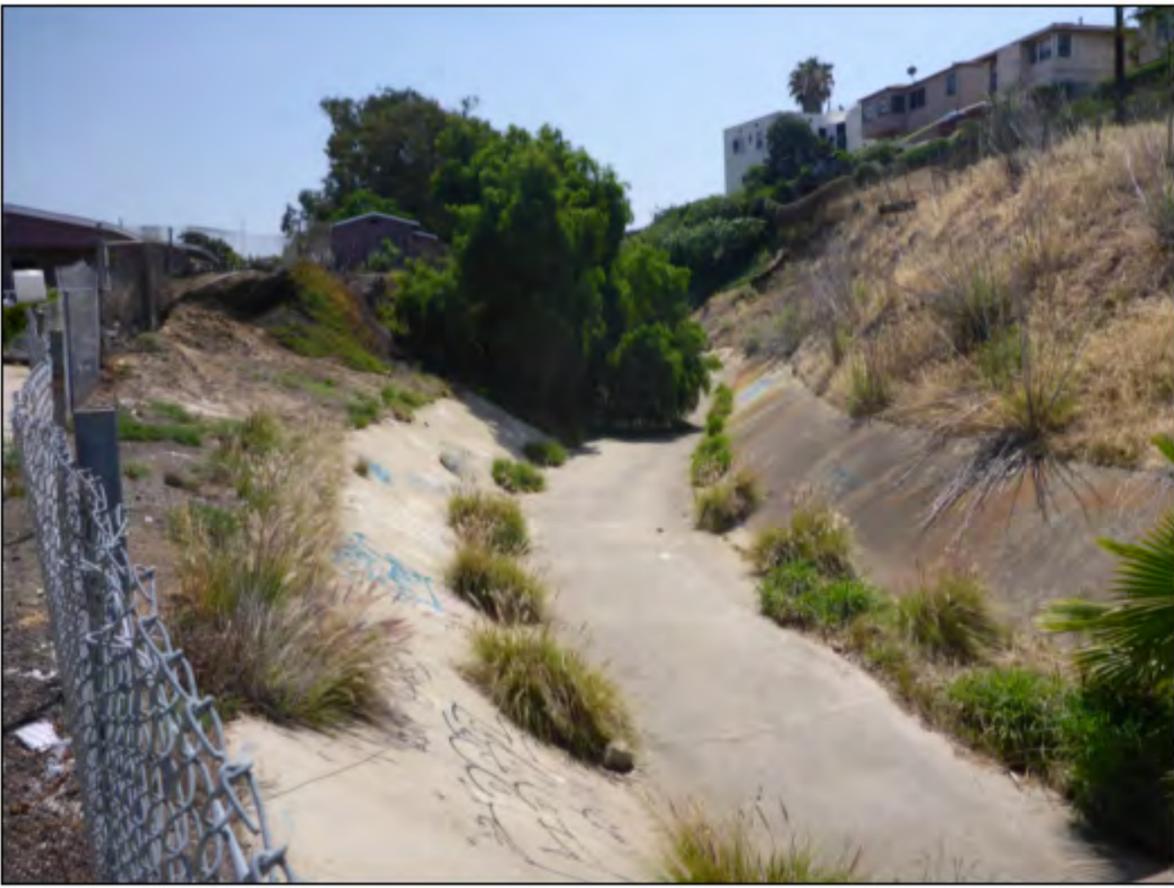
- Based on the site photos taken by the City of San Diego, vegetation has grown down from the top of the channel banks over the concrete side slopes. A high risk of vegetation flowing downstream and clogging the culvert exists.
- Based on site photos taken by the City of San Diego, a high risk of debris or trees flowing downstream and clogging the culvert exists.

It is recommended that this drainage channel be maintained to increase the current capacity of the channel from less than a 2-year storm event back to a 25- to 50-year storm event capacity.

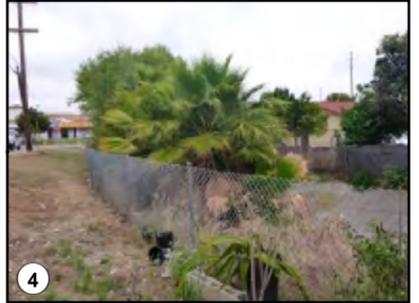
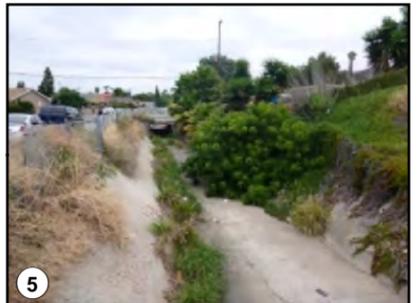
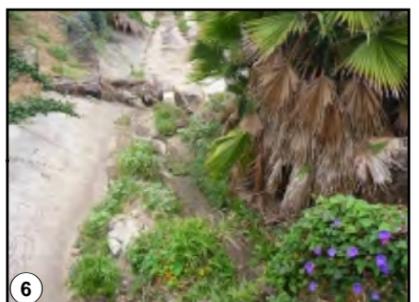
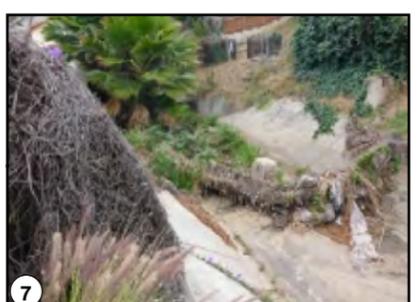
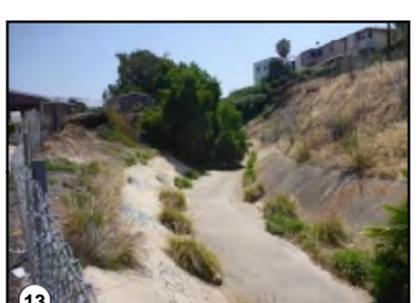
Photos:

- **Channel Prioritization Score:**
81.0 out of 100
 - **Flood Hazard Score:**
70.0 out of 75
 - **Water Quality Score:**
6 out of 10
 - **Community Input Score:**
5 out of 10
 - **Aesthetics Score:**
0 out of 5
- **Capacity Prior to Maintenance:**
Less than 2-year storm event
- **Capacity After Maintenance (As-built Capacity) :**
25- to 50-year storm event
- **Clogging Potential:** *HIGH*
- **Approximate Vegetation Coverage:** *HIGH*
- **Surrounding Area:** *Residential*
- **Infrastructure Failures:**
None
- **Site Evaluation Date:**
May 27, 2015
- **Notes/Comments:**
Vegetation has grown down from the top of the channel banks over the concrete side slopes. A high risk of vegetation flowing downstream and clogging the culvert exists.
