**SUMMARY OF FINDINGS FOR THE  
ANNUAL DRAINAGE CHANNEL FIELD  
ASSESSMENT AND MAINTENANCE PRIORITIZATION  
PROJECT (PHASE 1)  
FOR  
THE CITY OF SAN DIEGO – MASTER STORM WATER  
SYSTEM MAINTENANCE PROGRAM (MMP) MAP 105:  
EUCLID & CASTANA**

**Job Number 17204-D  
August 4, 2015**

RICK ENGINEERING COMPANY

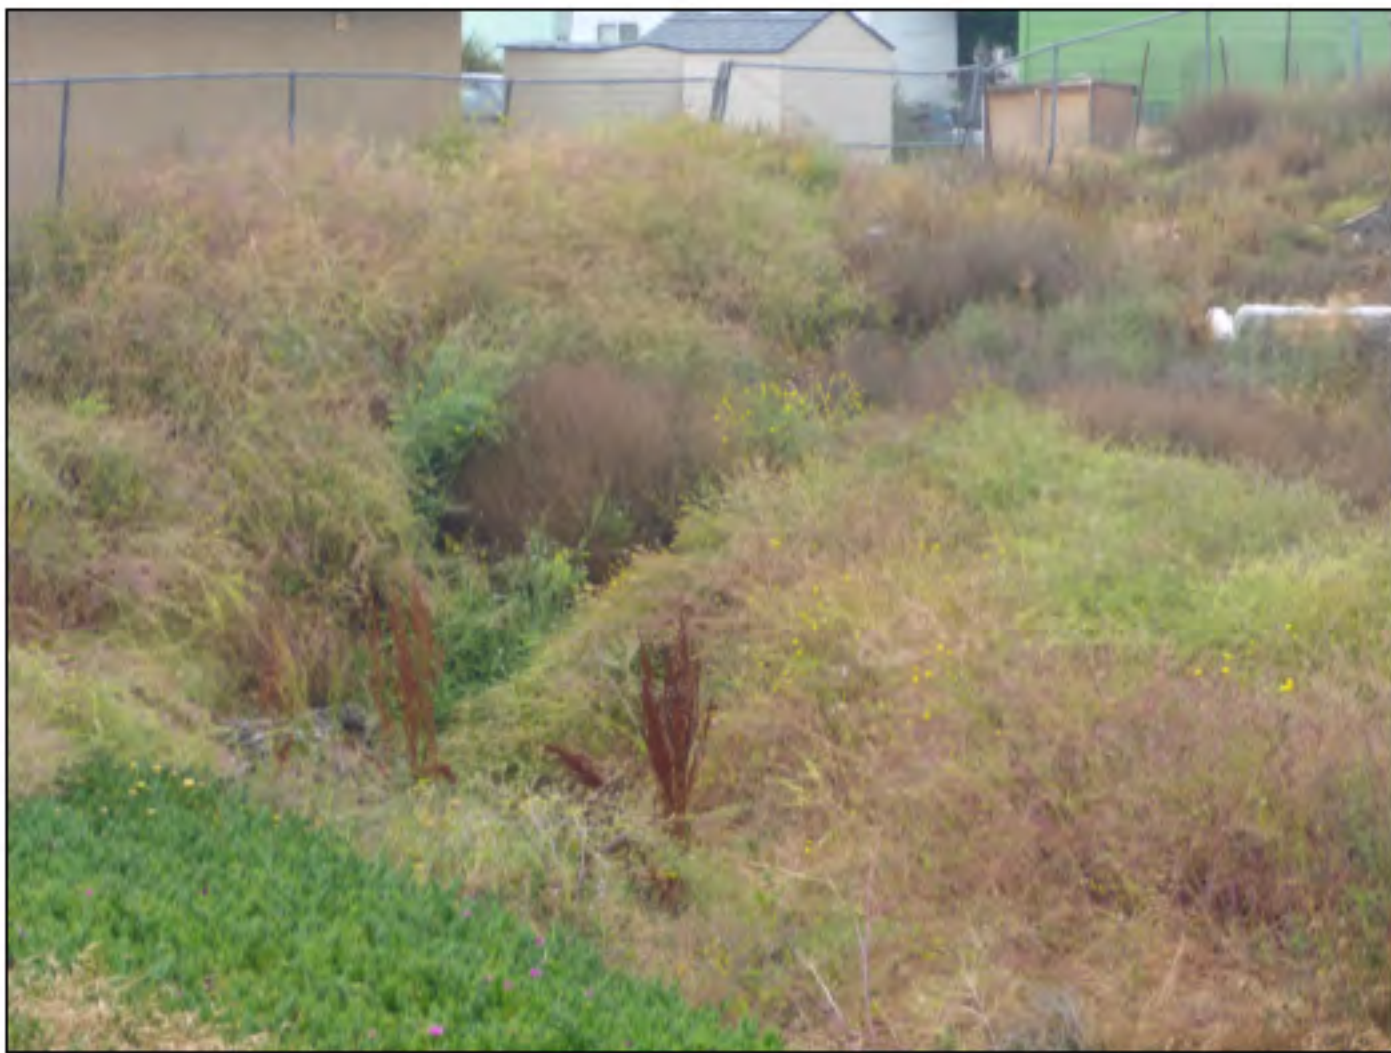
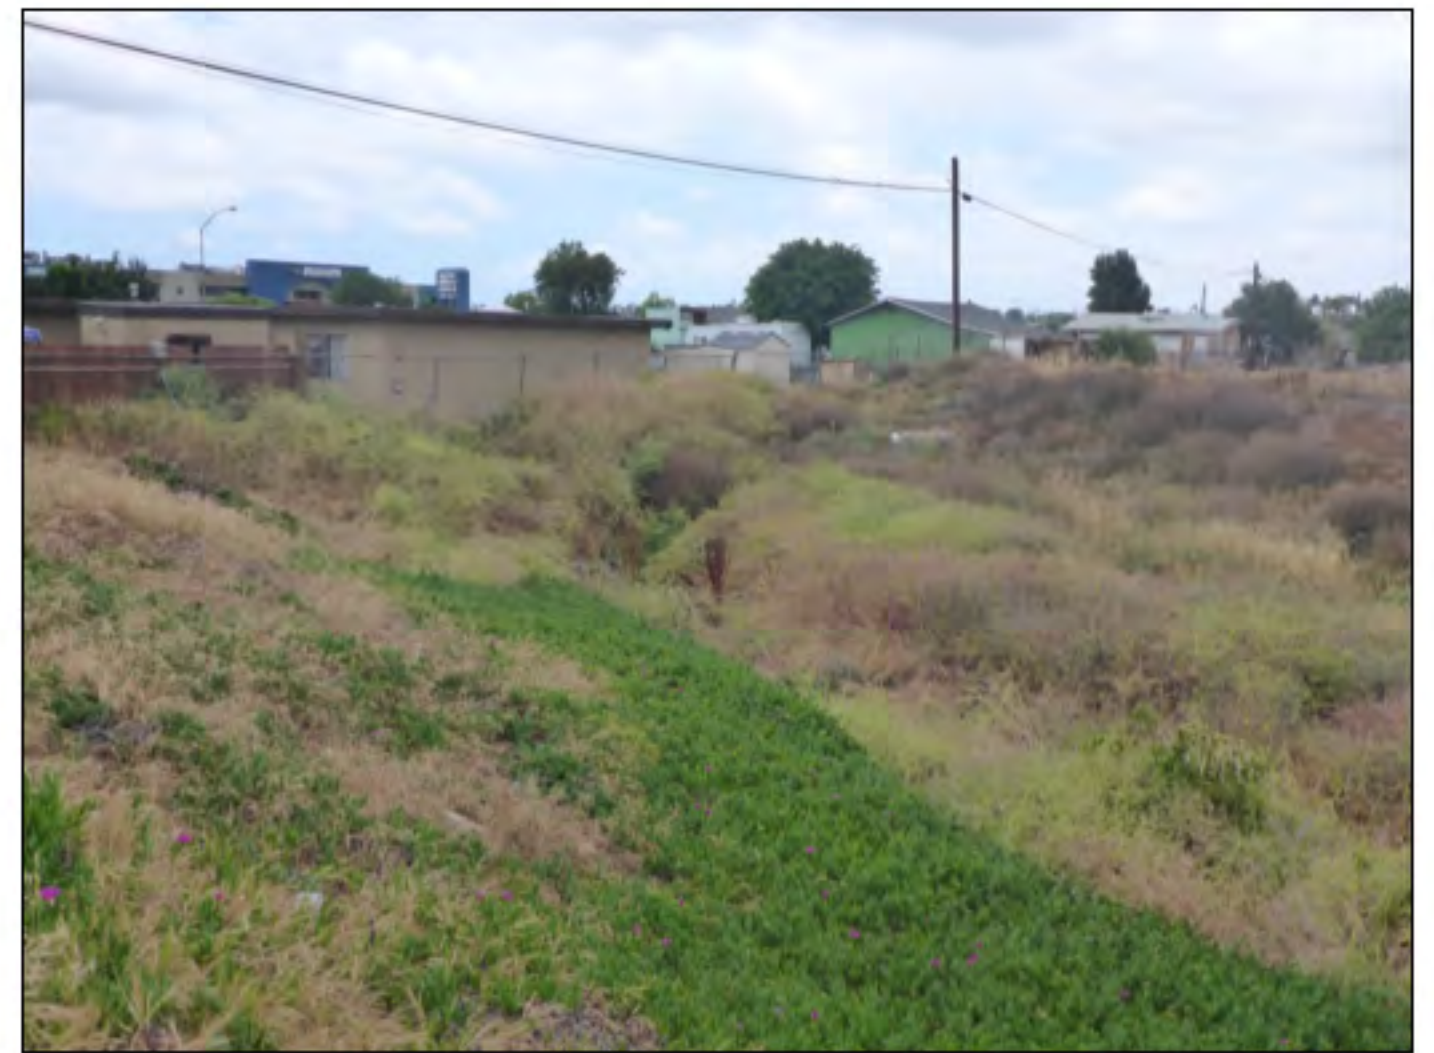
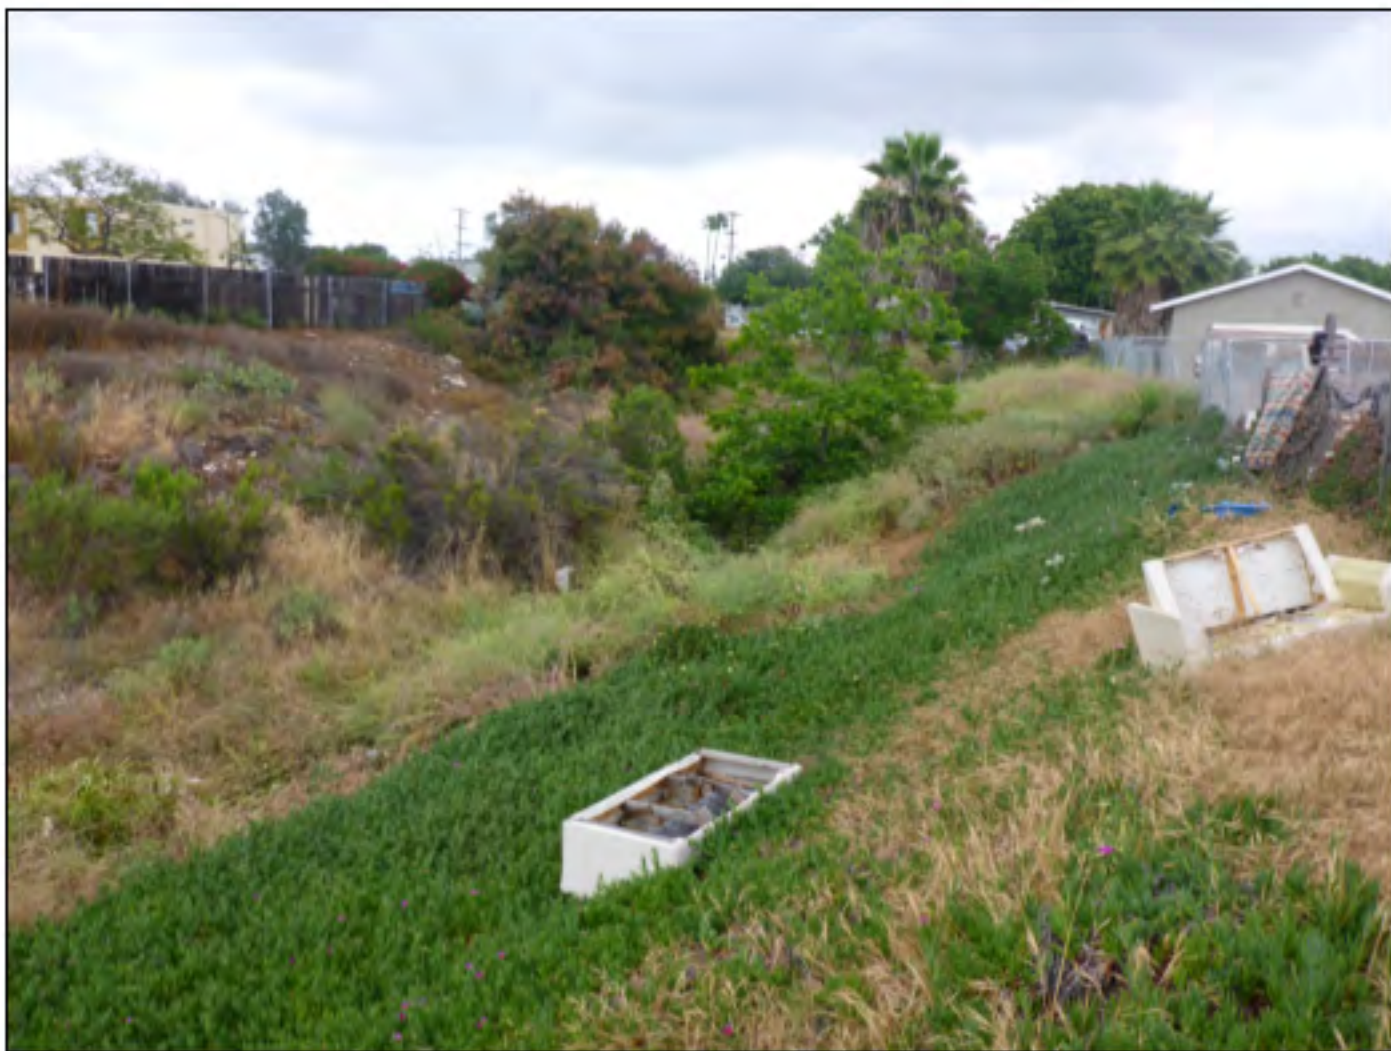
- The culvert entrance at the downstream end of the channel is protected by a grate. This grate is partially clogged and recommended for maintenance to prevent the grate from fully clogging.

Item	Condition	Comments
<b>A. Channel Condition</b> 1= Poor Condition/Needs Immediate Attention 2= Moderate Condition 3= Good Condition		
1. Structure Condition	1 2 <u>3</u> N/A	
2. Erosion	1 <u>2</u> 3 N/A	
3. Trash/Debris <u>veg</u>	1 <u>2</u> 3 N/A	Type of trash and source:
4. Water Conveyance/ Volume	1 2 <u>3</u> N/A	
5. Standing Water	Y <u>N</u>	
A. Ponding	Y <u>N</u>	
B. Noticeable odors	Y <u>N</u>	
C. Algae	Y <u>N</u>	
6. Vegetation	1 <u>2</u> 3 N/A	Approx. Coverage/Density of Vegetation: 40%
A. Invasive (Arundo)	1 <u>2</u> 3 N/A	<u>Palms</u>
B. Native	1 <u>2</u> 3 N/A	
7. Sediment	1 <u>2</u> 3 N/A	Approx. Depth/Coverage of Sediment:
8. Transients/ encampments	Y <u>N</u>

Item	Condition	Comments
1. Structure Condition	1 2 <u>3</u> N/A	
2. Trash/ <del>Debris</del> /Sediment <i>Tree</i>	1 <u>2</u> 3 N/A	
3. Clogging	1 2 <u>3</u> N/A

Access to channel has been blocked  
with two buildings !!

It is recommended that this drainage channel be maintained to increase the current capacity of the channel from a 1077 cfs (100-year storm event) back to a 1616.4 cfs (100-year storm event) capacity. It is important to note that although maintenance will not reduce the frequency of flooding, it will reduce the overall effect of flooding.
