**SUMMARY OF FINDINGS FOR THE  
ANNUAL DRAINAGE CHANNEL FIELD  
ASSESSMENT AND MAINTENANCE PRIORITIZATION  
PROJECT (PHASE 1)  
FOR  
THE CITY OF SAN DIEGO – MASTER STORM WATER  
SYSTEM MAINTENANCE PROGRAM (MMP) MAP 122:  
PARKSIDE CHANNEL**

**Job Number 17204-D  
August 4, 2015**

**August 4, 2015**

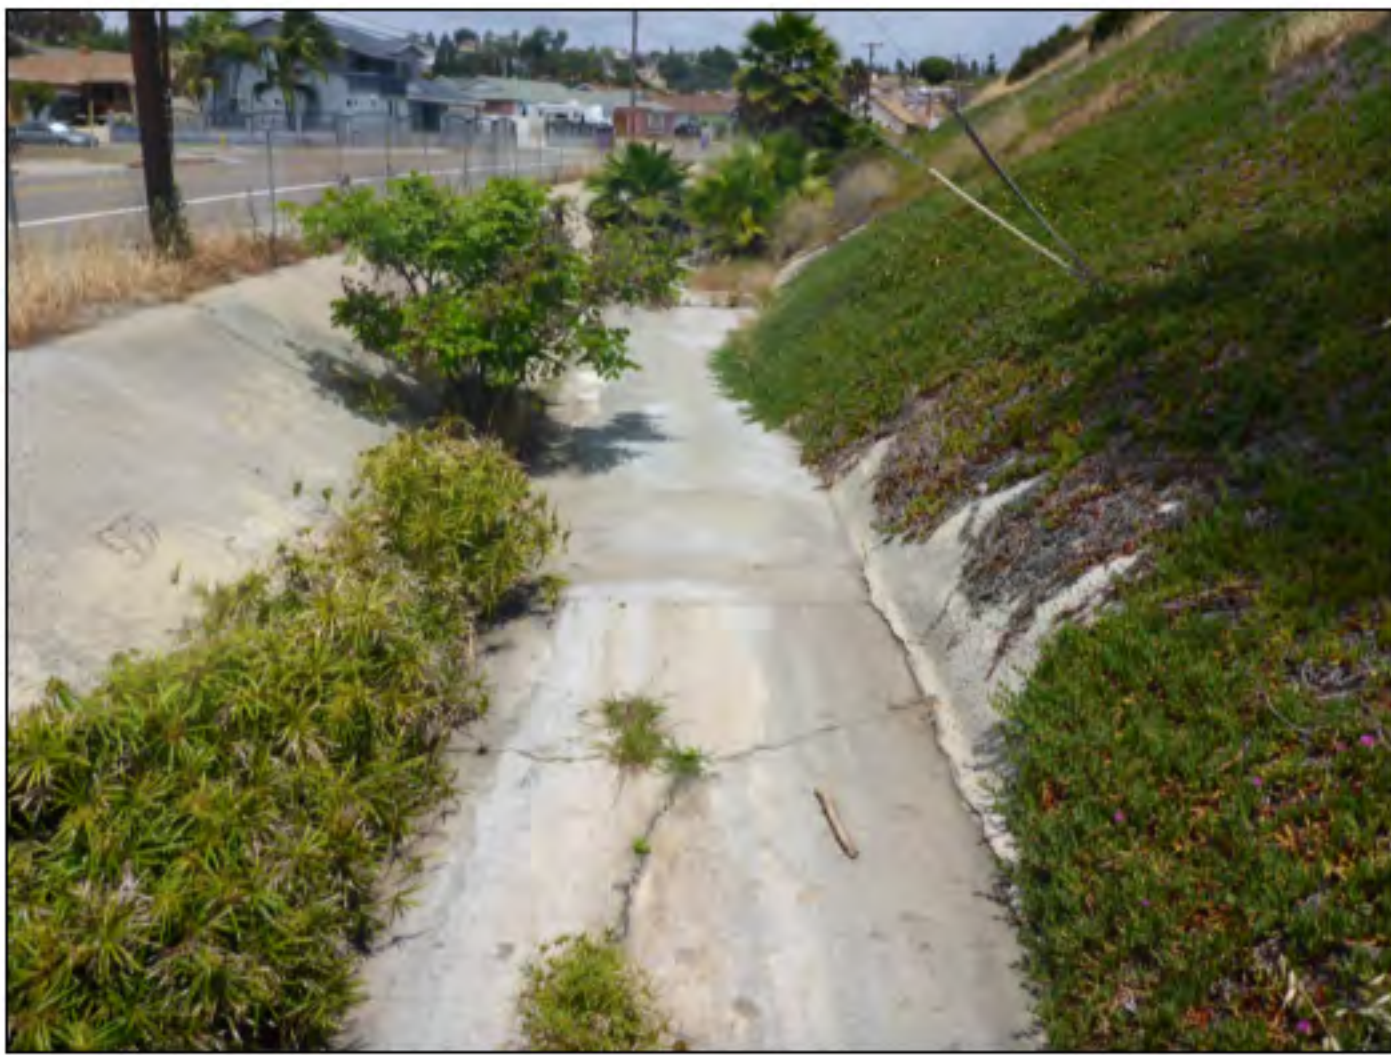
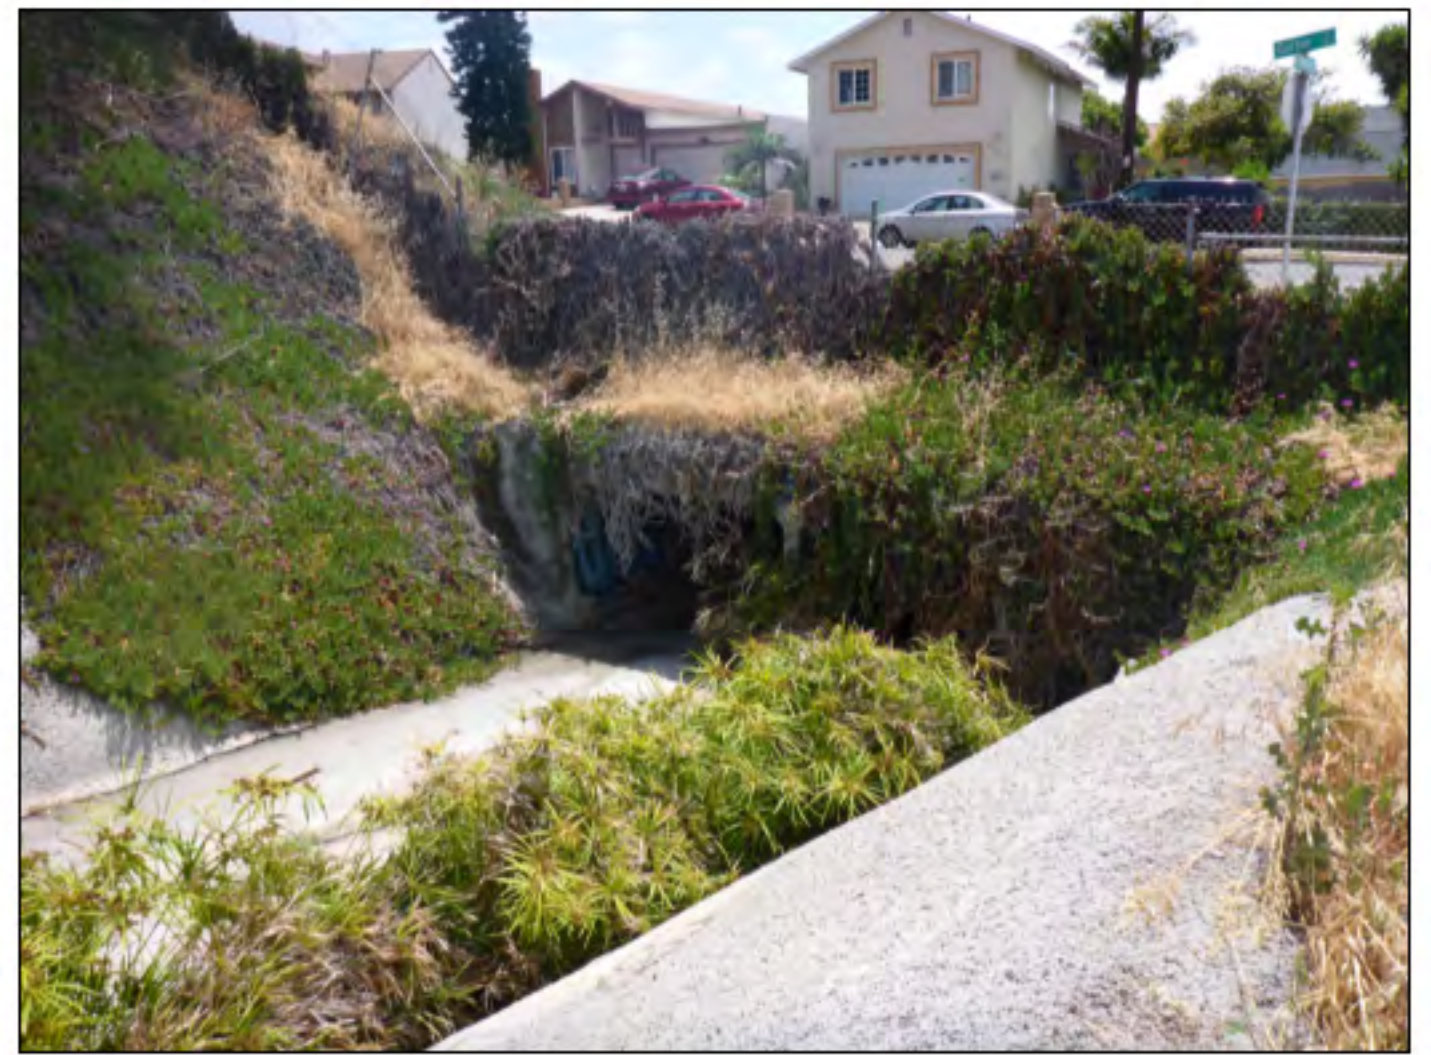
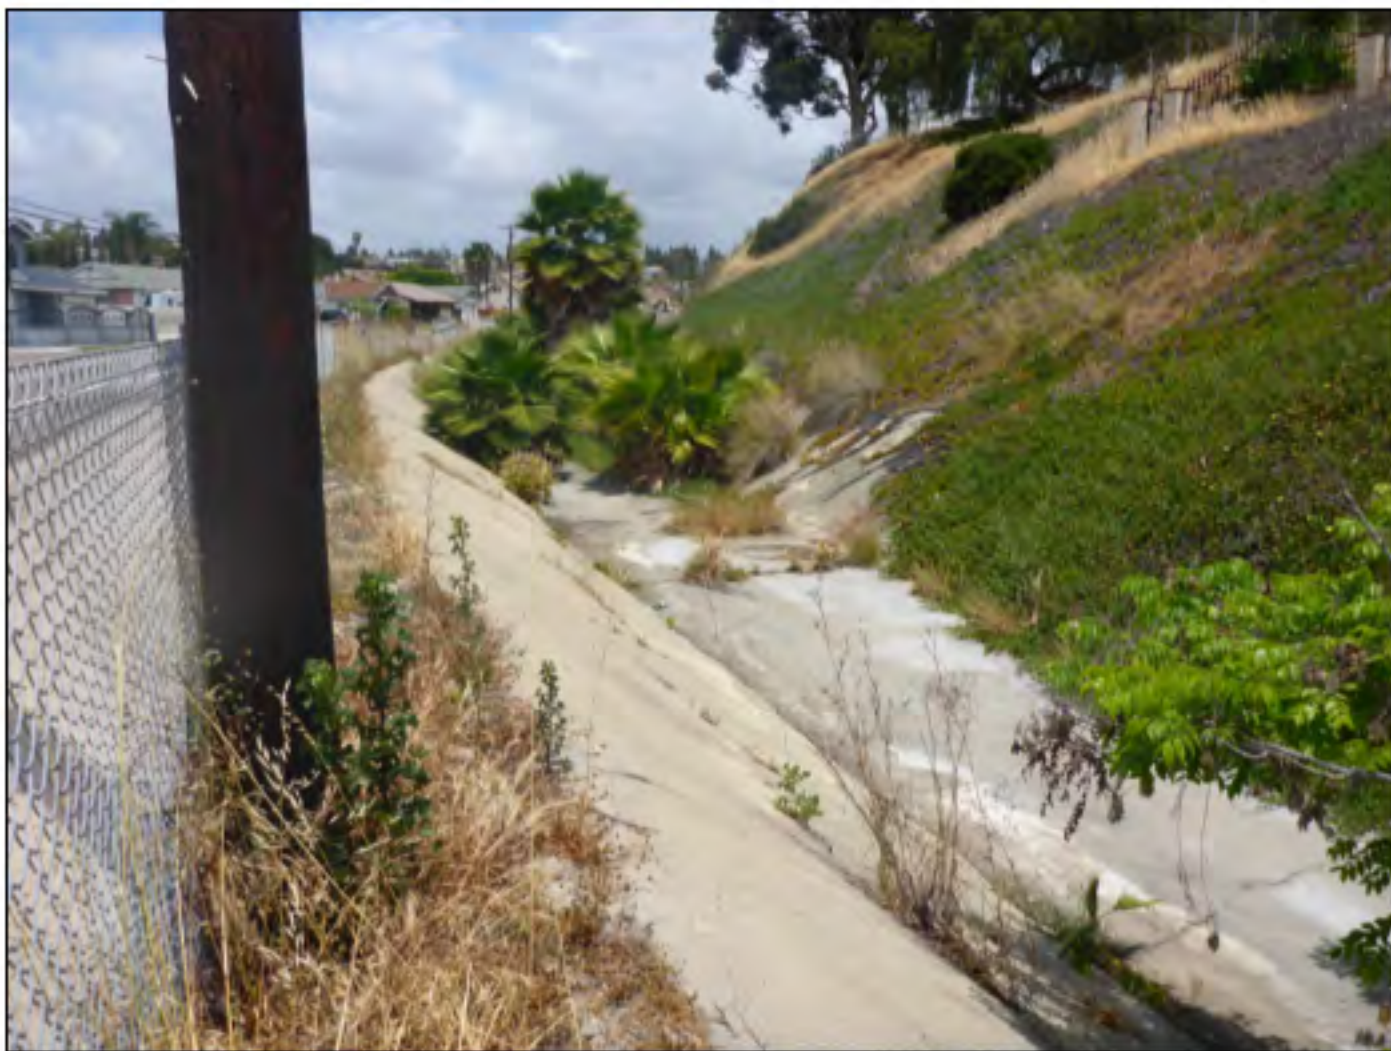
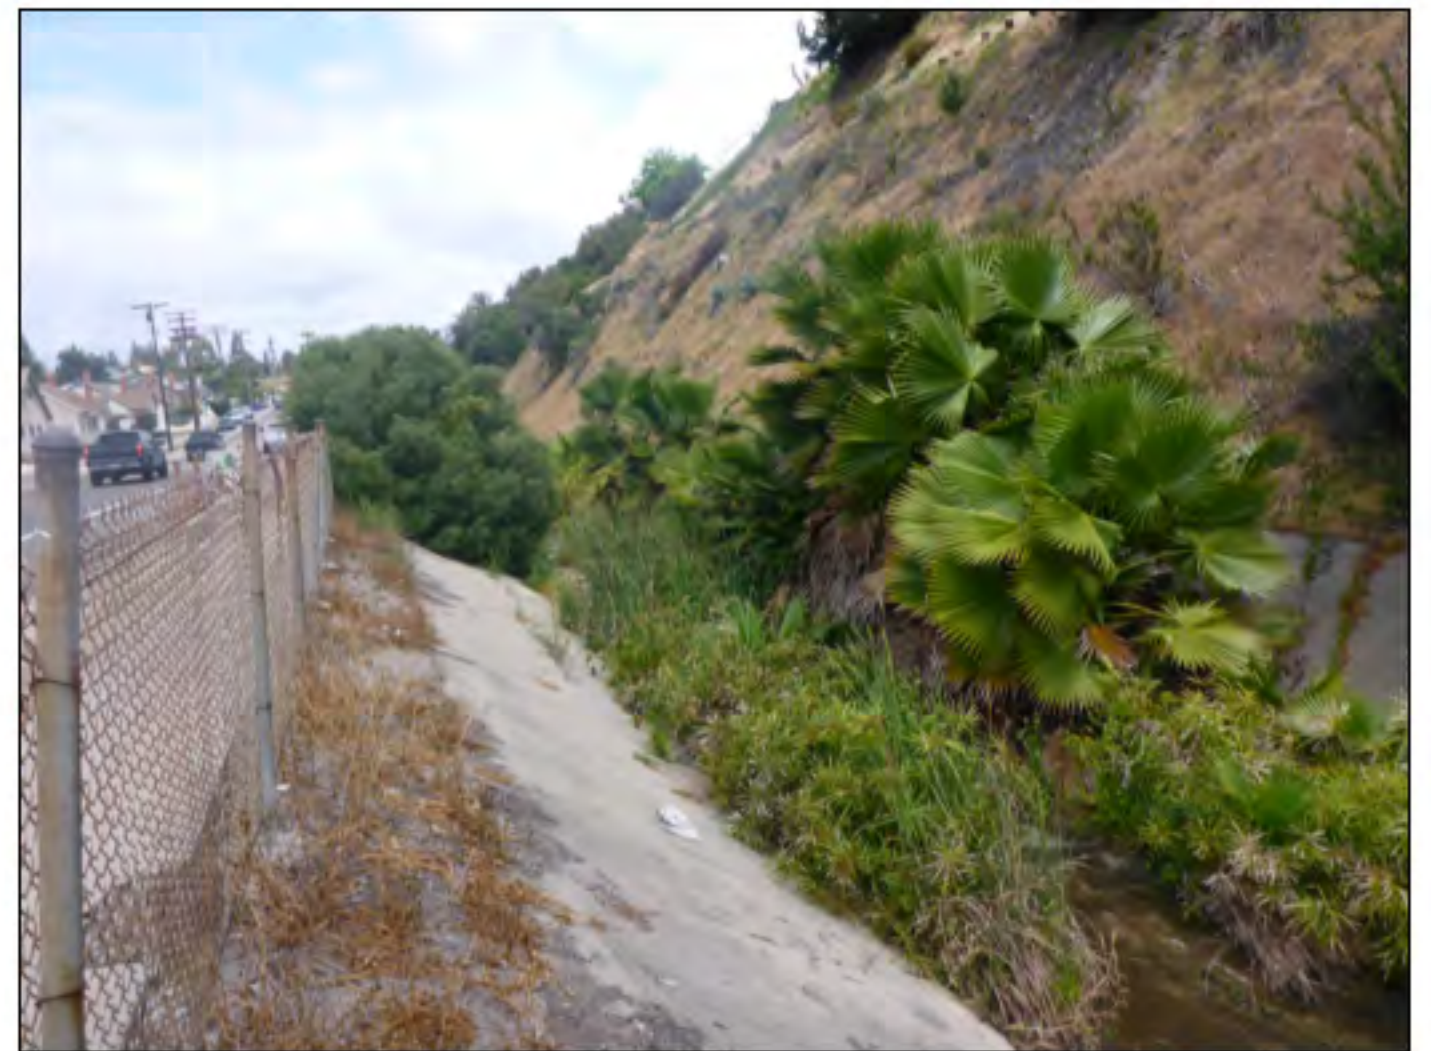
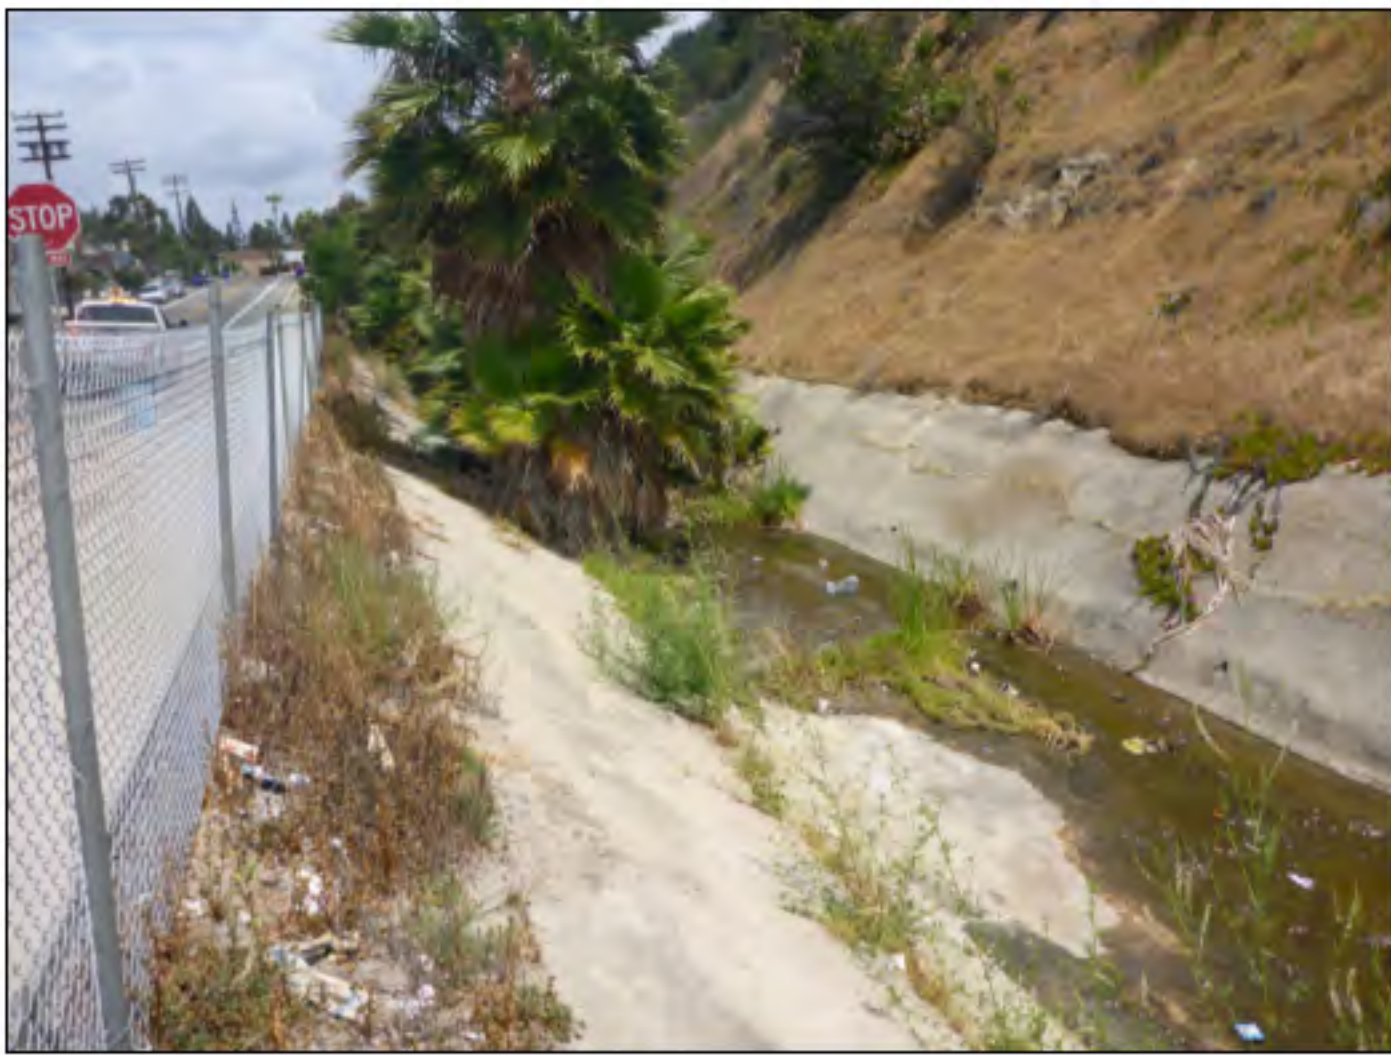
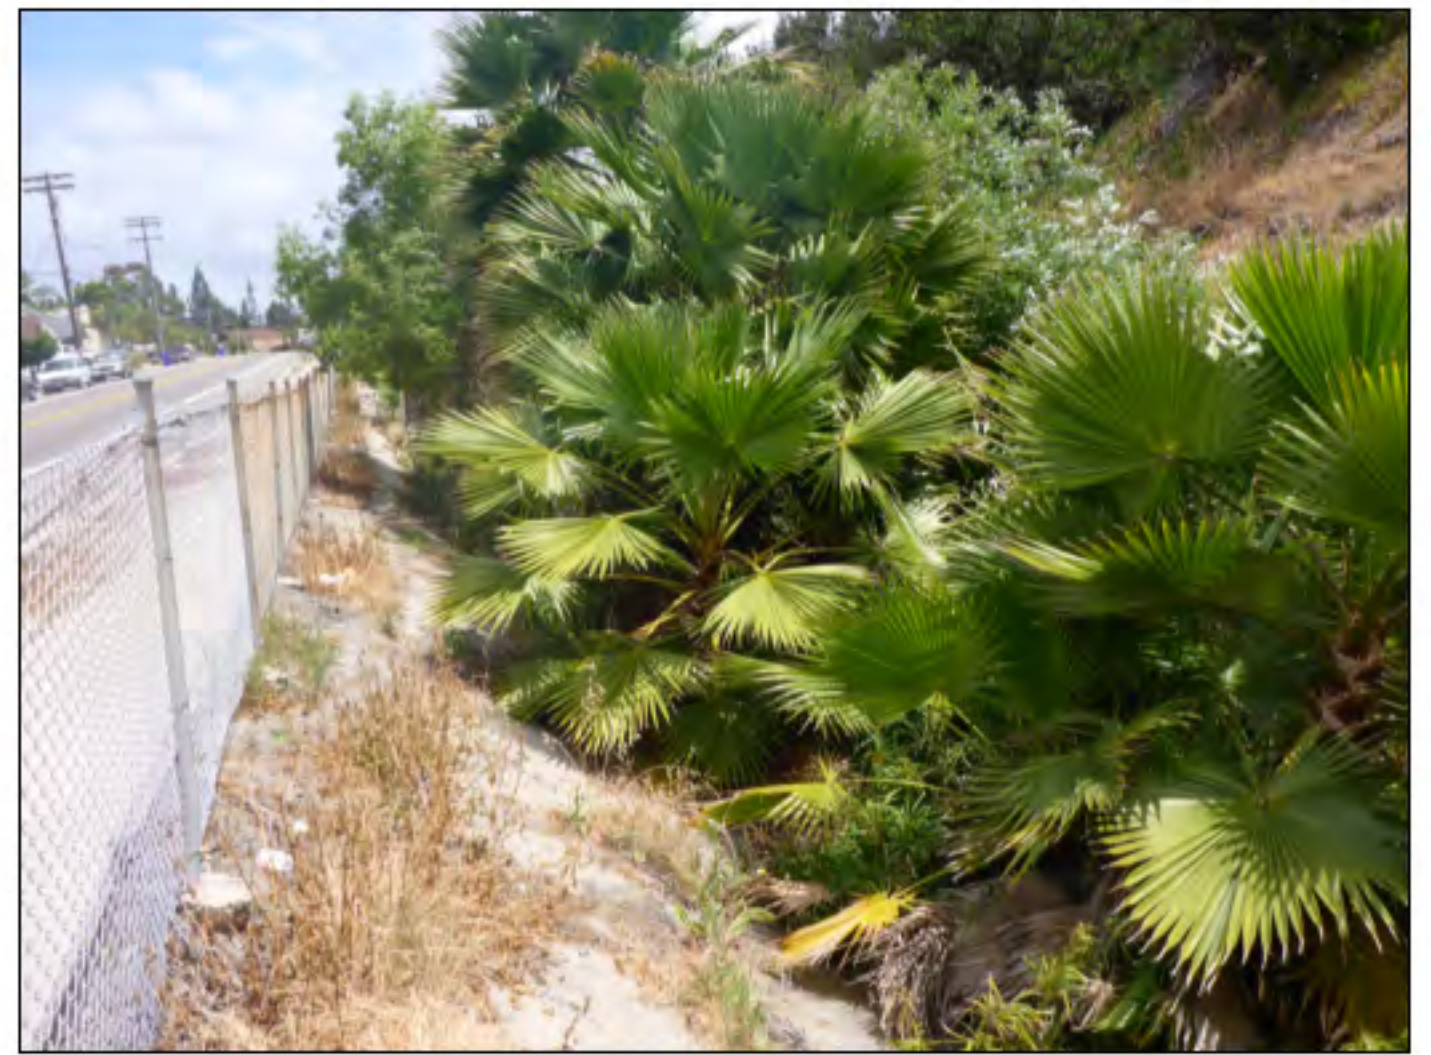
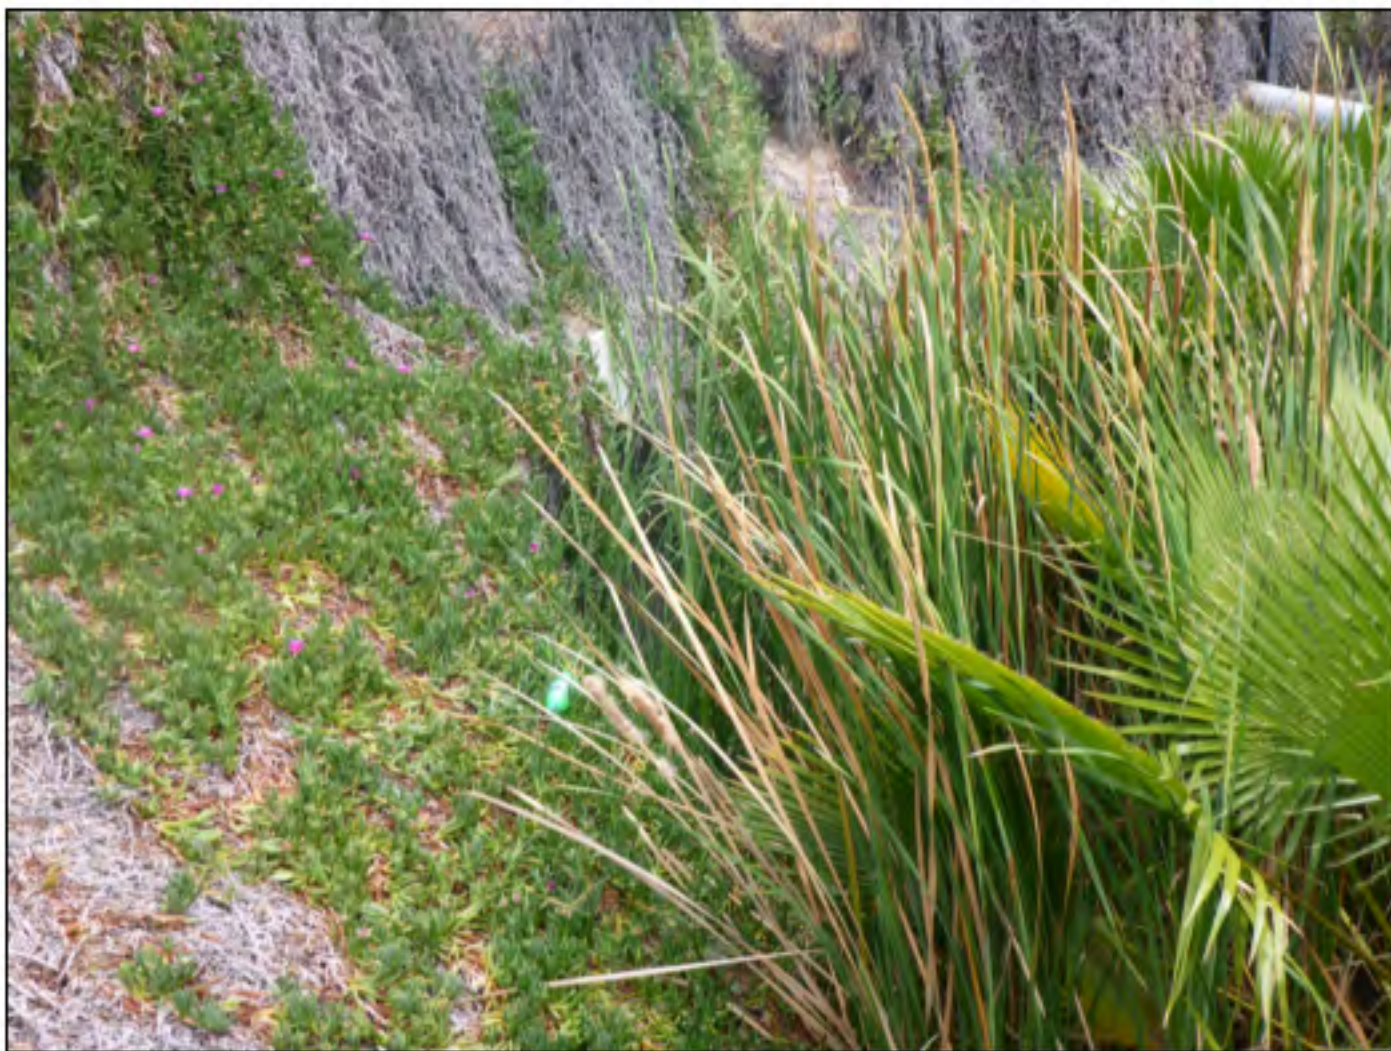
- Based on the site photos taken by the City of San Diego, vegetation has grown down from the top of the channel banks over the concrete side slopes. A high risk of vegetation flowing downstream and clogging the culvert exists.
- Additionally, vegetation has grown down from the top of the downstream culvert entrance. A high risk of vegetation flowing into the culvert and clogging it exists. It is recommended that this vegetation be maintained.

It is recommended that this drainage channel be maintained to increase the current capacity of the channel from less than a 2-year storm event back to a 100-year storm event capacity.

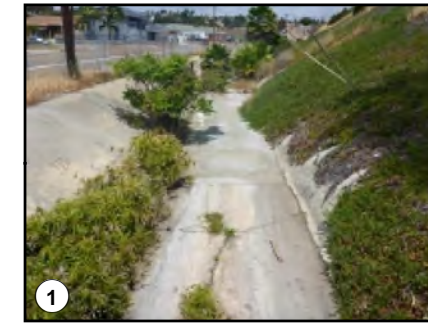
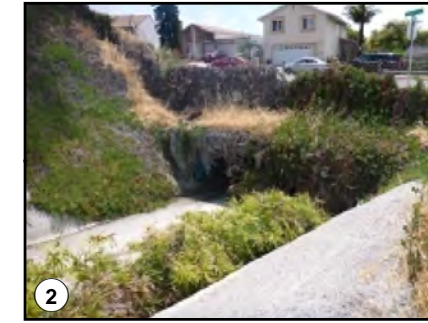
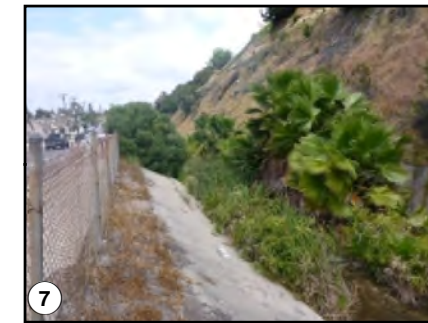
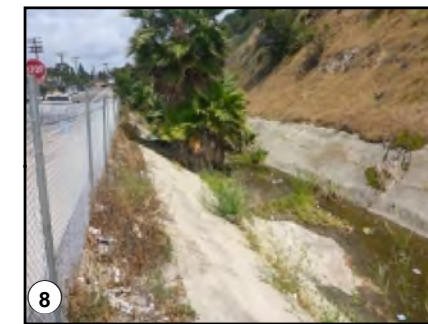
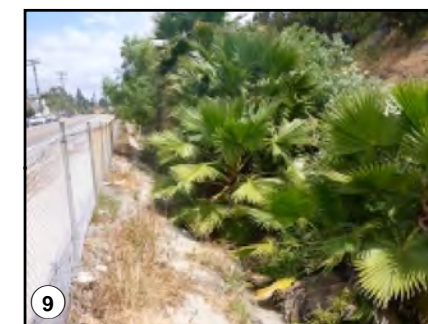
**Photos:**

- **Channel Prioritization Score:**  
*79.3 out of 100*
  - **Flood Hazard Score:**  
*71.3 out of 75*
  - **Water Quality Score:**  
*3 out of 10*
  - **Community Input Score:**  
*5 out of 10*
  - **Aesthetics Score:**  
*0 out of 5*
- **Capacity Prior to Maintenance:**  
*Less than 2-year storm event*
- **Capacity After Maintenance (As-built Capacity):**  
*100-year storm event*
- **Clogging Potential:** *HIGH*
- **Approximate Vegetation Coverage:** *MEDIUM*
- **Surrounding Area:** *Residential*
- **Infrastructure Failures:**  
*None*
- **Site Evaluation Date:**  
*May 7, 2015*
- **Notes/Comments:**  
*Vegetation has grown down from the top of the downstream culvert entrance as well as over the channel banks. A high risk of vegetation flowing into the culvert and clogging it exists. It is recommended that this vegetation be maintained.*
