**SUMMARY OF FINDINGS FOR THE
ANNUAL DRAINAGE CHANNEL FIELD
ASSESSMENT AND MAINTENANCE PRIORITIZATION
PROJECT (PHASE 1)
FOR
THE CITY OF SAN DIEGO – MASTER STORM WATER
SYSTEM MAINTENANCE PROGRAM (MMP) MAP 3:
RANCHO BERNARDO**

**Job Number 17204-D
August 4, 2015**

Prepared For:
City of San Diego
2781 Caminito Chollas
San Diego, California 92105

Prepared By:
Rick Engineering Company
Water Resources Division
5620 Friars Road
San Diego, California 92110-2596
(619) 291-0707

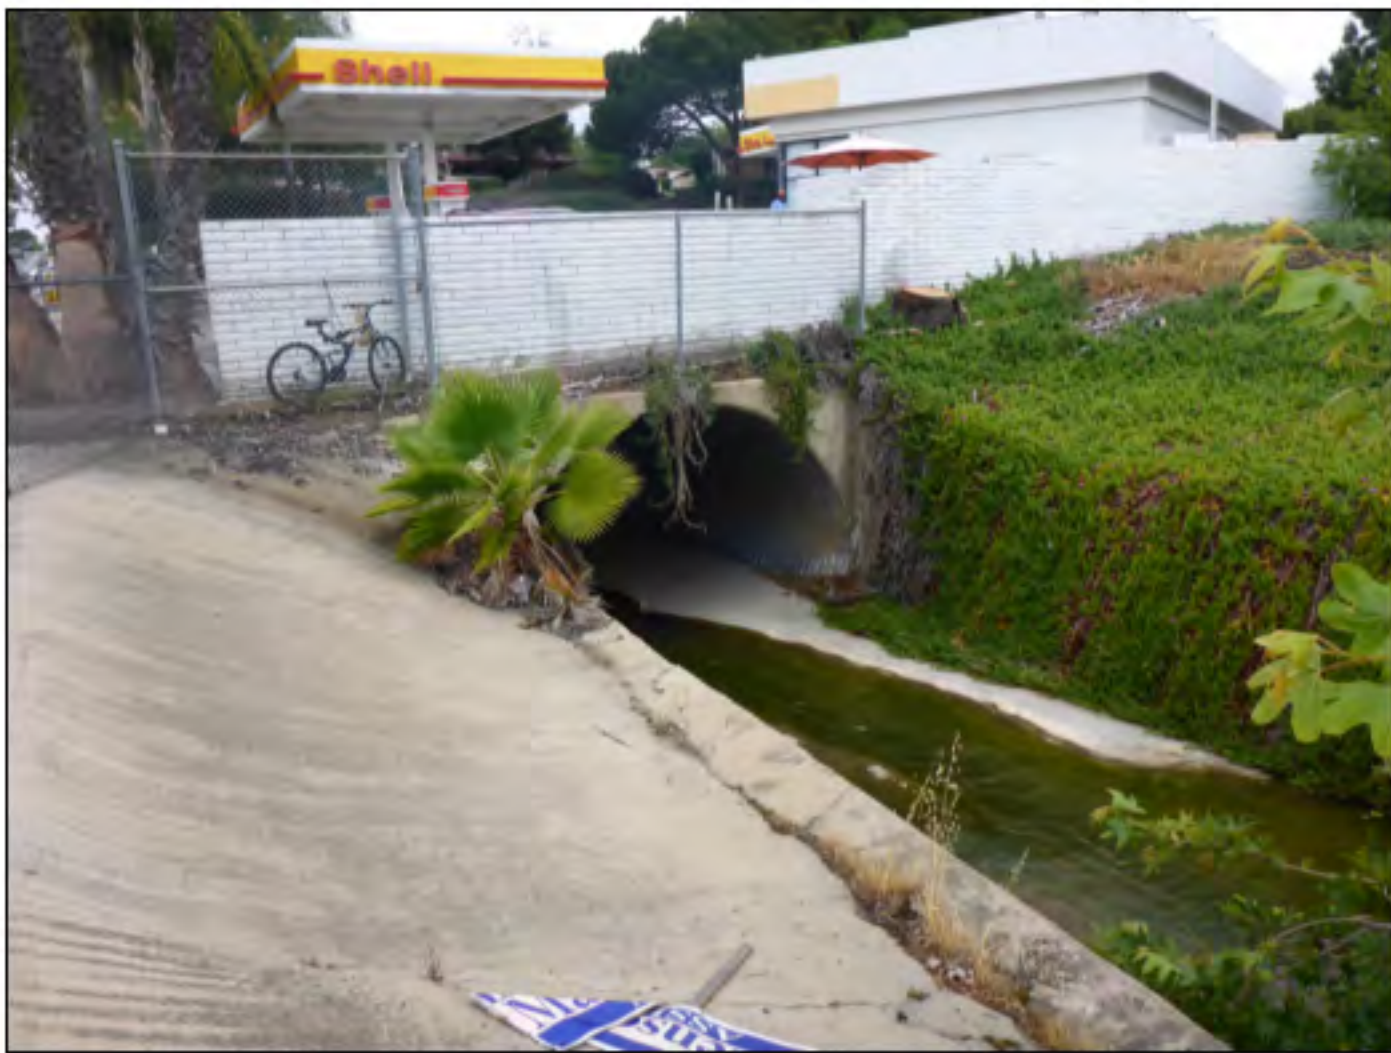
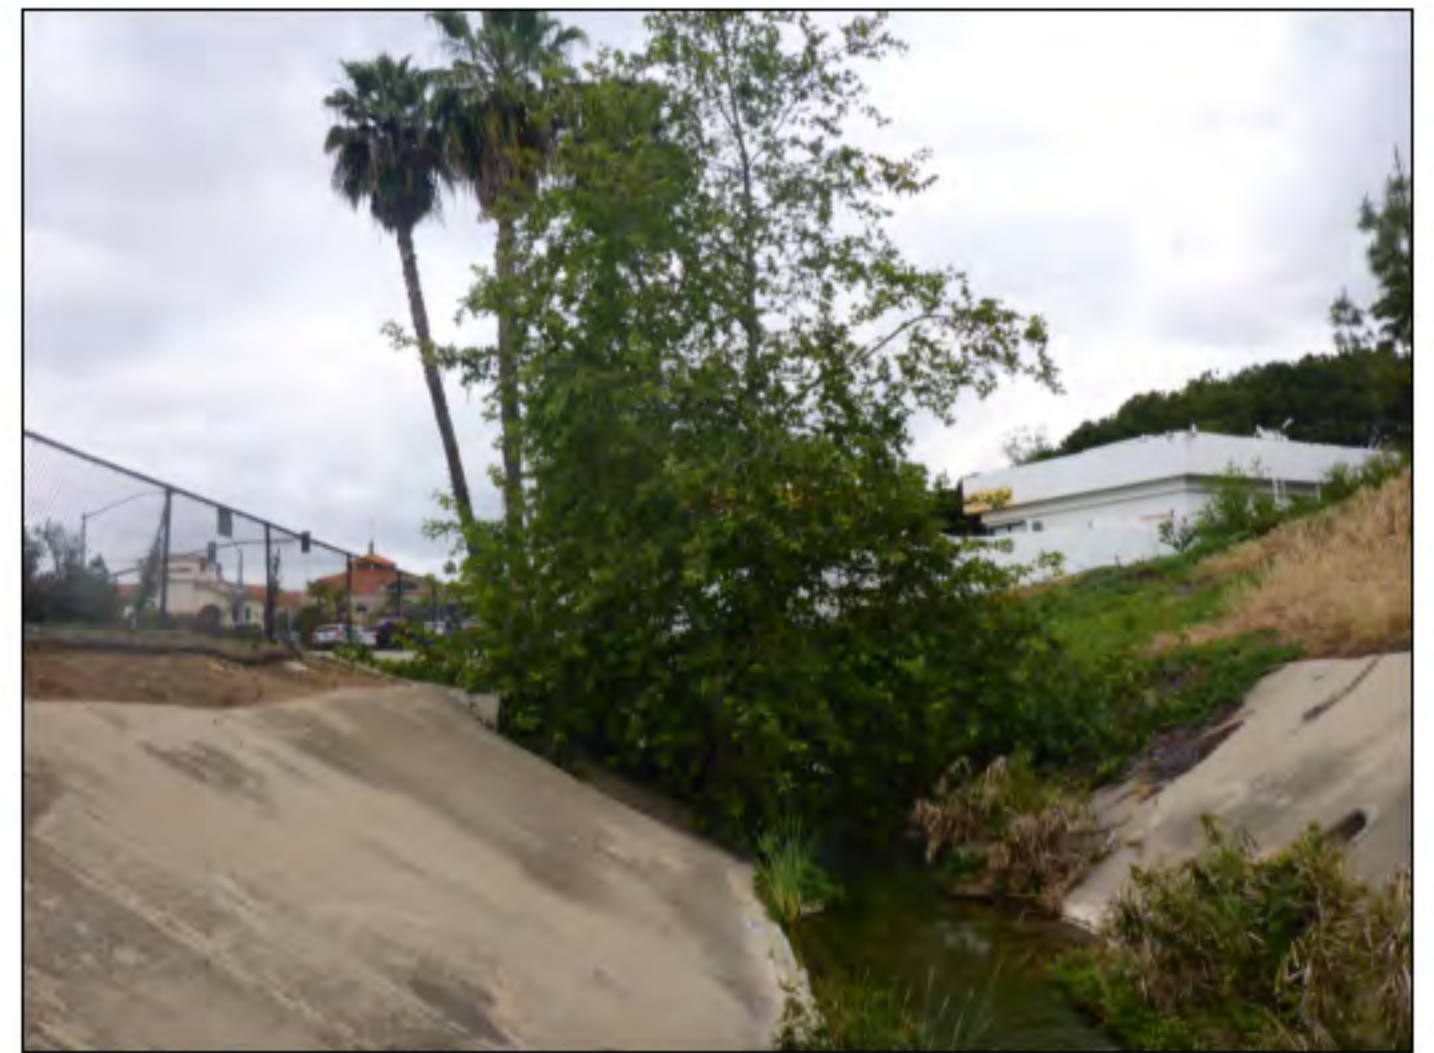
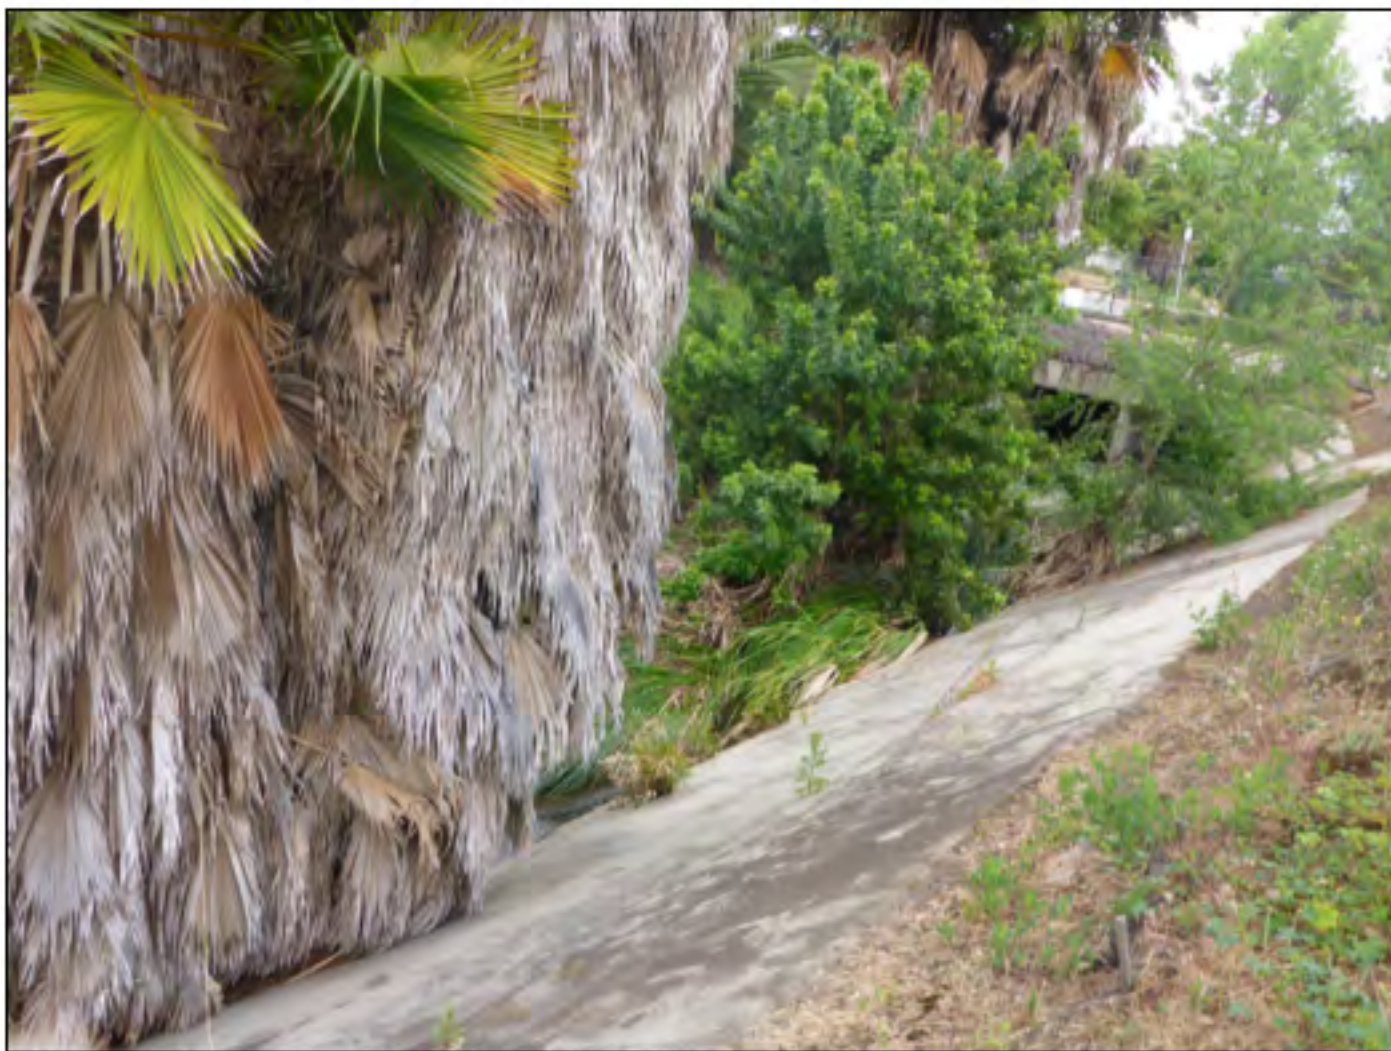
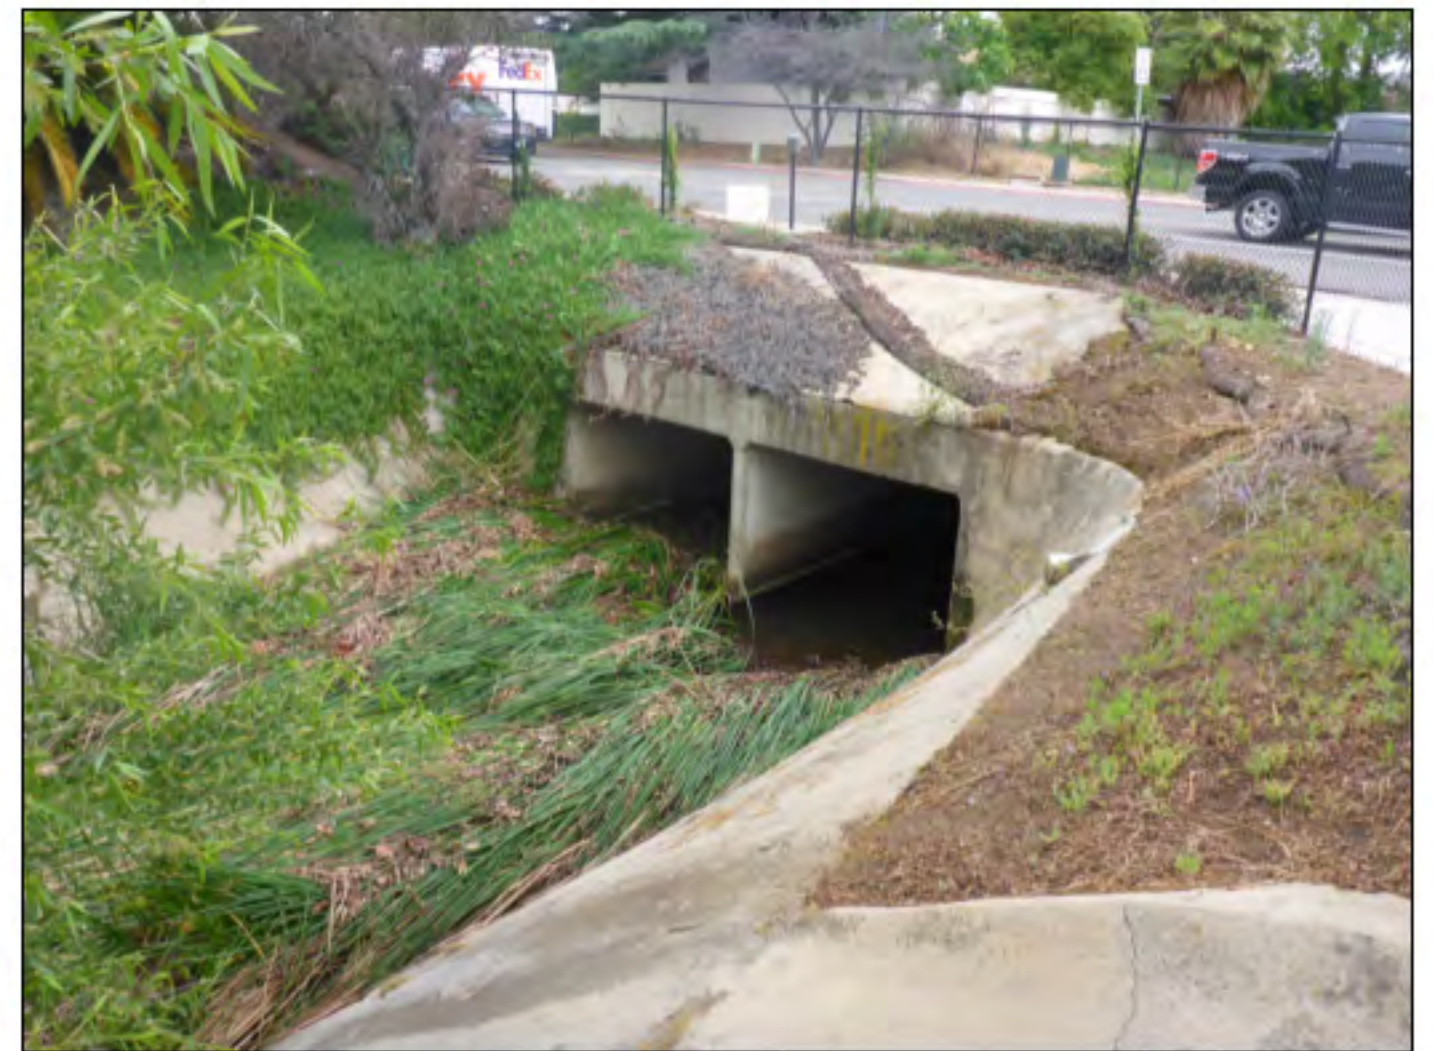
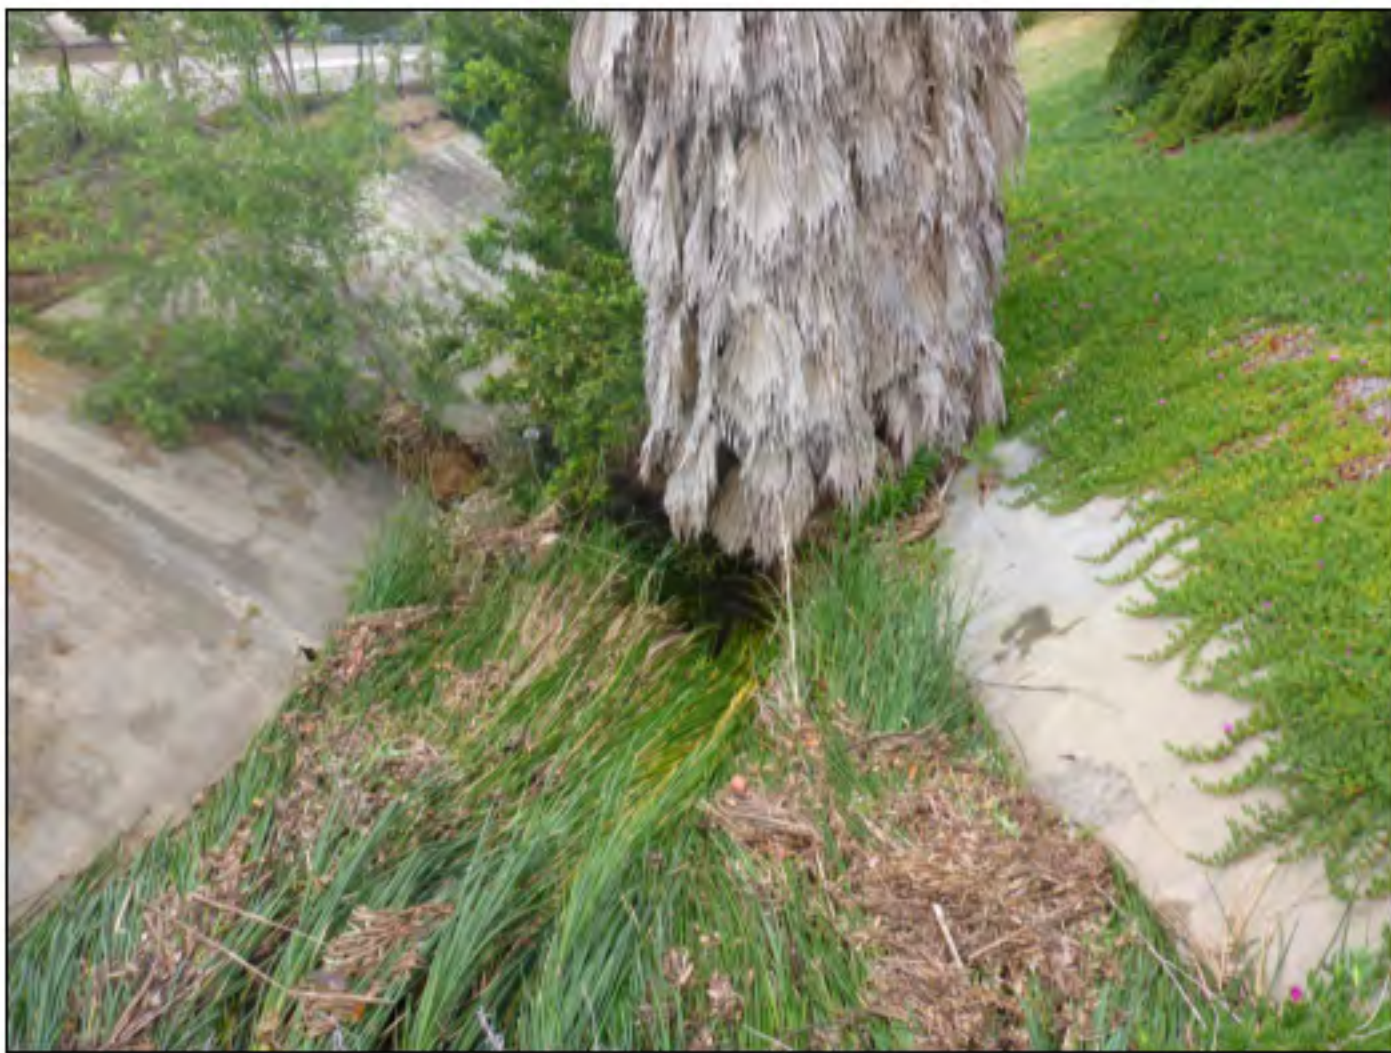
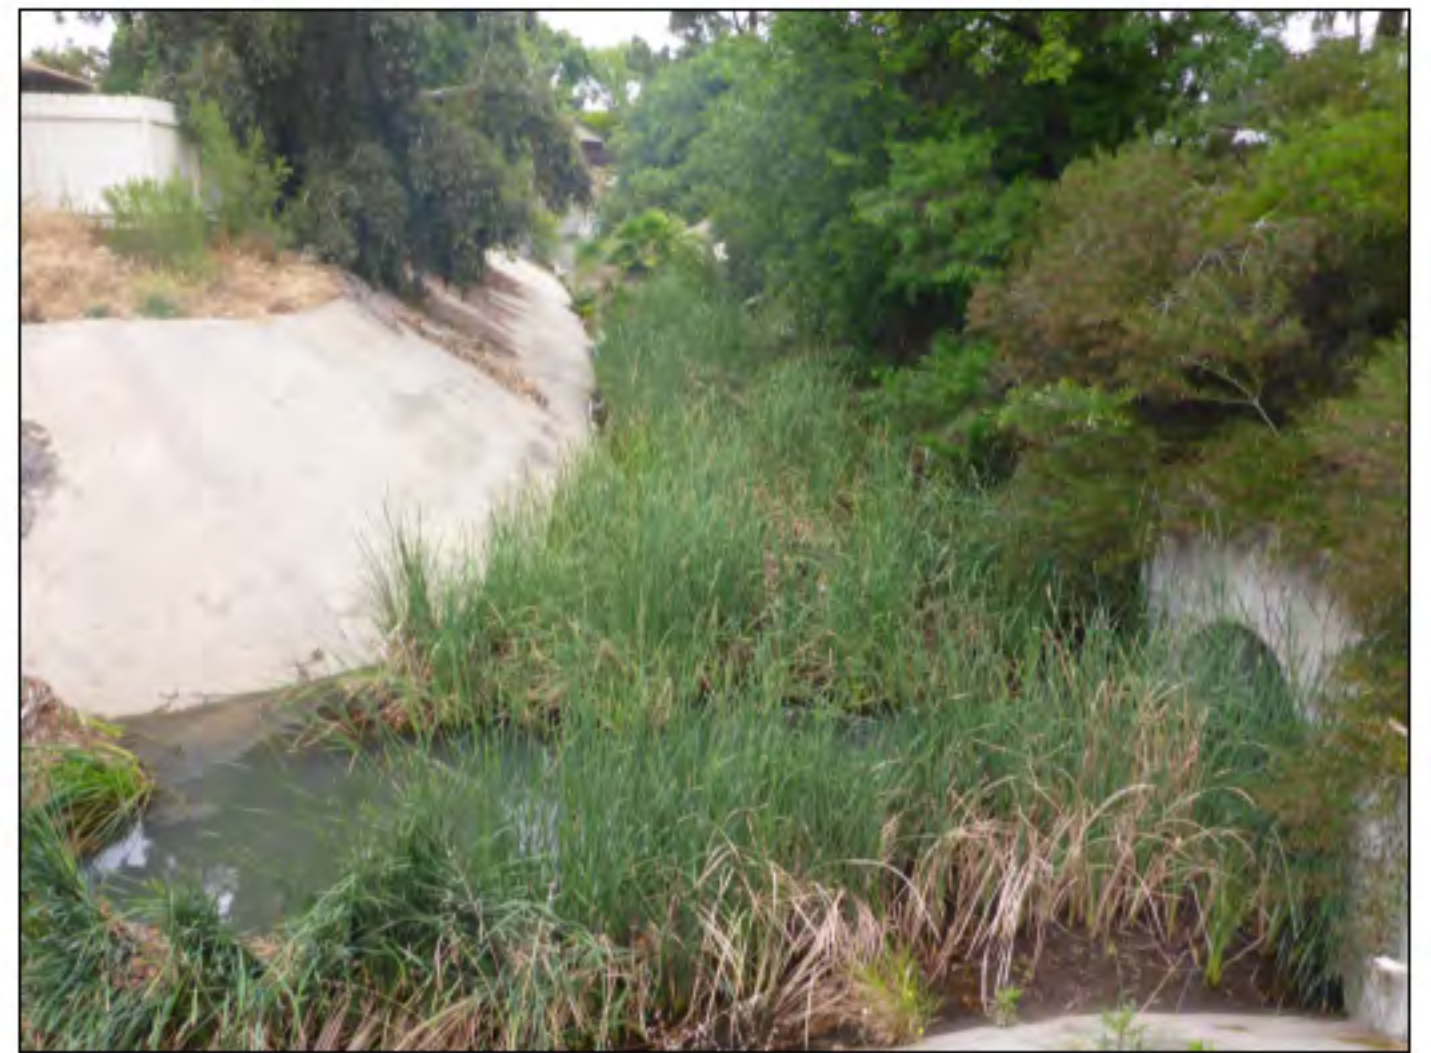
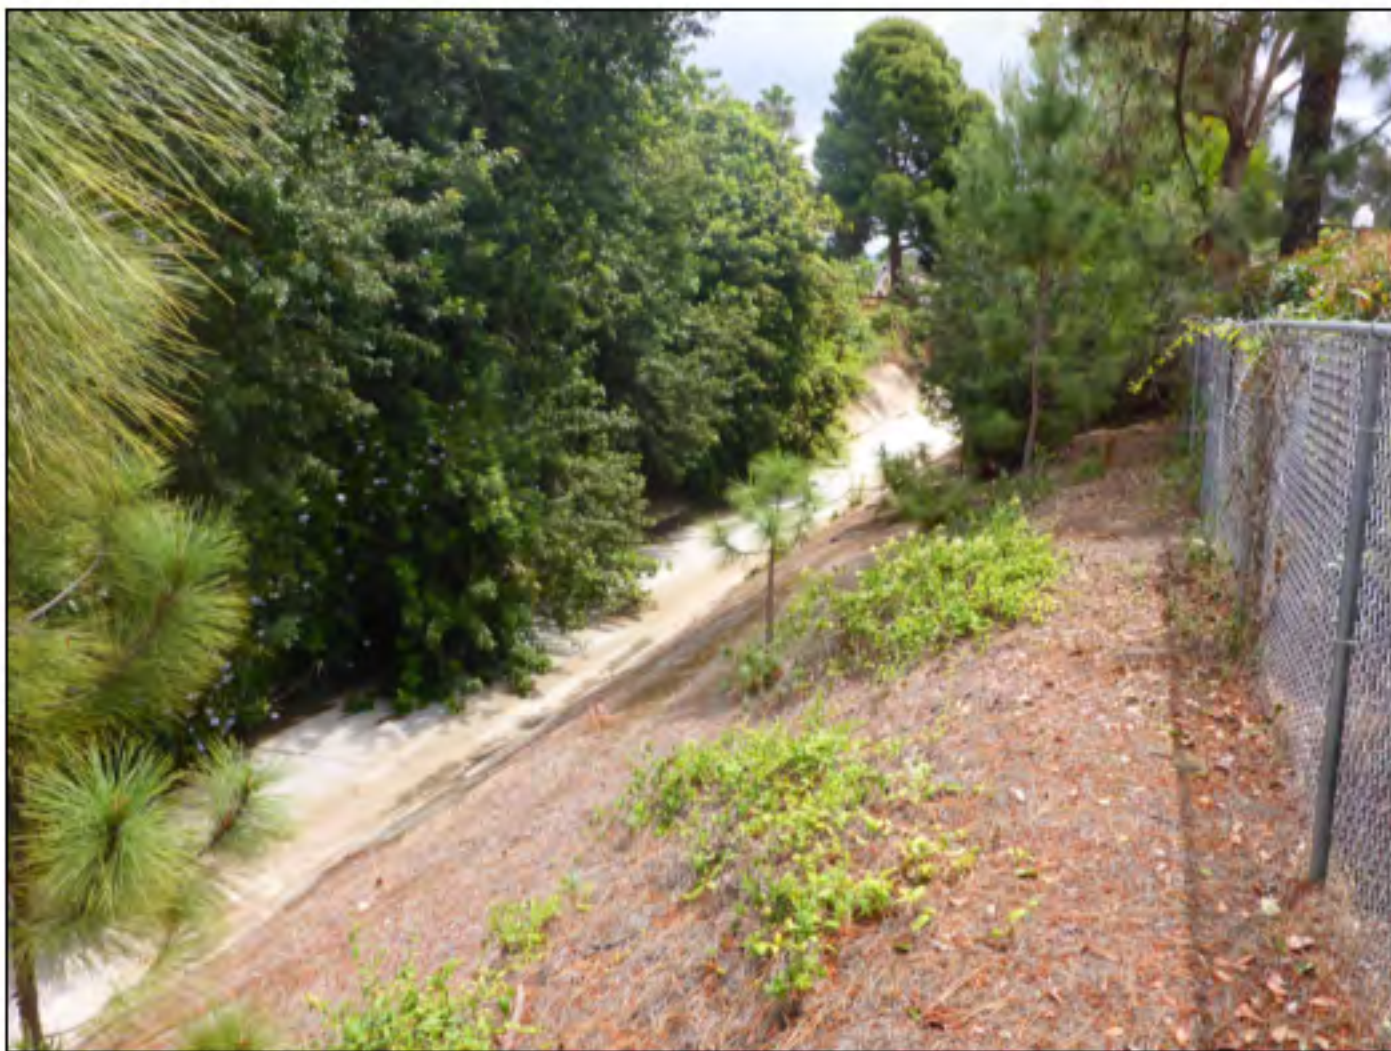
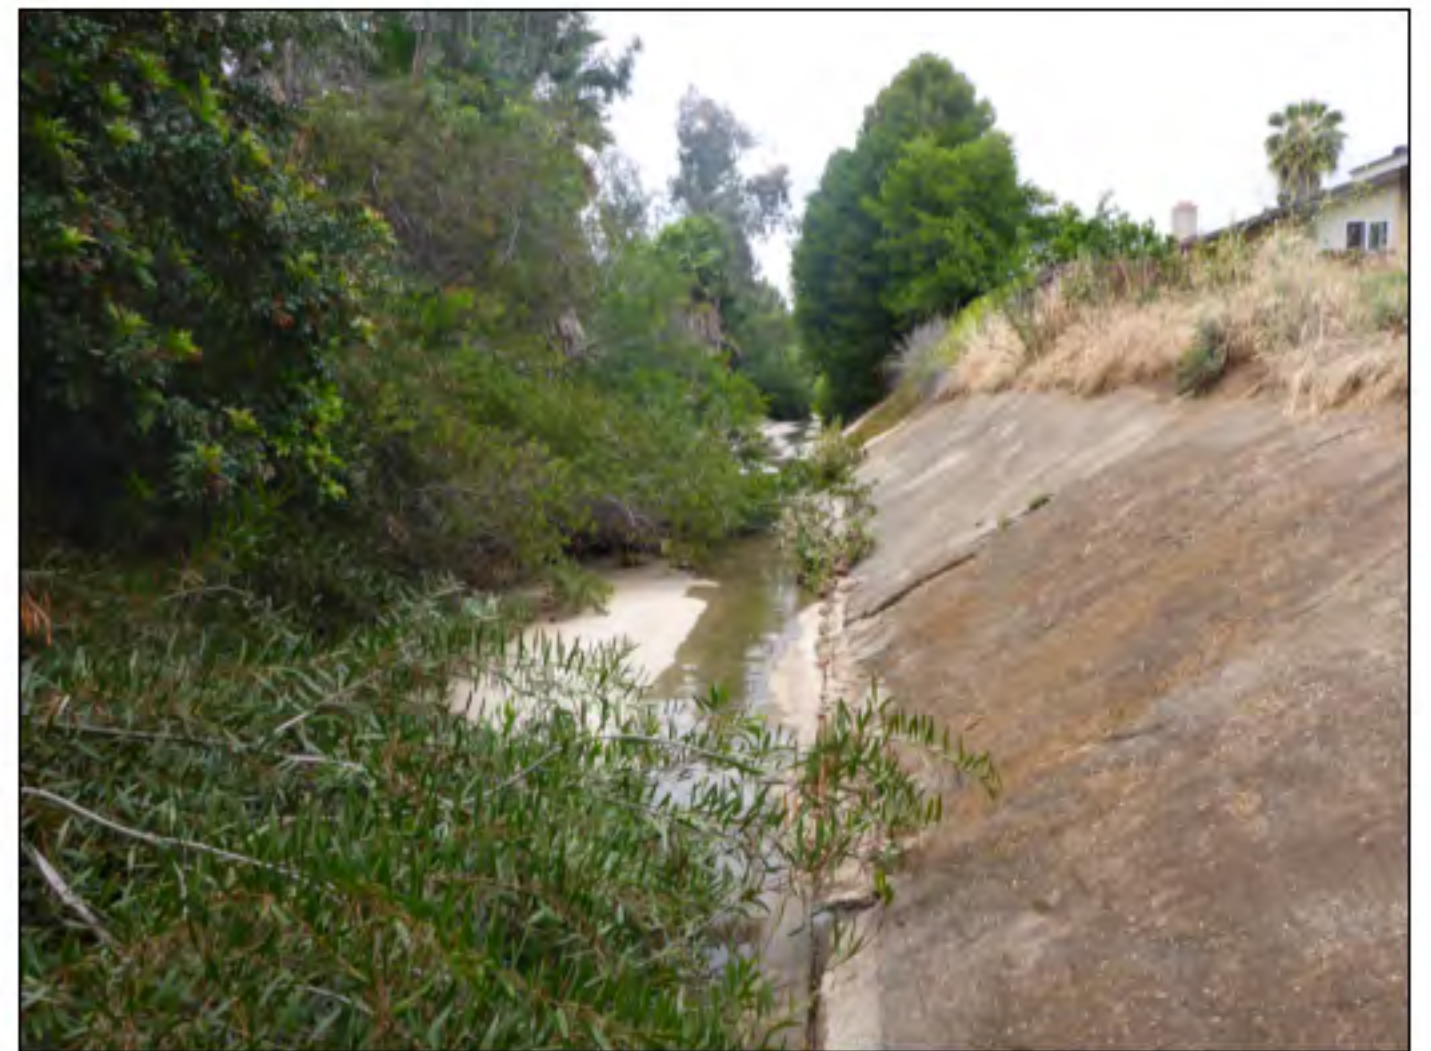
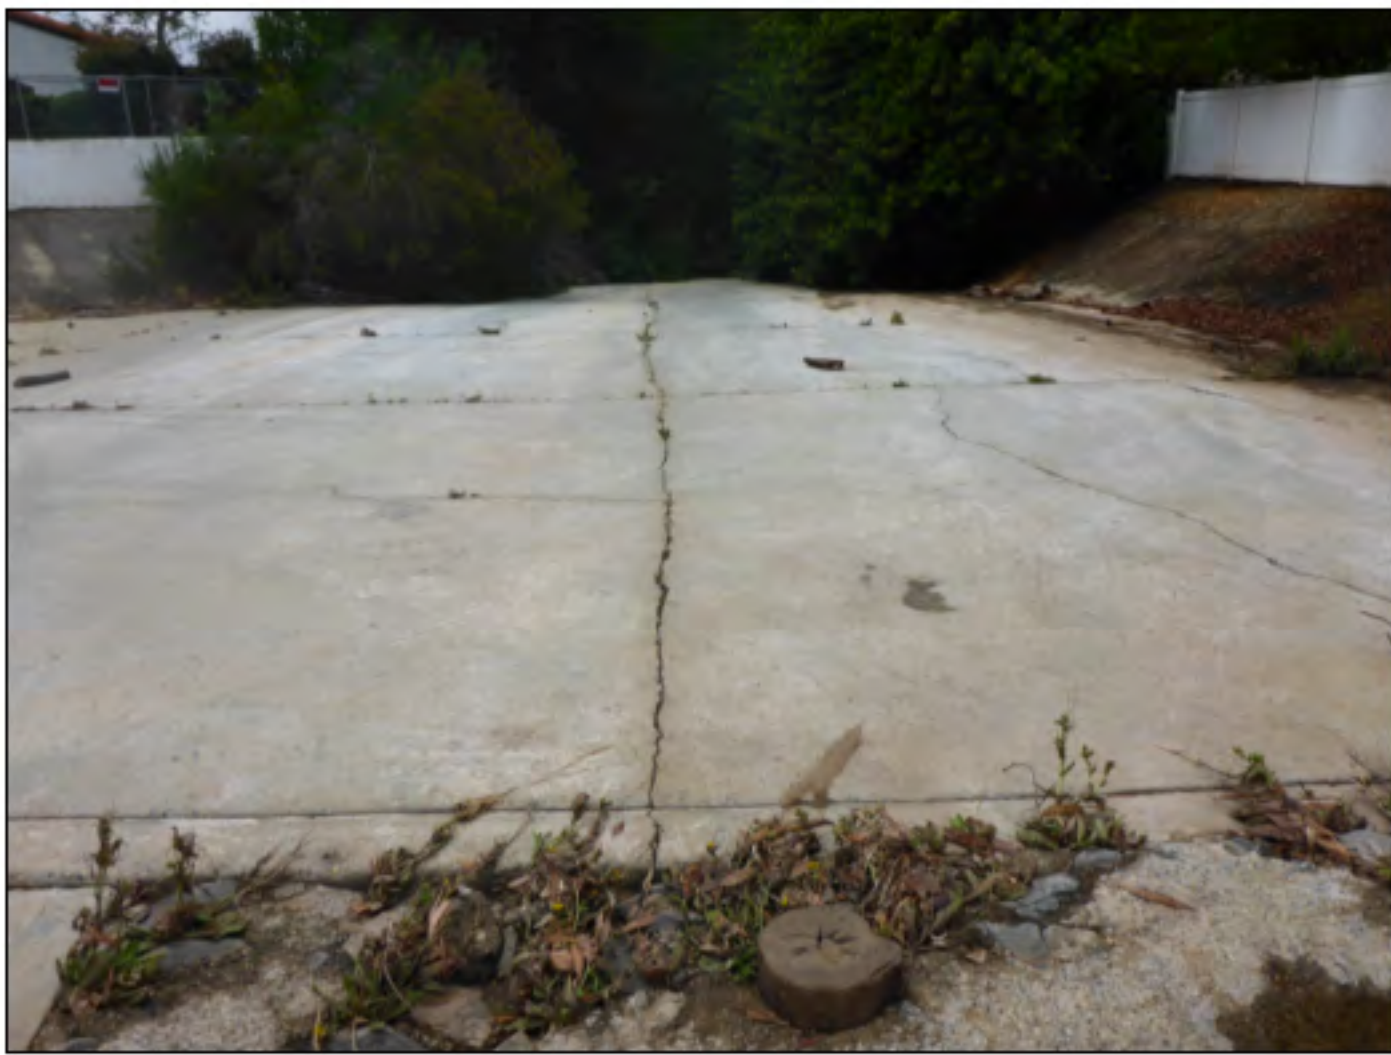
- The channel has holes and cracks in the concrete sides and bottoms throughout portions of its reach. It is recommended that these areas be maintained to prevent continuous vegetation growth from exacerbating these areas. It is also recommended that the holes and cracks be repaired to prevent water from potentially flowing through them and undermining the channel.

Item	Condition	Comments
1. Structure Condition	1 (2) 3 N/A	CHANNEL HAS WHOLLS SEE PICTURES
2. Trash/Debris/Sediment	1 (2) 3 N/A	
3. Clogging	1 (2) 3 N/A	Potential Flooding

Item	Condition			Comments
1. <u>Broken Concrete</u> /Gunite?	<input checked="" type="radio"/> Y	<input type="radio"/> N	<input type="radio"/> N/A	See Pictures
2. Broken/Missing Trash Fence?	<input type="radio"/> Y	<input checked="" type="radio"/> N	<input type="radio"/> N/A	
3. Broken/Missing Poles/Supports?	<input type="radio"/> Y	<input checked="" type="radio"/> N	<input type="radio"/> N/A	
4. Exposed Rebar?	<input type="radio"/> Y	<input checked="" type="radio"/> N	<input type="radio"/> N/A	
5. Rock/Debris Accumulation?	<input type="radio"/> Y	<input checked="" type="radio"/> N	<input type="radio"/> N/A	
6. Potential Flooding/Litigation?	<input checked="" type="radio"/> Y	<input type="radio"/> N	<input type="radio"/> N/A	
7. Slope Failure?	<input type="radio"/> Y	<input checked="" type="radio"/> N	<input type="radio"/> N/A

It is recommended that this drainage channel be maintained to increase the current capacity of the channel from less than a 2-year storm event back to a 100-year storm event capacity.

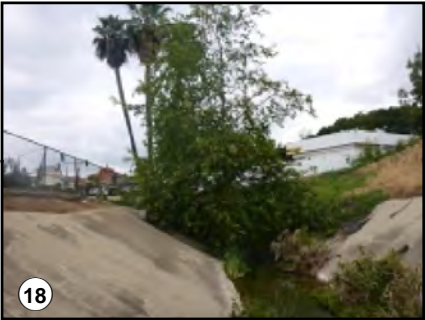
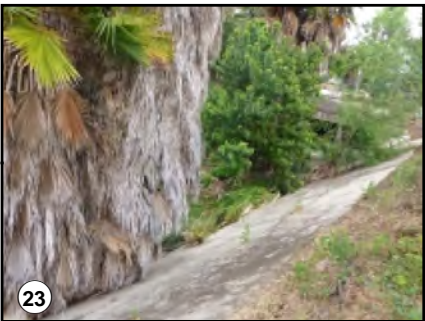
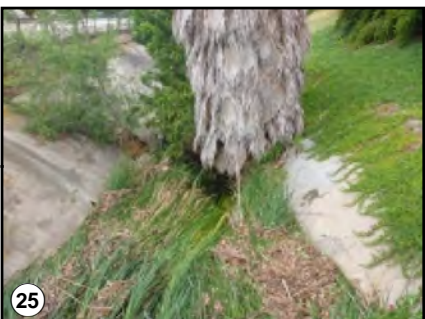
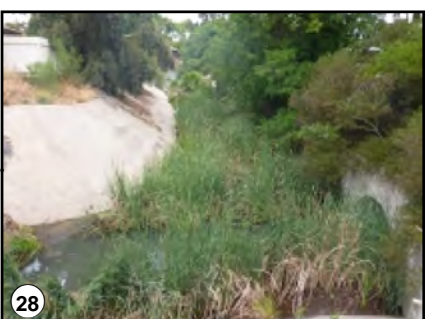
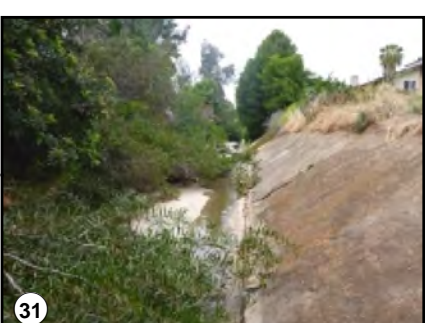
Photos:

- Channel Prioritization Score:
88.6 out of 100
 - Flood Hazard Score:
73.8 out of 75
 - Water Quality Score:
6 out of 10
 - Community Input Score:
5 out of 10
 - Aesthetics Score:
3.8 out of 5
- Capacity Prior to Maintenance:
Less than 2-year storm event
- Capacity After Maintenance (As-built Capacity) :
100-year storm event
- Clogging Potential: *HIGH*
- Approximate Vegetation Coverage: *HIGH*
- Surrounding Area: *Residential*
- Infrastructure Failures:
Yes
- Site Evaluation Date:
May 9, 2015
- Notes/Comments:
The channel has holes and cracks in the concrete throughout portions of the channel. It is recommended that these areas be maintained to prevent continuous vegetation growth to exacerbate these areas.
