**SUMMARY OF FINDINGS FOR THE
ANNUAL DRAINAGE CHANNEL FIELD
ASSESSMENT AND MAINTENANCE PRIORITIZATION
PROJECT (PHASE 1)
FOR
THE CITY OF SAN DIEGO – MASTER STORM WATER
SYSTEM MAINTENANCE PROGRAM (MMP) MAP 51:
RED RIVER DR & CONESTOGA DR**

Job Number 17204-D

August 4, 2015

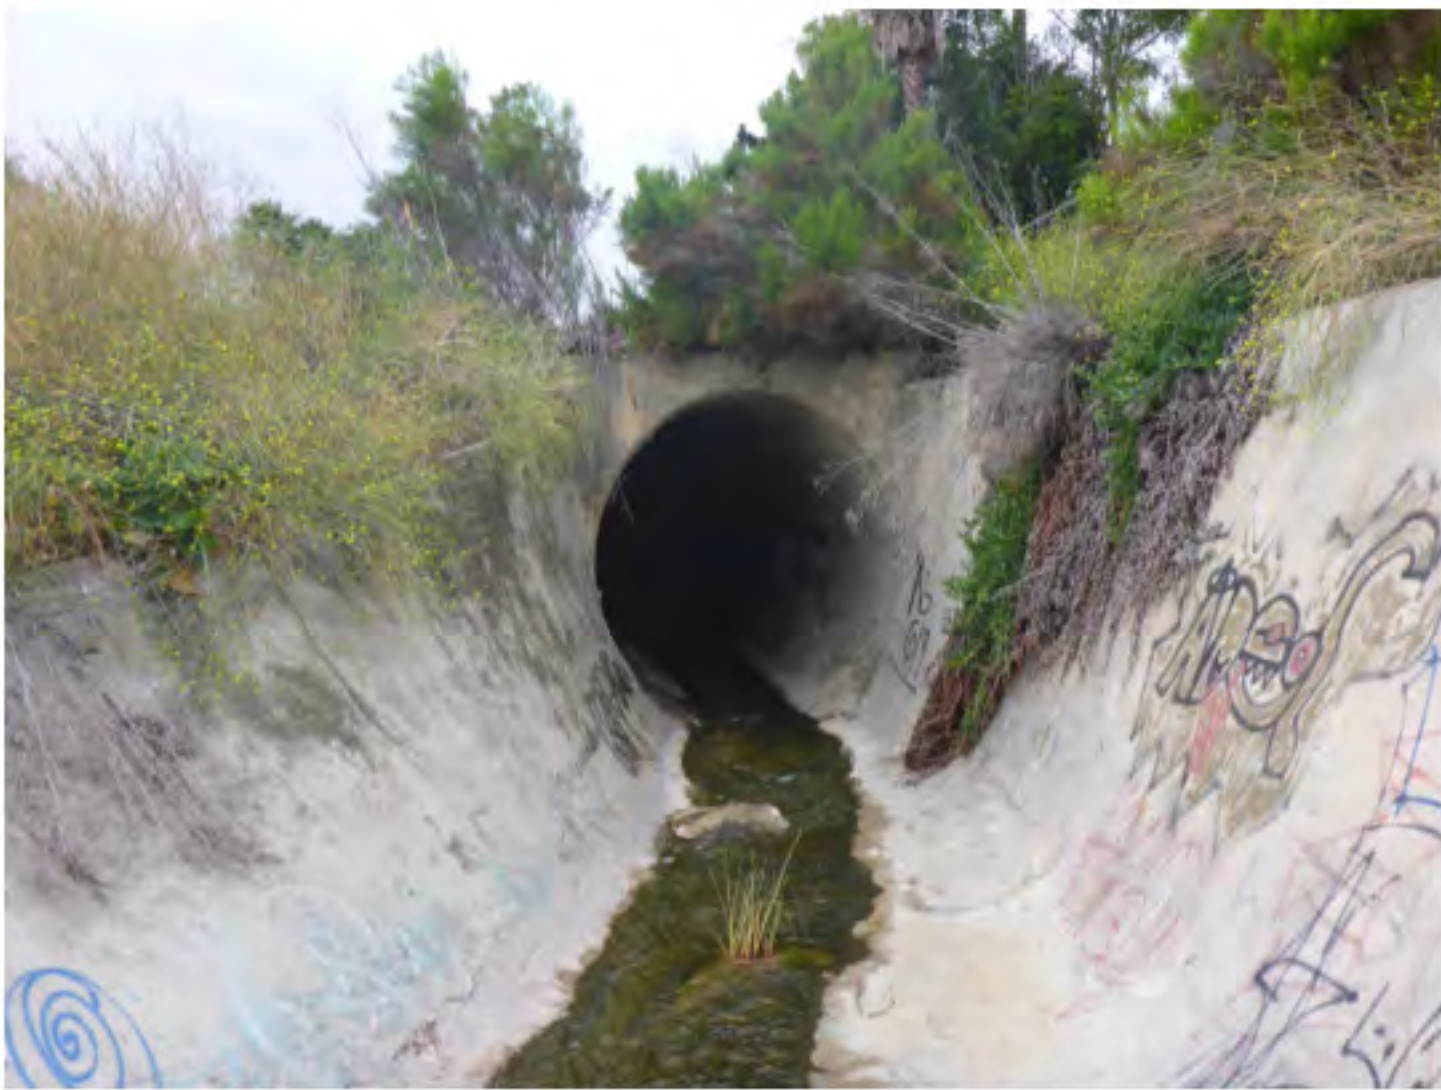
Red River Drive & Conestoga Drive.1 (5-16-2015)

- It was noted on the O&M Channel Maintenance Inspection Form completed for the channel by the City of San Diego that there is heavy vegetation within portions of the channel. It appears from the site photos taken by the City of San Diego that the heavy vegetation exists at the upstream end. A high risk of vegetation flowing downstream and clogging the culvert exists.
- It was noted on the O&M Channel Maintenance Inspection Form completed for the channel by the City of San Diego that there is a small hole and broken concrete at the downstream end of the channel. Additionally, it appears from the site photos taken by the City of San Diego that there are cracks in the side slopes along the channel.

It is recommended that this drainage channel be maintained to increase the current capacity of the channel from less than a 2- to 2-year storm event back to a 100-year storm event capacity.

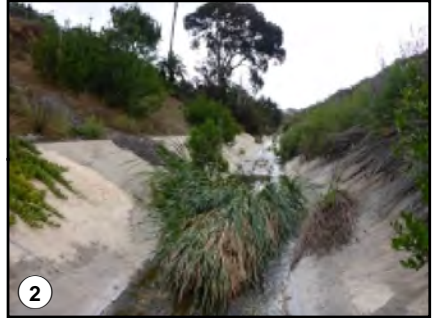
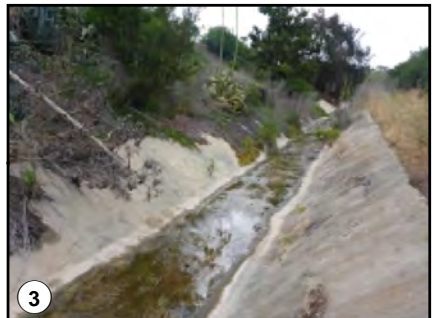
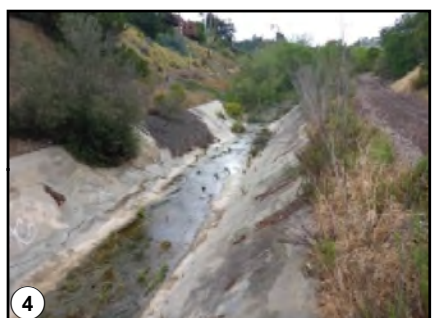
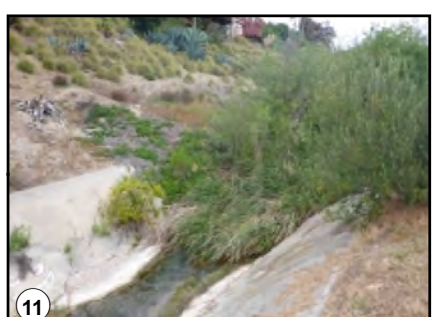
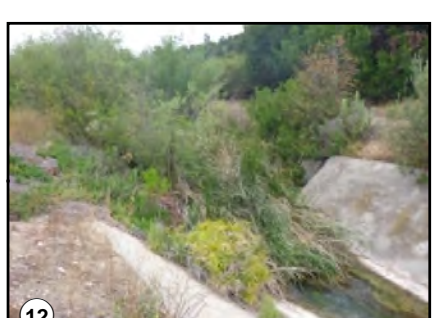
Photos:

- **Channel Prioritization Score:**
63.9 out of 100
 - **Flood Hazard Score:**
61.9 out of 75
 - **Water Quality Score:**
2 out of 10
 - **Community Input Score:**
0 out of 10
 - **Aesthetics Score:**
0 out of 5
- **Capacity Prior to Maintenance:**
Less than 2 to 2-year storm event
- **Capacity After Maintenance (As-built Capacity):**
100-year storm event
- **Clogging Potential:** *HIGH*
- **Approximate Vegetation Coverage:** *MEDIUM*
- **Surrounding Area:** *Residential*
- **Infrastructure Failures:**
Holes and cracks in gunite channel
- **Site Evaluation Date:**
May 16, 2015
- **Notes/Comments:**
It was noted on the O&M Channel Maintenance Inspection Form that there is a small hole and broken concrete at the downstream end of the channel and cracks in the side slopes along the channel. A high risk of vegetation clogging the culvert exists.
