**SUMMARY OF FINDINGS FOR THE
ANNUAL DRAINAGE CHANNEL FIELD
ASSESSMENT AND MAINTENANCE PRIORITIZATION
PROJECT (PHASE 1)
FOR
THE CITY OF SAN DIEGO – MASTER STORM WATER
SYSTEM MAINTENANCE PROGRAM (MMP) MAP 104:
SOUTH CHOLLAS CREEK CHANNEL**

**Job Number 17204-D
August 4, 2015**

August 4, 2015

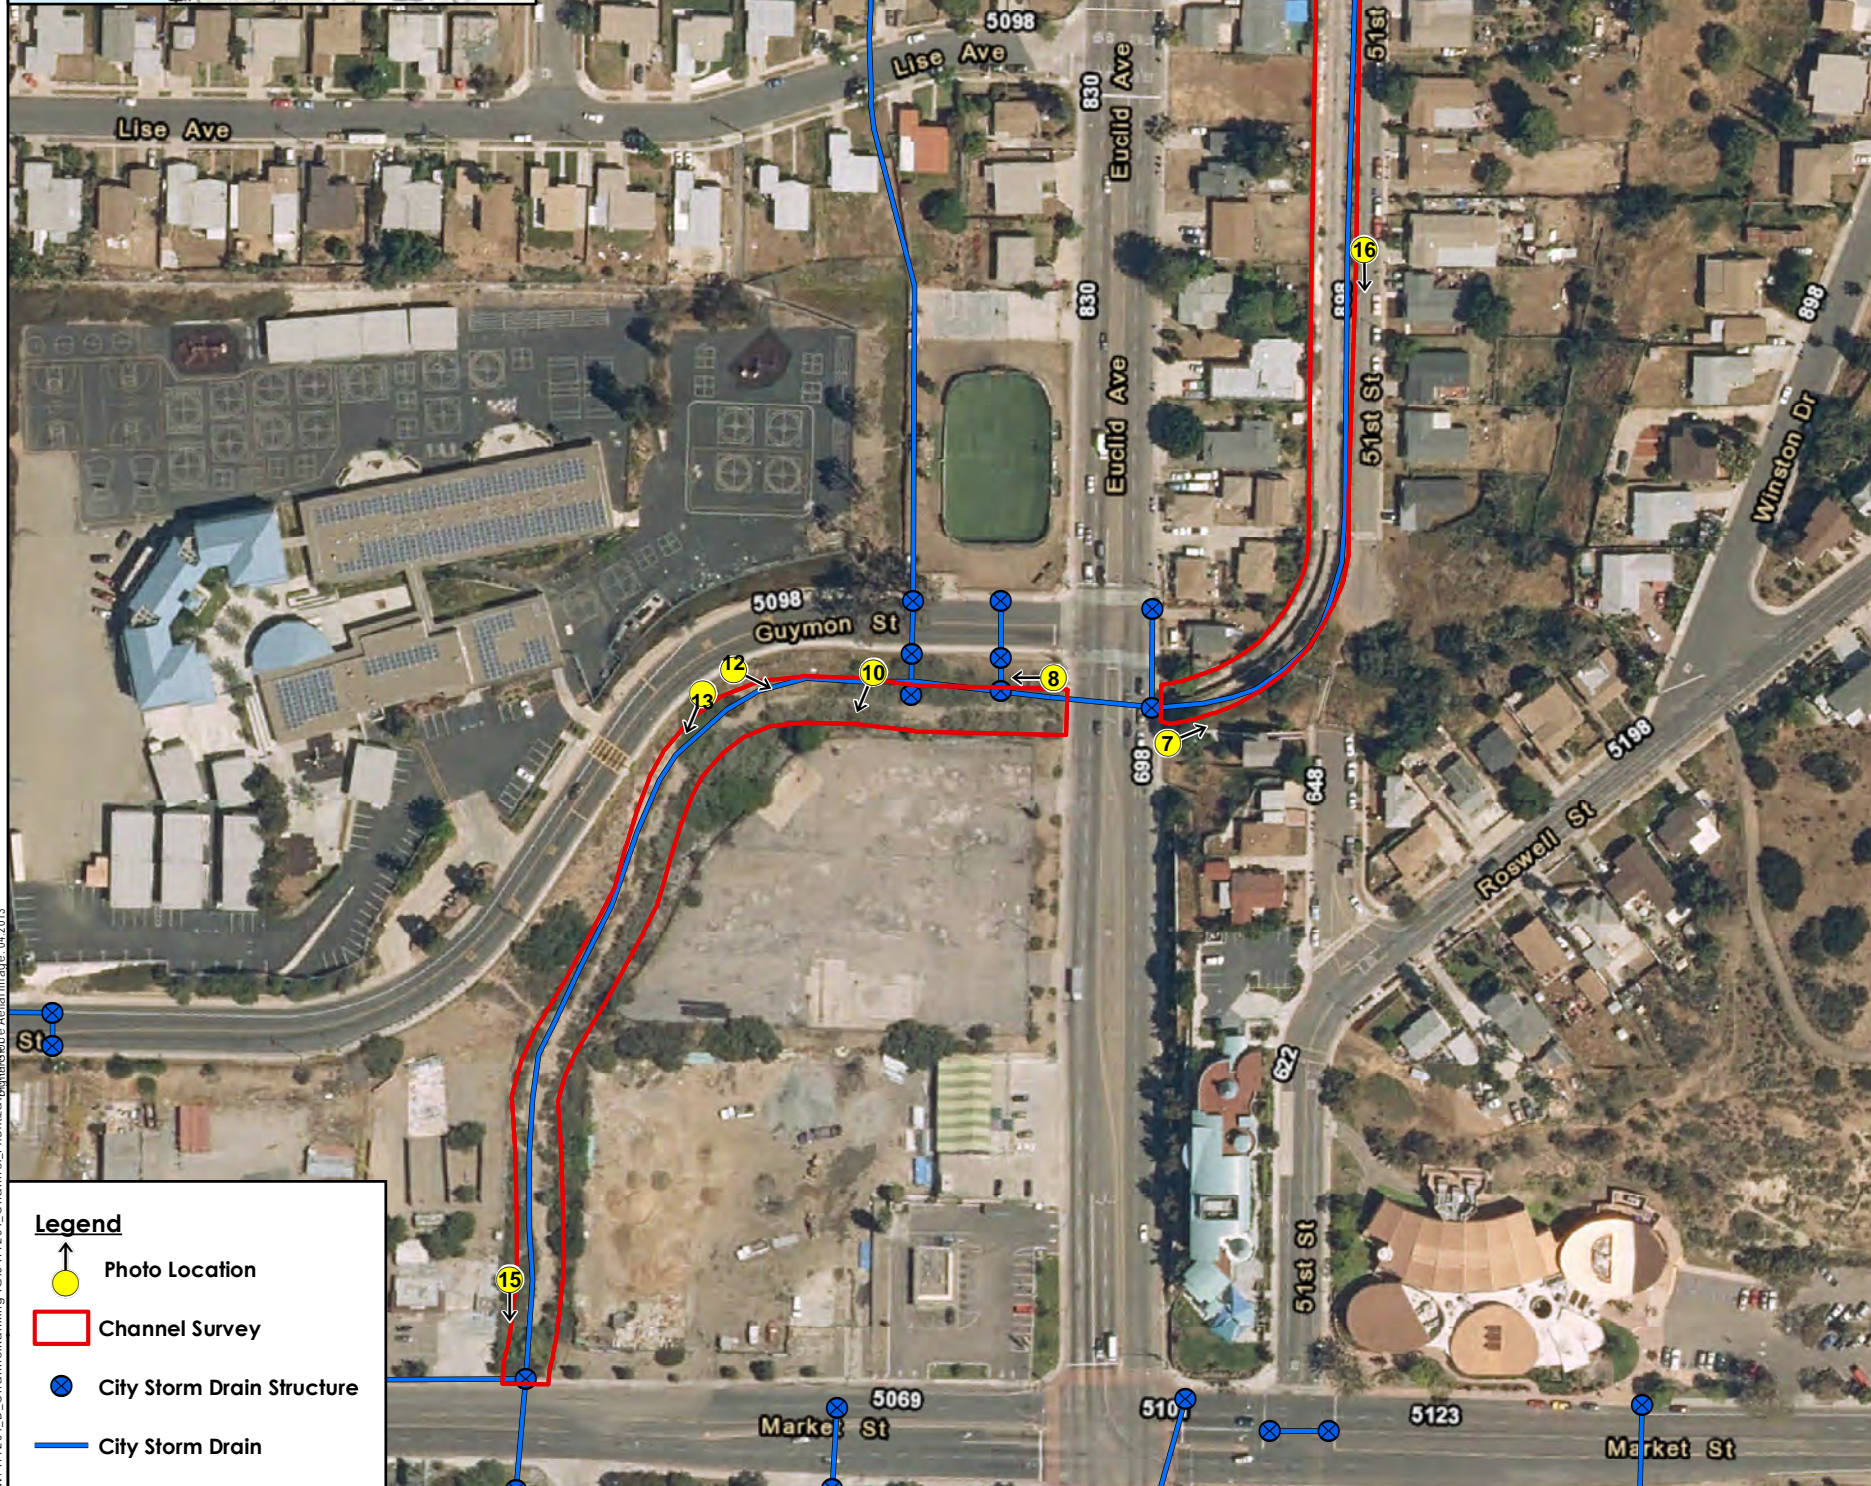
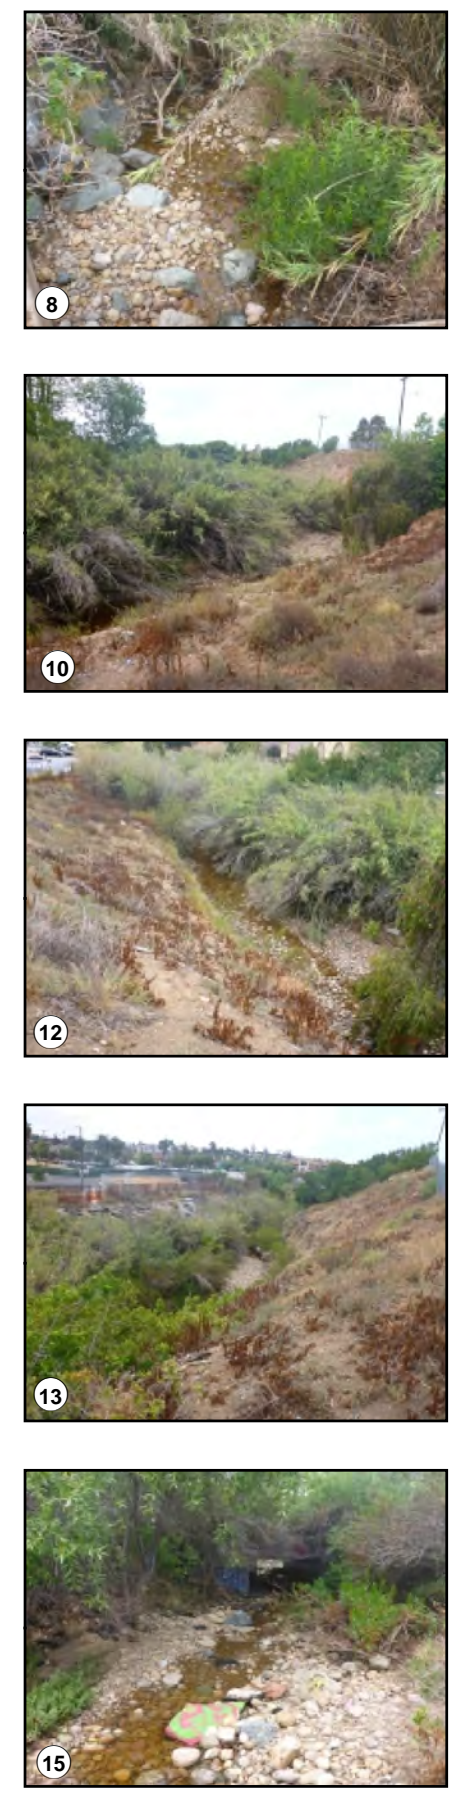
Channel Maintenance Prioritization Summary Sheet

- **Channel Prioritization Score:**
70.3 out of 100
 - **Flood Hazard Score:**
56.3 out of 75
 - **Water Quality Score:**
4 out of 10
 - **Community Input Score:**
5 out of 10
 - **Aesthetics Score:**
5 out of 5
- **Capacity Prior to Maintenance:**
100-year storm event
- **Capacity After Maintenance (As-built Capacity):**
100-year storm event
- **Clogging Potential:** *MEDIUM*
- **Approximate Vegetation Coverage:** *MEDIUM*
- **Surrounding Area:** *Commercial*
- **Infrastructure Failures:**
Slope failure
- **Site Evaluation Date:**
May 9, 2015
- **Notes/Comments:**
One of the side slopes has failed and blocked part of the culvert entrance at the downstream end of the channel.

It is recommended that this drainage channel be maintained to increase the current capacity of the channel from a 1904.3 cfs (100-year storm event) back to a 2549.9 cfs (100-year storm event) capacity. It is important to note that although maintenance will not reduce the frequency of flooding, it will reduce the overall effect of flooding.
