**SUMMARY OF FINDINGS FOR THE
ANNUAL DRAINAGE CHANNEL FIELD
ASSESSMENT AND MAINTENANCE PRIORITIZATION
PROJECT (PHASE 1)
FOR
THE CITY OF SAN DIEGO – MASTER STORM WATER
SYSTEM MAINTENANCE PROGRAM (MMP) MAP 95:
SOUTH CHOLLAS CREEK CHANNEL**

**Job Number 17204-D
August 4, 2015**

Prepared For:
City of San Diego
2781 Caminito Chollas
San Diego, California 92105

Prepared By:
Rick Engineering Company
Water Resources Division
5620 Friars Road
San Diego, California 92110-2596
(619) 291-0707

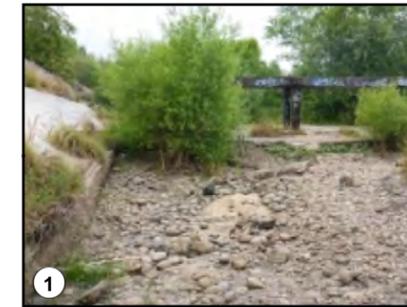
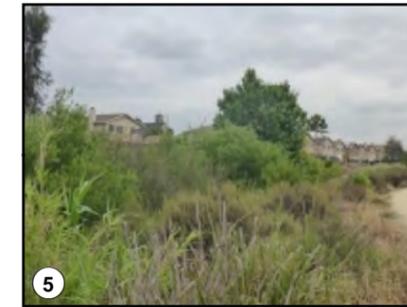
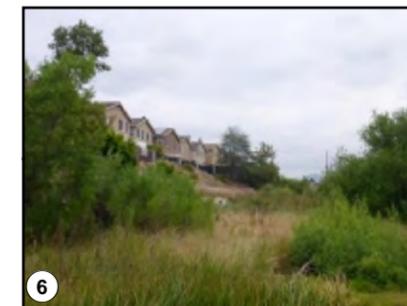
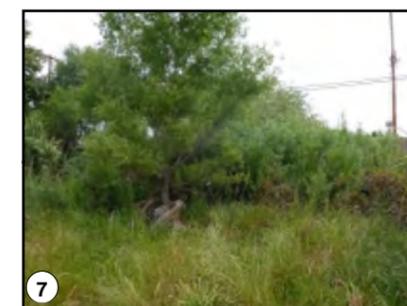
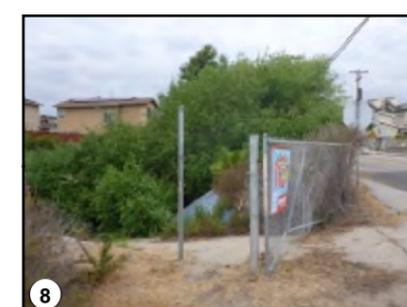
Photos:

- It was noted on the O&M Channel Maintenance Inspection Form completed for the channel by the City of San Diego that there is heavy vegetation in the majority of the channel reach. A high risk of vegetation flowing downstream and clogging the culvert exists.
- It was noted on the O&M Channel Maintenance Inspection Form completed for the channel by the City of San Diego that there is moderate erosion at the west end of the channel near the foot bridge.

- **Channel Prioritization Score:**
72.0 out of 100
 - **Flood Hazard Score:**
65.0 out of 75
 - **Water Quality Score:**
2 out of 10
 - **Community Input Score:**
5 out of 10
 - **Aesthetics Score:**
0 out of 5
- **Capacity Prior to Maintenance:**
5-year storm event
- **Capacity After Maintenance (As-built Capacity):**
25-year storm event
- **Clogging Potential:** *HIGH*
- **Approximate Vegetation Coverage:** *HIGH*
- **Surrounding Area:** *Residential*
- **Infrastructure Failures:**
None
- **Site Evaluation Date:**
May 5, 2015
- **Notes/Comments:**
Moderate erosion in west end of channel near the foot bridge

It is recommended that this drainage channel be maintained to increase the current capacity of the channel from a 5-year storm event back to a 25-year storm event capacity.
