**SUMMARY OF FINDINGS FOR THE
ANNUAL DRAINAGE CHANNEL FIELD
ASSESSMENT AND MAINTENANCE PRIORITIZATION
PROJECT (PHASE 1)
FOR
THE CITY OF SAN DIEGO – MASTER STORM WATER
SYSTEM MAINTENANCE PROGRAM (MMP) MAP 97:
SOUTH CHOLLAS CREEK CHANNEL**

**Job Number 17204-D
August 4, 2015**

Prepared By:
Rick Engineering Company
Water Resources Division
5620 Friars Road
San Diego, California 92110-2596
(619) 291-0707

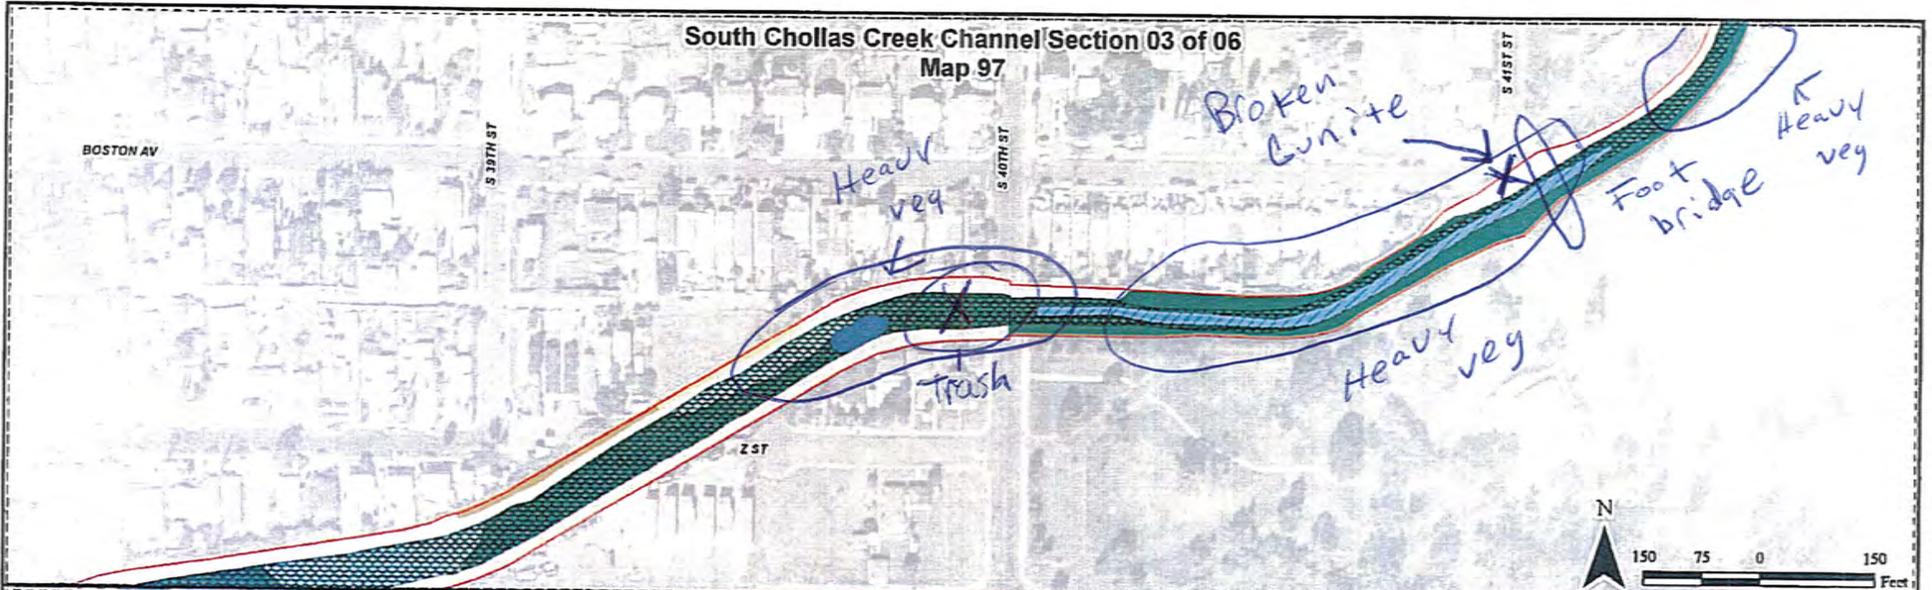
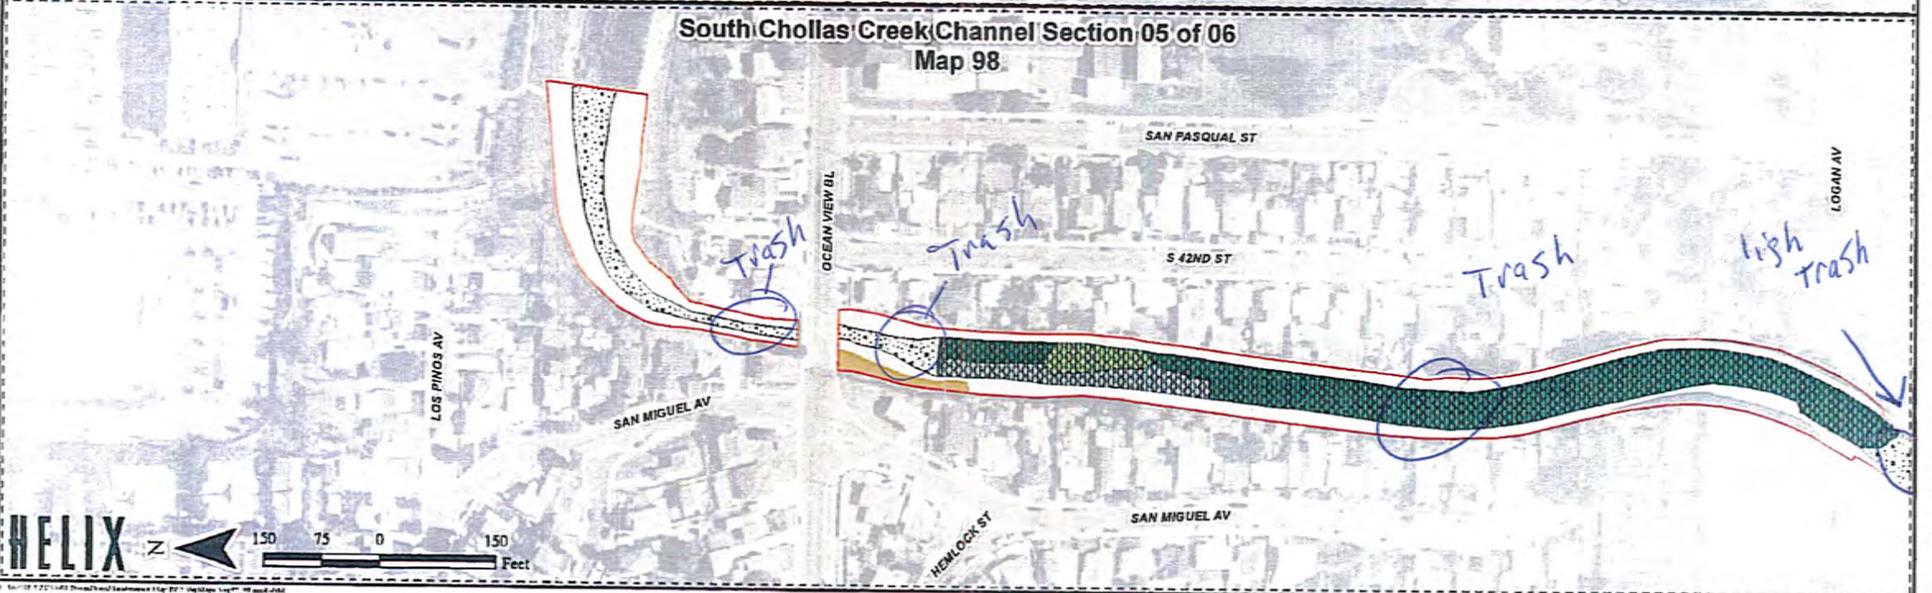
Broke Gunite near foot bridge to Park

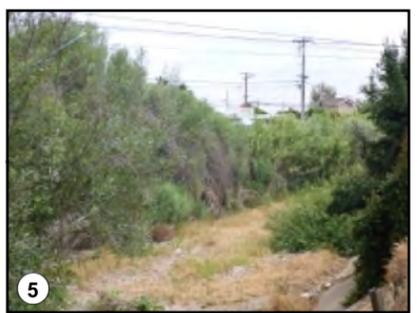
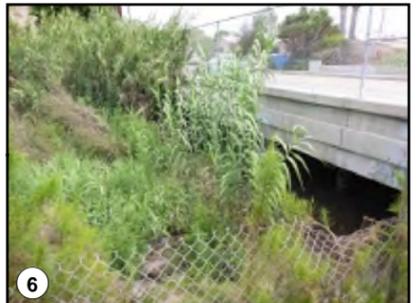
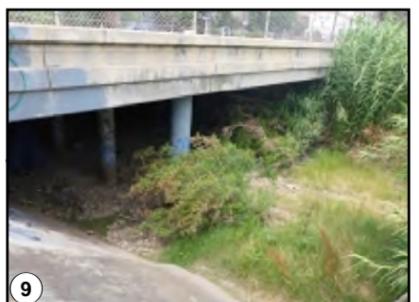
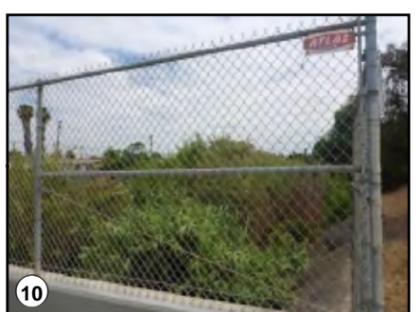
Photos:

- **Channel Prioritization Score:**
71.8 out of 100
 - **Flood Hazard Score:**
63.8 out of 75
 - **Water Quality Score:**
3 out of 10
 - **Community Input Score:**
5 out of 10
 - **Aesthetics Score:**
0 out of 5
- **Capacity Prior to Maintenance:**
10- to 25-year storm event
- **Capacity After Maintenance (As-built Capacity) :**
50- to 100-year storm event
- **Clogging Potential:** *HIGH*
- **Approximate Vegetation Coverage:** *HIGH*
- **Surrounding Area:** *Residential*
- **Infrastructure Failures:**
NONE
- **Site Evaluation Date:**
May 5, 2015
- **Notes/Comments:**
A high risk of vegetation flowing downstream and clogging the culvert exists. It was noted on the O&M Channel Maintenance Inspection Form completed for the channel by the City of San Diego that there is broken gunite near the foot bridge to the park.

It is recommended that this drainage channel be maintained to increase the current capacity of the channel from a 10- to 25-year storm event back to a 50- to 100-year storm event capacity.
