**SUMMARY OF FINDINGS FOR THE
ANNUAL DRAINAGE CHANNEL FIELD
ASSESSMENT AND MAINTENANCE PRIORITIZATION
PROJECT (PHASE 1)
FOR
THE CITY OF SAN DIEGO – MASTER STORM WATER
SYSTEM MAINTENANCE PROGRAM (MMP) MAP 99:
SOUTH CHOLLAS CREEK CHANNEL**

**Job Number 17204-D
August 4, 2015**

August 4, 2015

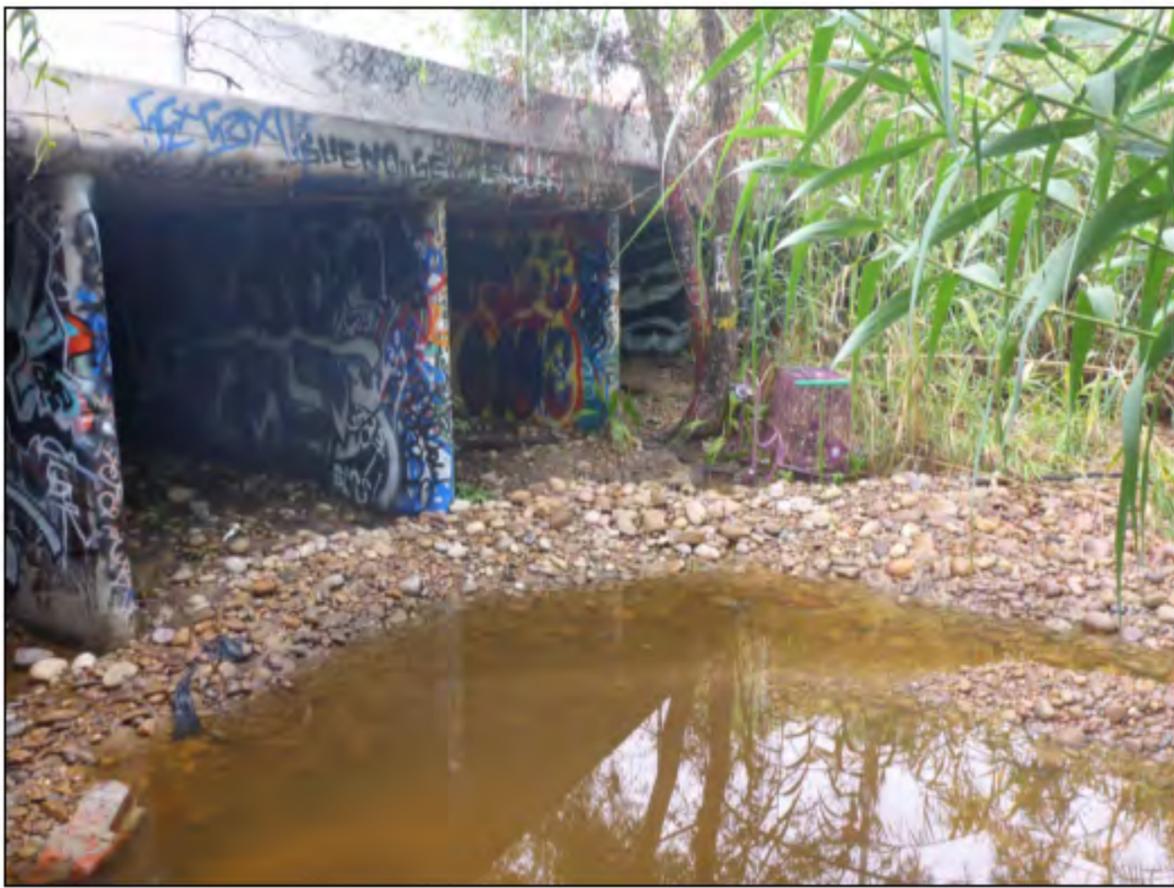
South Chollas Creek.1 (5-9-2015).JPG

- It was noted on the O&M Channel Maintenance Inspection Form completed for the channel by the City of San Diego that there is heavy vegetation in the majority of the channel reach. A high risk of vegetation flowing downstream and clogging the culvert exists.
- The channel is in the vicinity of a YMCA.

It is recommended that this drainage channel be maintained to increase the current capacity of the channel from a 50-year storm event back to a 100-year storm event capacity.
