**SUMMARY OF FINDINGS FOR THE
ANNUAL DRAINAGE CHANNEL FIELD
ASSESSMENT AND MAINTENANCE PRIORITIZATION
PROJECT (PHASE 1)
FOR
THE CITY OF SAN DIEGO – MASTER STORM WATER
SYSTEM MAINTENANCE PROGRAM (MMP) MAP 137:
TOCAYO CHANNEL**

**Job Number 17204-D
August 4, 2015**

August 4, 2015

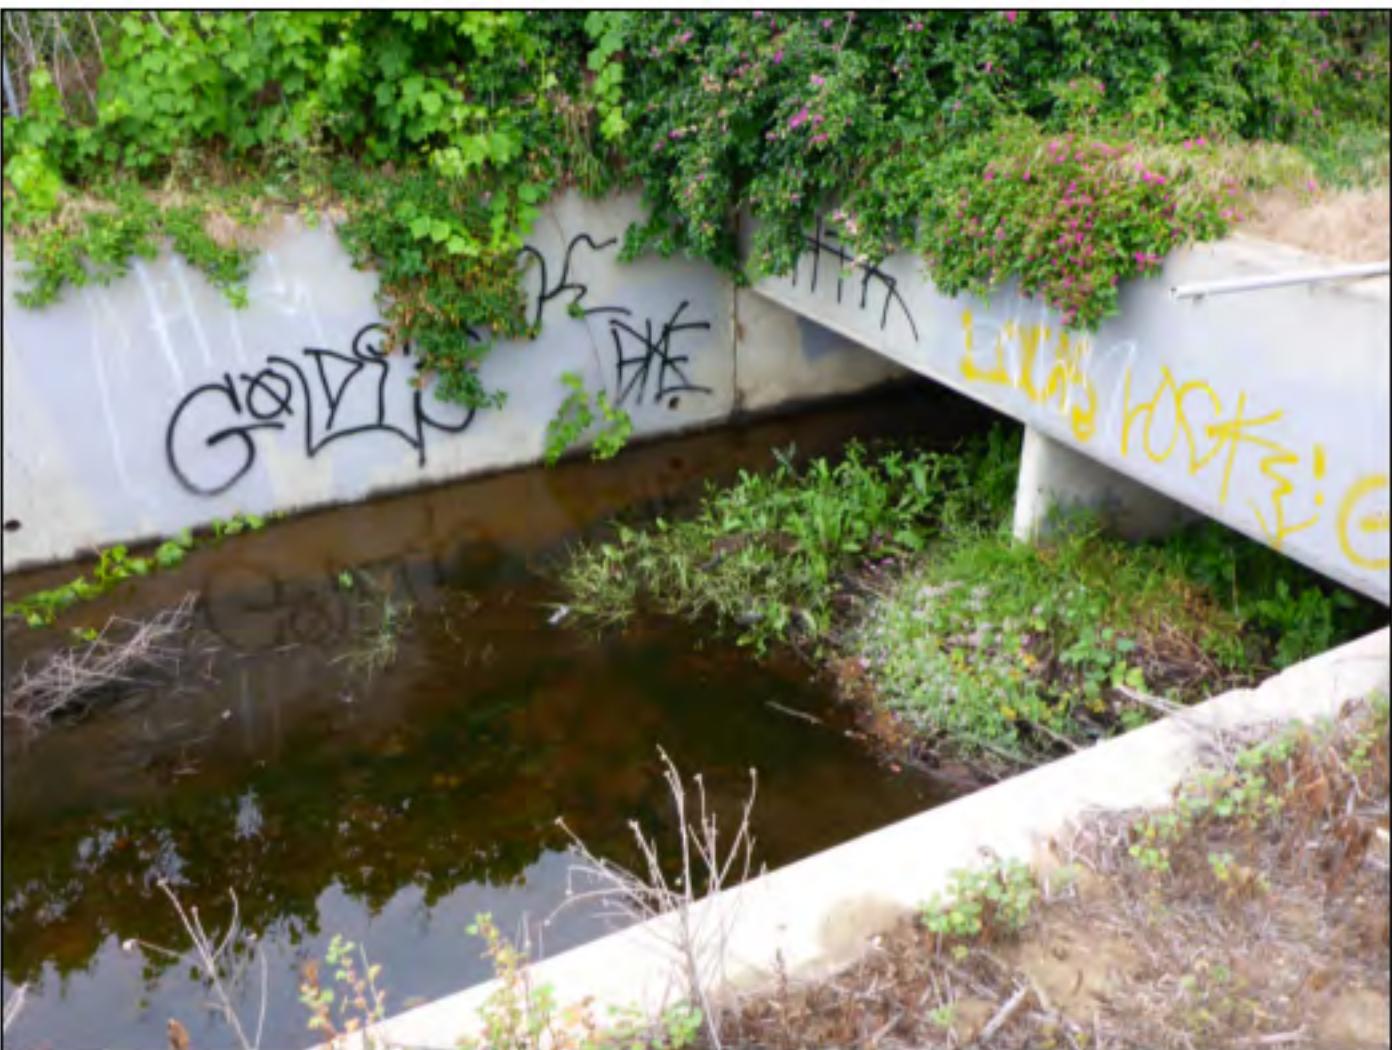
Tocayo.1 (5-16-2015).JPG

Based on the site photos provided and discussion with the City of San Diego, there are areas where vegetation has grown down from the top of the channel banks over the concrete side slopes. Therefore, for the Current Condition hydraulic model the roughness coefficient used for the side slopes reflects the vegetation.

- There are sporadic patches of sediment throughout the channel. It is recommended that these patches be maintained in order to increase overall capacity of the channel.
- Based on the site photos taken by the City of San Diego, vegetation has grown down from the top of the channel banks over the concrete side slopes. A high risk of vegetation flowing downstream and clogging the culvert exists.

It is recommended that this drainage channel be maintained to increase the current capacity of the channel from a 399.3 cfs (less than 2-year storm event) back to a 922.5 cfs (less than 2-year storm event) capacity. It is important to note that although maintenance will not significantly reduce the frequency of flooding, it will reduce the effect of flooding on the surrounding area.

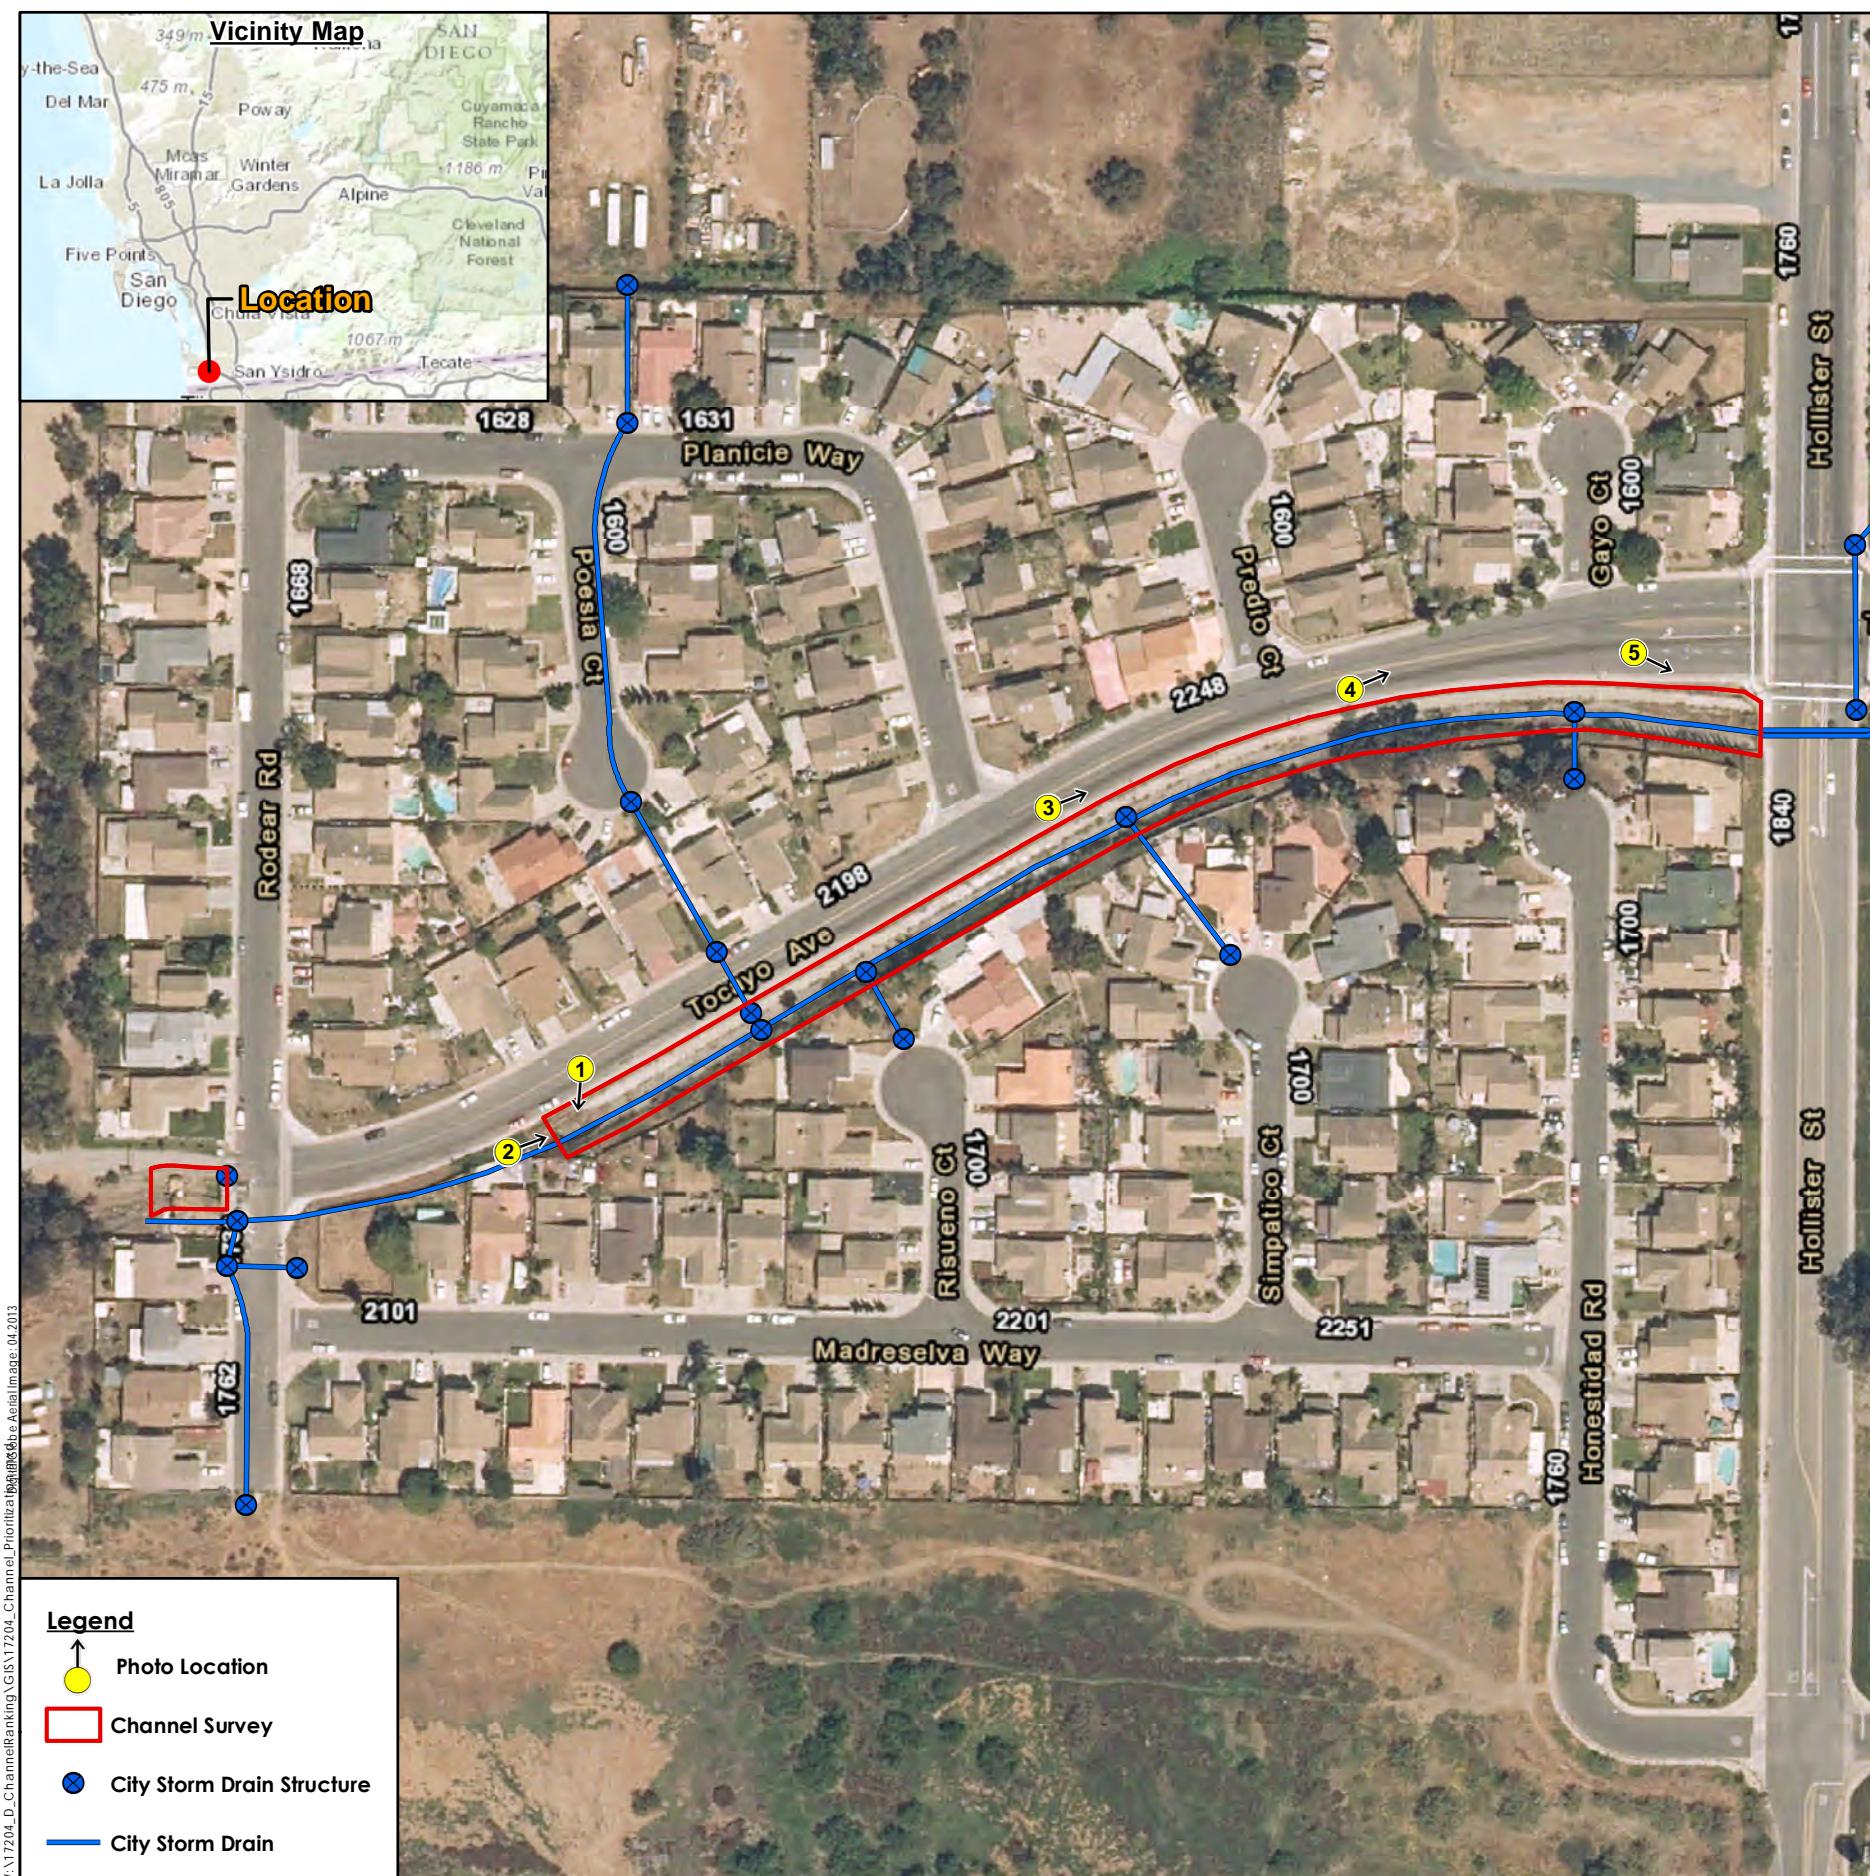
Appendix F
Channel Maintenance Prioritization Summary Sheet

- Assessment Results**
- Channel Prioritization Score:** 71.8 out of 100
 - Flood Hazard Score:** 63.8 out of 75
 - Water Quality Score:** 3 out of 10
 - Community Input Score:** 5 out of 10
 - Aesthetics Score:** 0 out of 5
 - Capacity Prior to Maintenance:** Less than 2-year storm event
 - Capacity After Maintenance (As-built Capacity):** Less than 2-year storm event
 - Clogging Potential:** MEDIUM
 - Approximate Vegetation Coverage:** MEDIUM
 - Surrounding Area:** Residential
 - Infrastructure Failures:** None
 - Site Evaluation Date:** May 16, 2015
 - Notes/Comments:** There are sporadic patches of sediment and vegetation overhanging onto the side slopes throughout the channel. It is recommended that these be maintained in order to increase overall capacity of the channel.
