**SUMMARY OF FINDINGS FOR THE
ANNUAL DRAINAGE CHANNEL FIELD
ASSESSMENT AND MAINTENANCE PRIORITIZATION
PROJECT (PHASE 1)
FOR
THE CITY OF SAN DIEGO – MASTER STORM WATER
SYSTEM MAINTENANCE PROGRAM (MMP) MAP 84:
WASHINGTON CHANNEL**

**Job Number 17204-D
August 4, 2015**

Prepared For:
City of San Diego
2781 Caminito Chollas
San Diego, California 92105

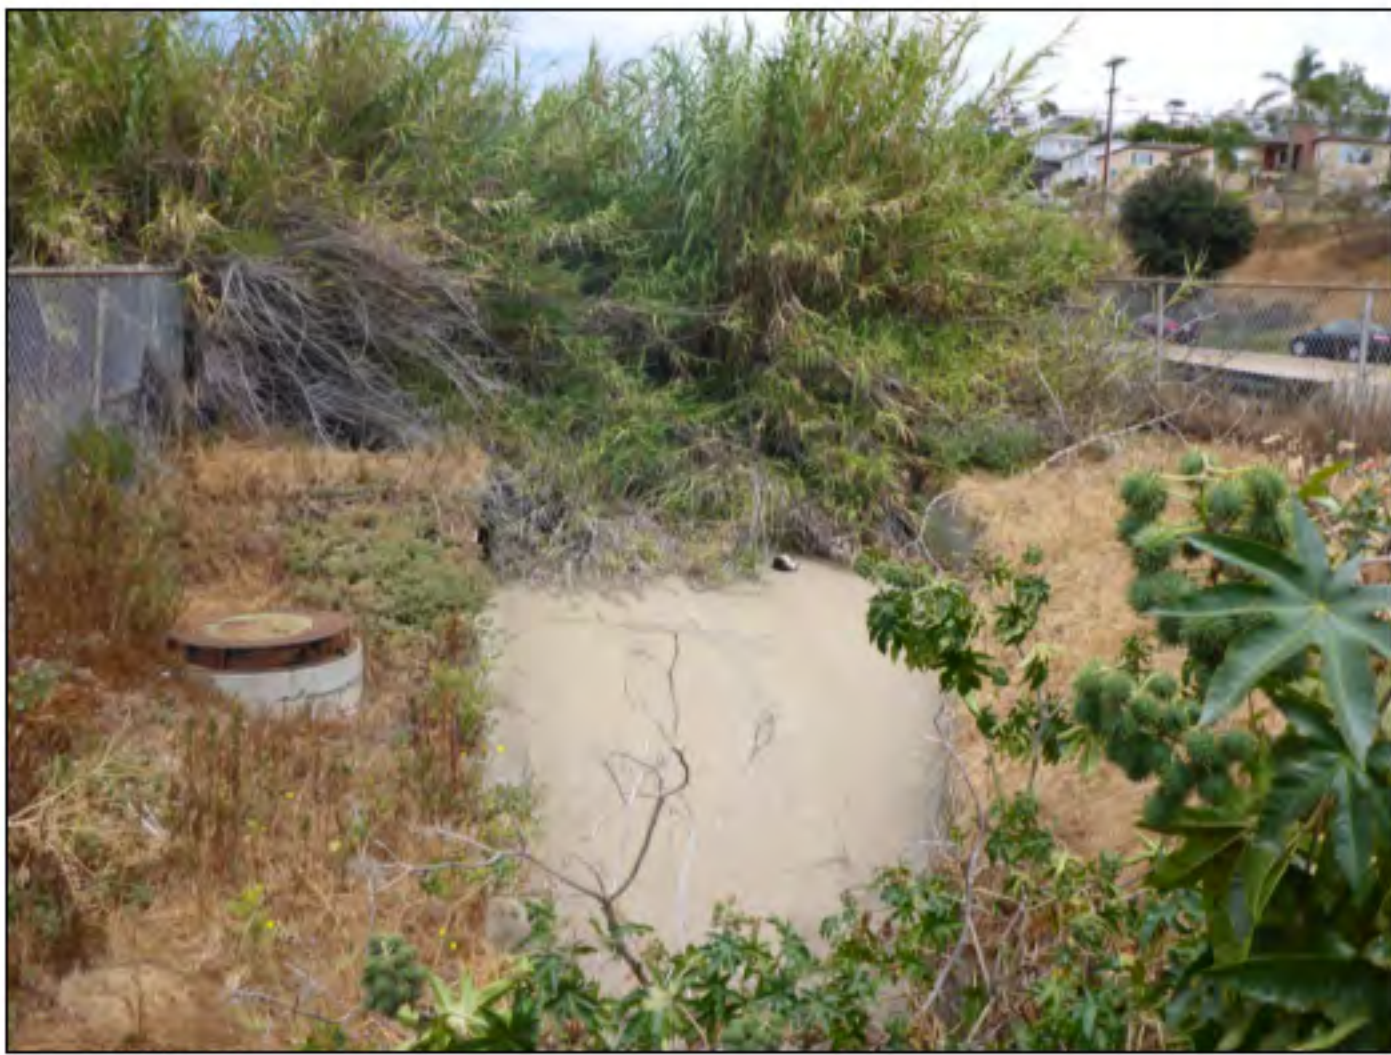
Washington Channel.1 (5-5-2015).JPG

- Based on site photos taken by the City of San Diego, heavy vegetation exists in the downstream end of the channel. A high risk of vegetation clogging the downstream culvert exists.

It is recommended that the downstream end of this drainage channel be maintained to increase the current capacity of the channel from a less than 2-year storm event back to a 100-year storm event capacity.

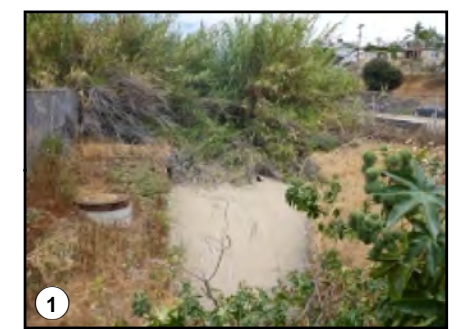
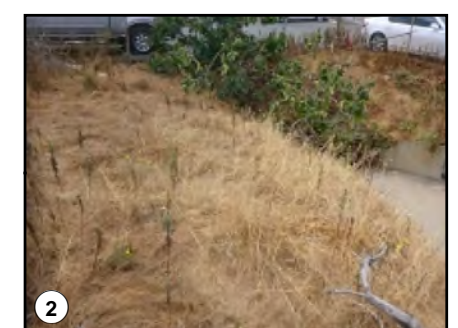
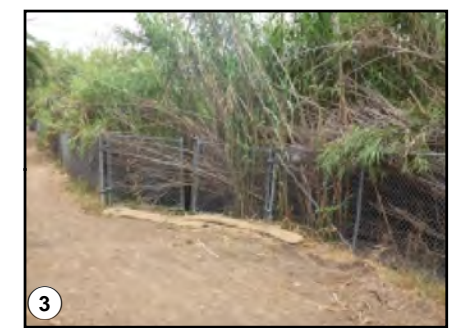
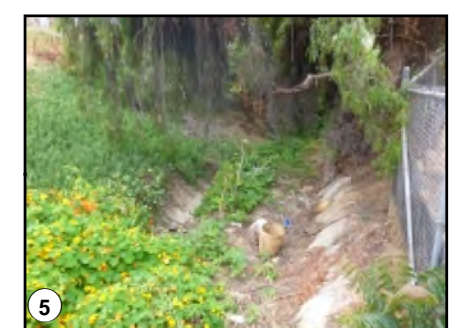
Photos:

- **Channel Prioritization Score:**
80.3 out of 100
 - **Flood Hazard Score:**
71.3 out of 75
 - **Water Quality Score:**
4 out of 10
 - **Community Input Score:**
5 out of 10
 - **Aesthetics Score:**
0 out of 5
- **Capacity Prior to Maintenance:**
Less than 2-year storm event
- **Capacity After Maintenance (As-built Capacity):**
100-year storm event
- **Clogging Potential:** *HIGH*
- **Approximate Vegetation Coverage:** *HIGH*
- **Surrounding Area:** *Residential*
- **Infrastructure Failures:**
None
- **Site Evaluation Date:**
May 5, 2015
- **Notes/Comments:**
Based on site photos taken by the City of San Diego, heavy vegetation exists in the downstream end of the channel. A high risk of vegetation clogging the downstream culvert exists.
