THE CITY OF SAN DIEGO

Subject: Annual Inspection and Maintenance Report for Inlet Filter per Federal Clean Water Act Section 401 Water Quality Certification for Routine Maintenance of Storm Water Facility, Map 134

Nestor Creek Channel - Proposed Best Management Practices (BMPs) Location Exhibit

Nestor Channel Annual Photo Documentation

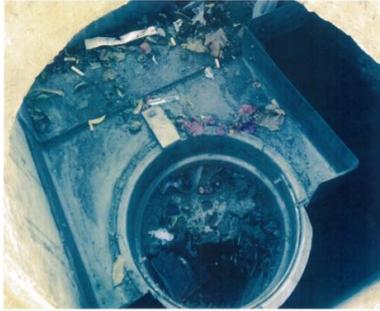
Photo 1 – Looking into manhole facing southwest prior to cleaning of BMP.

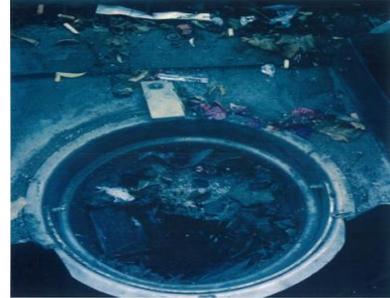
Photo 2 – Looking into manhole facing south prior to cleaning of BMP.

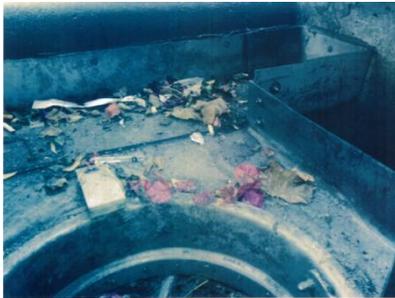
Photo 3 – Looking southwest towards the curb inlet prior to cleaning of BMP.

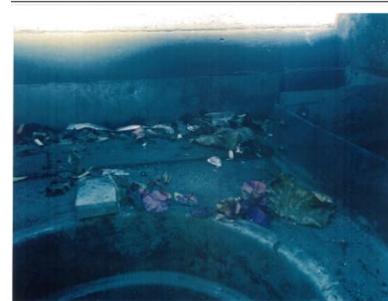
Photo 4 – Looking south out of curb inlet towards Palm Avenue prior to cleaning of BMP.

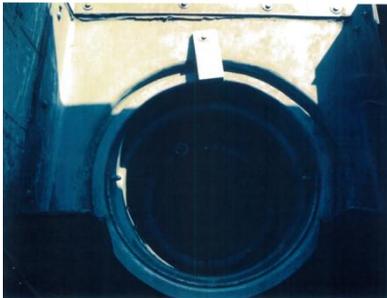
Photo 5 – Looking into the manhole facing south after the BMP has been clean.

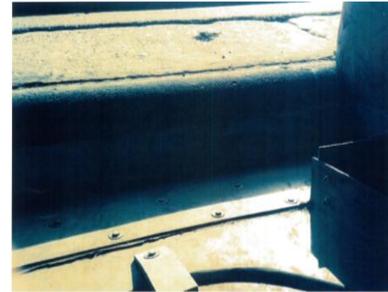
Photo 6 – Looking southwest out of curb inlet towards Palm Avenue after BMP has been clean.

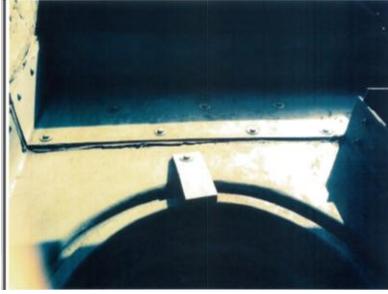
Photo 7 – Looking south towards curb inlet after BMP has been clean.

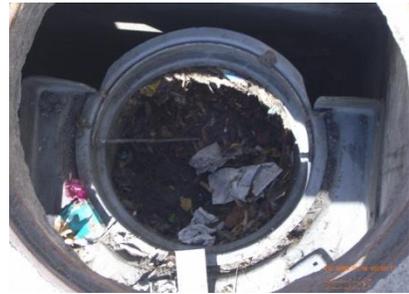
Photo 8 - Looking into manhole facing north prior to cleaning of BMP.

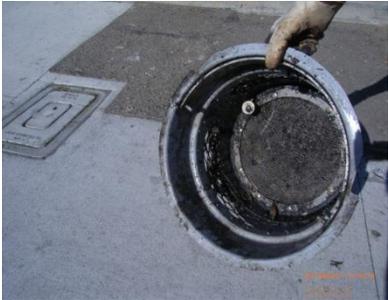
Photo 9 – Looking north into the BMP filter basket after cleaning.

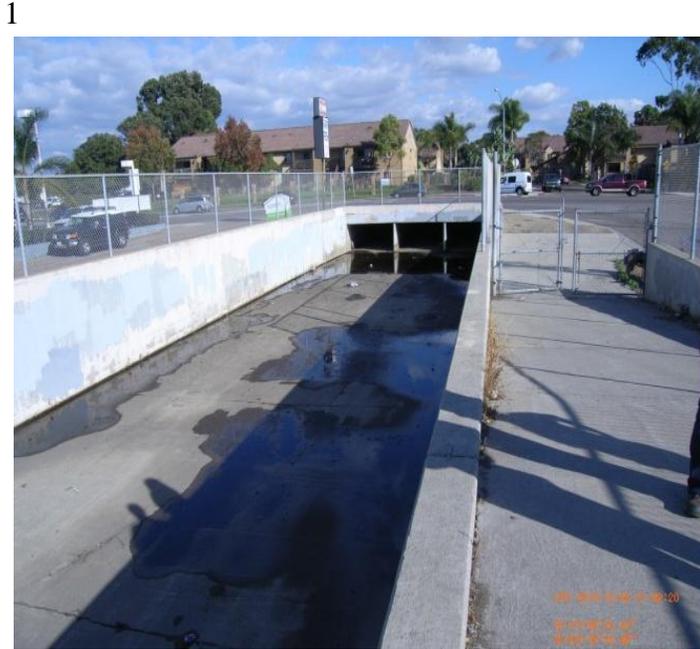
Photo 1 - Looking east immediately upstream from culverts running under Saturn Street. Note, water ponding on the south side of channel and scattered pieces of trash located towards the middle entrance of the culverts. No vegetation growth.

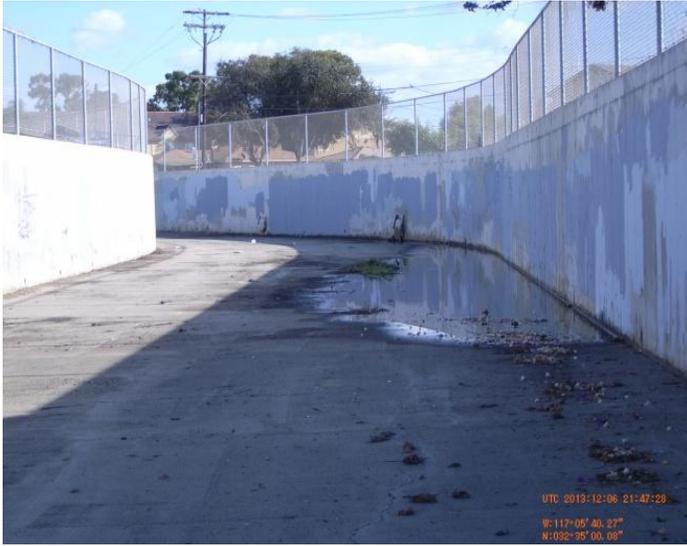
Photo 3 - Looking southeast towards Saturn Street. Vegetation growth near ponding water.

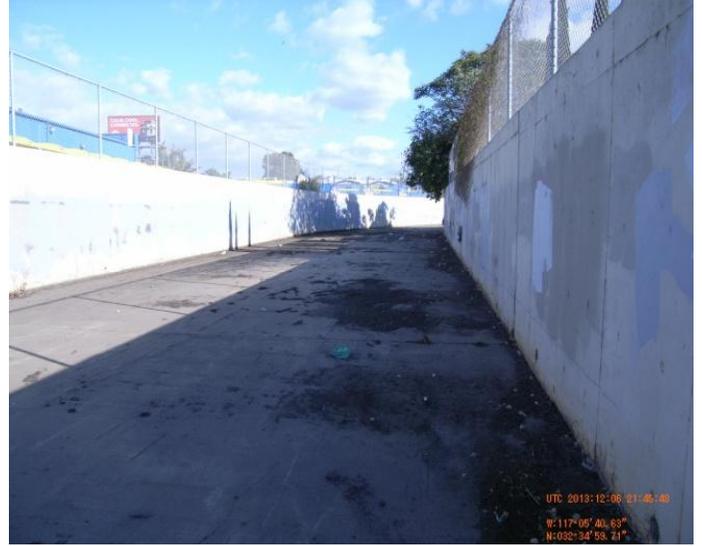
Photo 4 - Looking southeast of channel from 18th Street. Scattered trash and sediment accumulation.

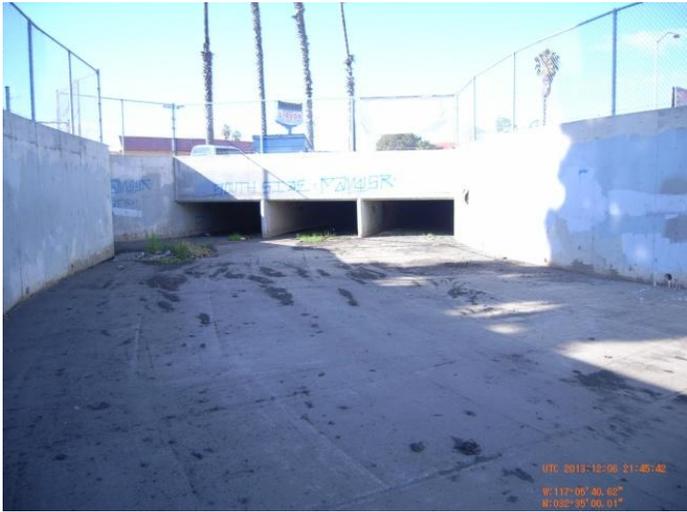
Photo 5 - Looking northwest towards culverts running under 18th and Palm Ave. Little vegetation growth towards the entrance of the culvert and scattered sedimentation deposit.

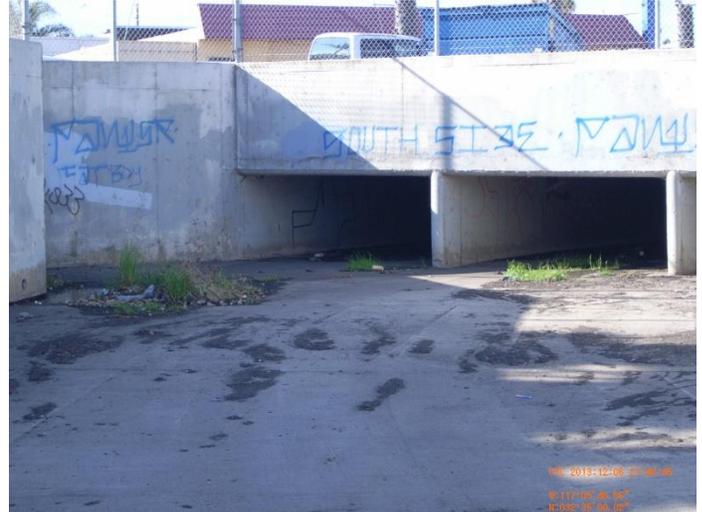
Photo 6 - Enlarged photo of the vegetation growth in photo 5. Note, trash accumulation near vegetation patches.

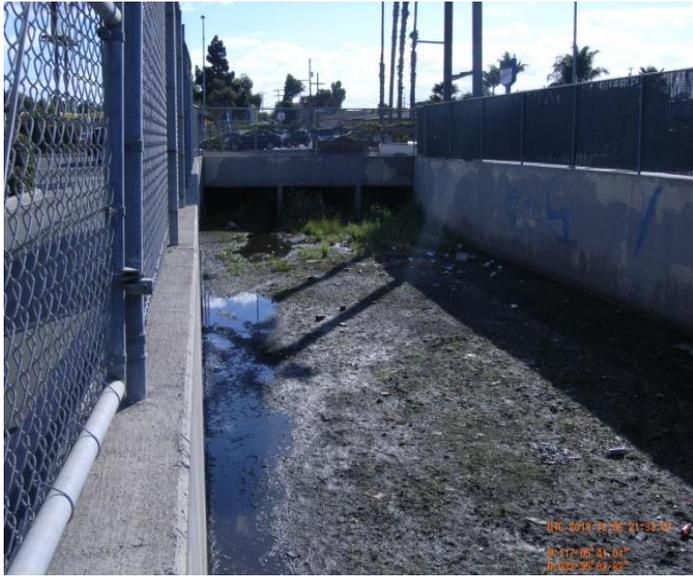
Photo 7 - Facing southwest, north of Palm Ave. and east of Thermal Ave. looking towards culverts running under Palm Ave. Sedimentation approximately a quarter inch to an inch deep. Notice, vegetation growth located in front of the middle and right culverts.

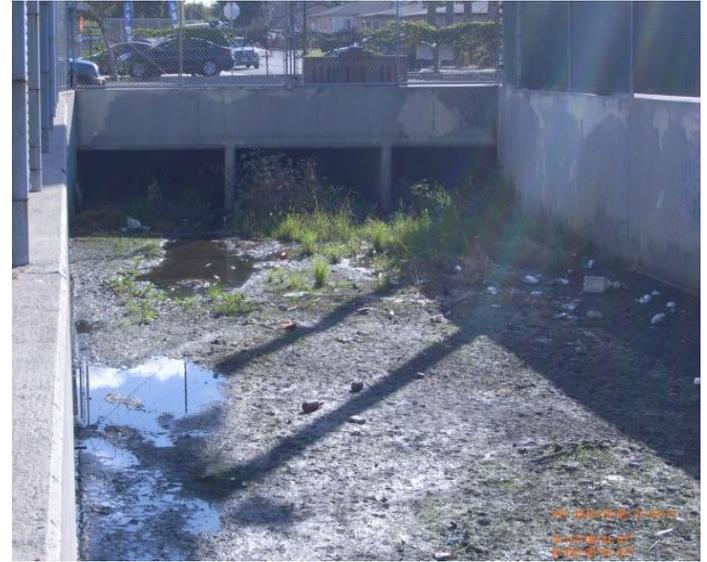
Photo 8 - Enlarged portion of the vegetation growth and trash accumulation in photo 7.

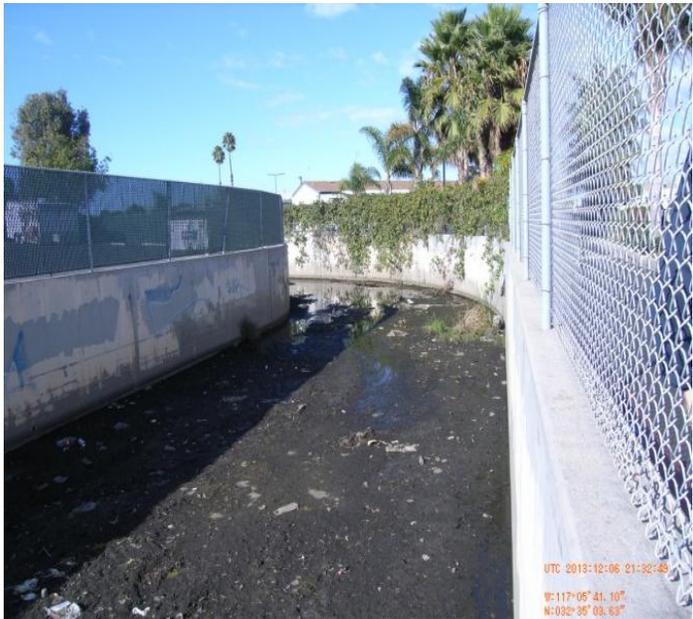
Photo 9 - Facing northwest, north of Palm Ave. and east of Thermal Ave. Sediment is approximately a quarter inch to an inch deep with trash scattered throughout the channel. Vegetation growth concentrated in the northeast bend of the channel.

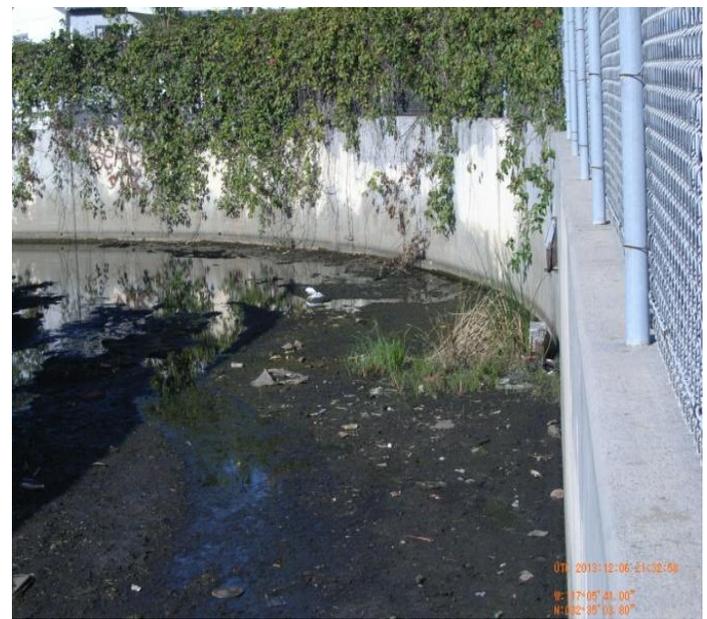
Photo 10 - Enlarged portion of photo 9 where vegetation growth is most dense.

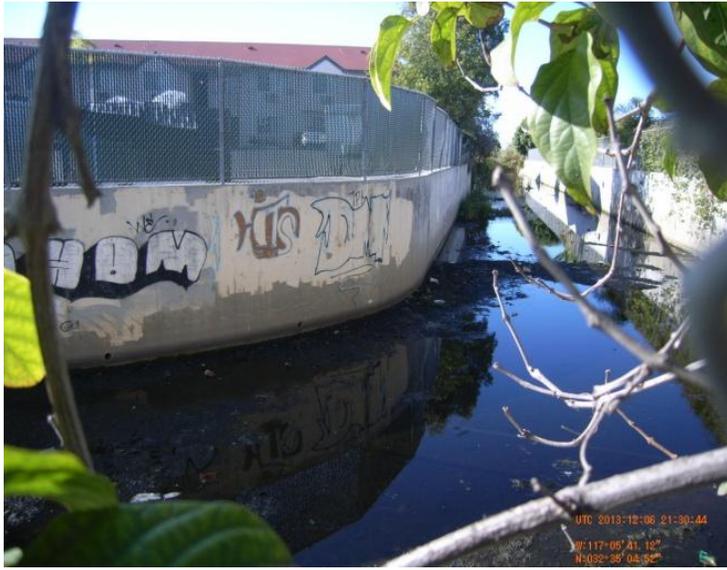
Photo 11 - Looking northwest of the channel running west of Thermal Ave. Water is approximately half an inch to one inch deep with no visual signs of movement.

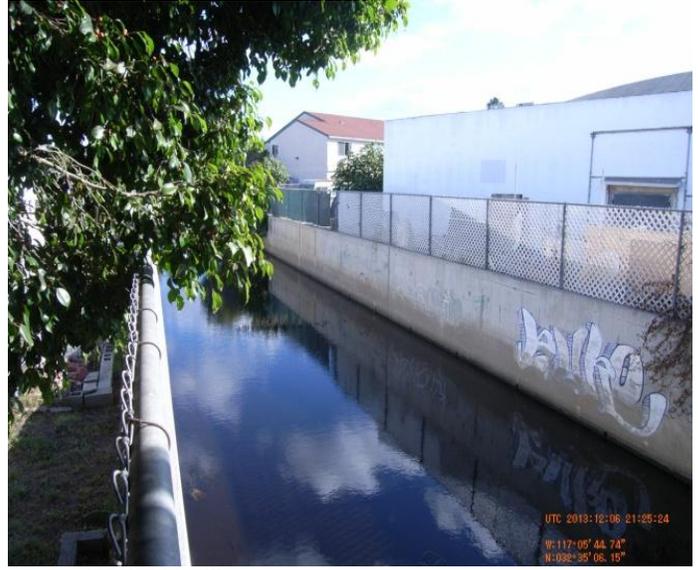
Photo 12 - Looking southeast towards Thermal Ave. the water is half an inch to an inch deep.

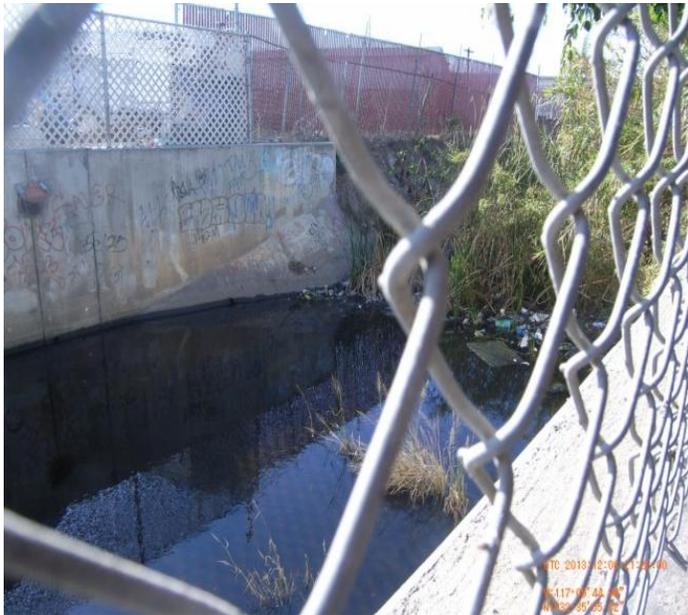
Photo 13 - Looking northwest at the end of the concrete lined channel. Abrupt vegetation growth at the end of the concrete channel leading into the earthen channel.
