PHOTO-LOG FORM

Project: City of San Diego MSWSMP
 Location: Nestor Creek, Map 134 from MSWSMP Appx B Biology Maps
 Date: 10/18/2010
 Photographer: S. NIGRO
 Team members: S. Trnka
 *Pre-maintenance Condition

PRE-MAINTENANCE SITE PHOTOS Map 134 Nestor Creek 11/18/10

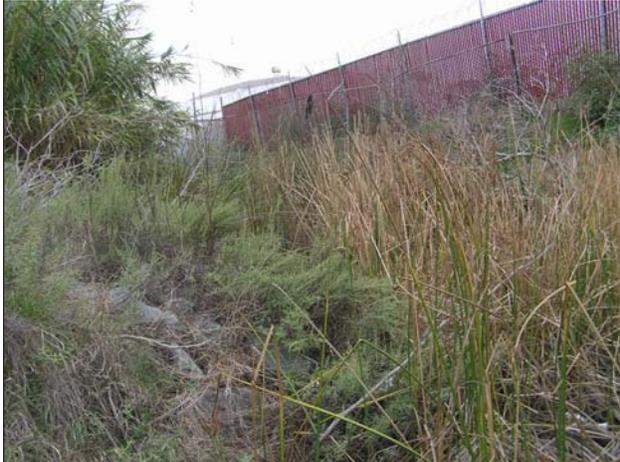
<p>PHOTO NOTES: Looking east/upstream from access point for maintenance north of Palm Avenue. Vegetation in this area will be driven over but not removed.</p>	<p>PHOTO NOTES: Looking west/downstream from access point for maintenance north of Palm Avenue. Vegetation in this area will not be maintained.</p>

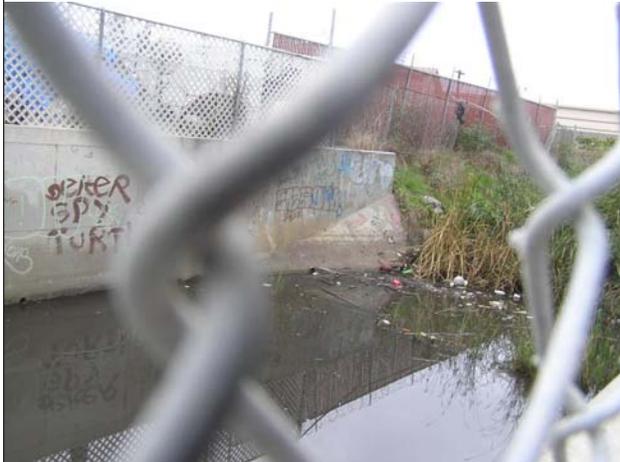
<p>PHOTO NOTES: Looking west/downstream at beginning of maintenance area for the concrete channel north of Palm Avenue. Standing water is present.</p>	<p>PHOTO NOTES: Looking east/upstream at maintenance area for the concrete channel north of Palm Avenue. Standing water is present.</p>

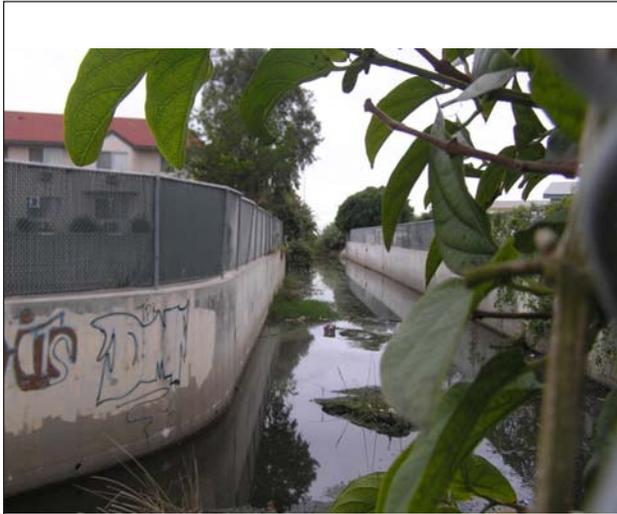
Looking west/downstream at maintenance area for the concrete channel north of Palm Avenue. Standing water is present.

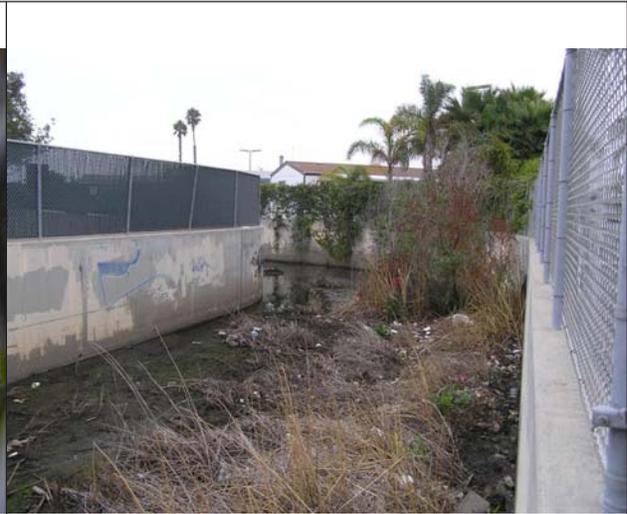
Looking north/downstream at maintenance area for the concrete channel north of Palm Avenue. Standing water and freshwater marsh are present.

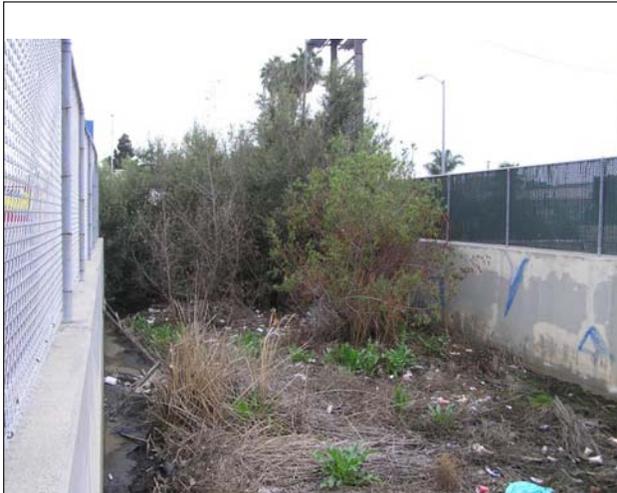
Looking south/upstream at maintenance area for the concrete channel north of Palm Avenue. Freshwater marsh and southern willow scrub are present.

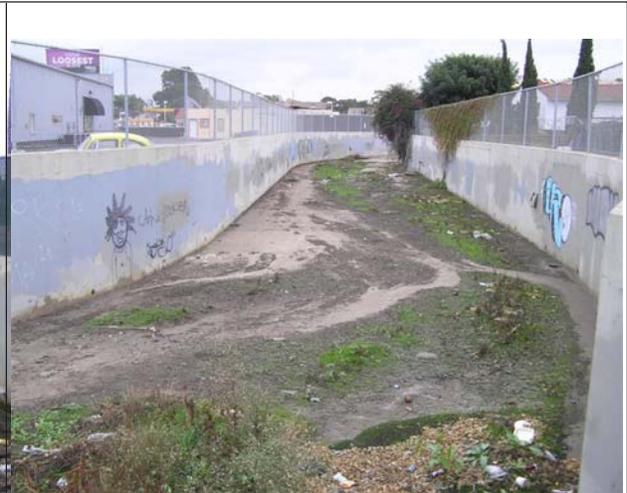
Looking east/upstream at maintenance area for the concrete channel south of Palm Avenue.

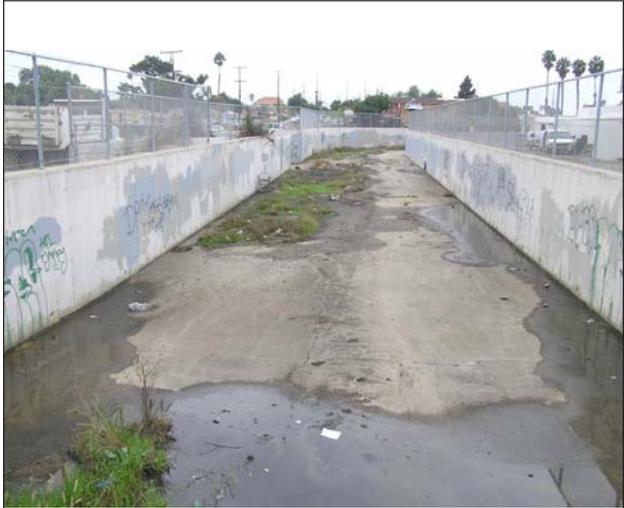
Looking west at the concrete channel from upstream of the area proposed for maintenance.
