5.5.6 Adams Avenue at Hawley Blvd.

District 3 Sidewalk Study-Phase III

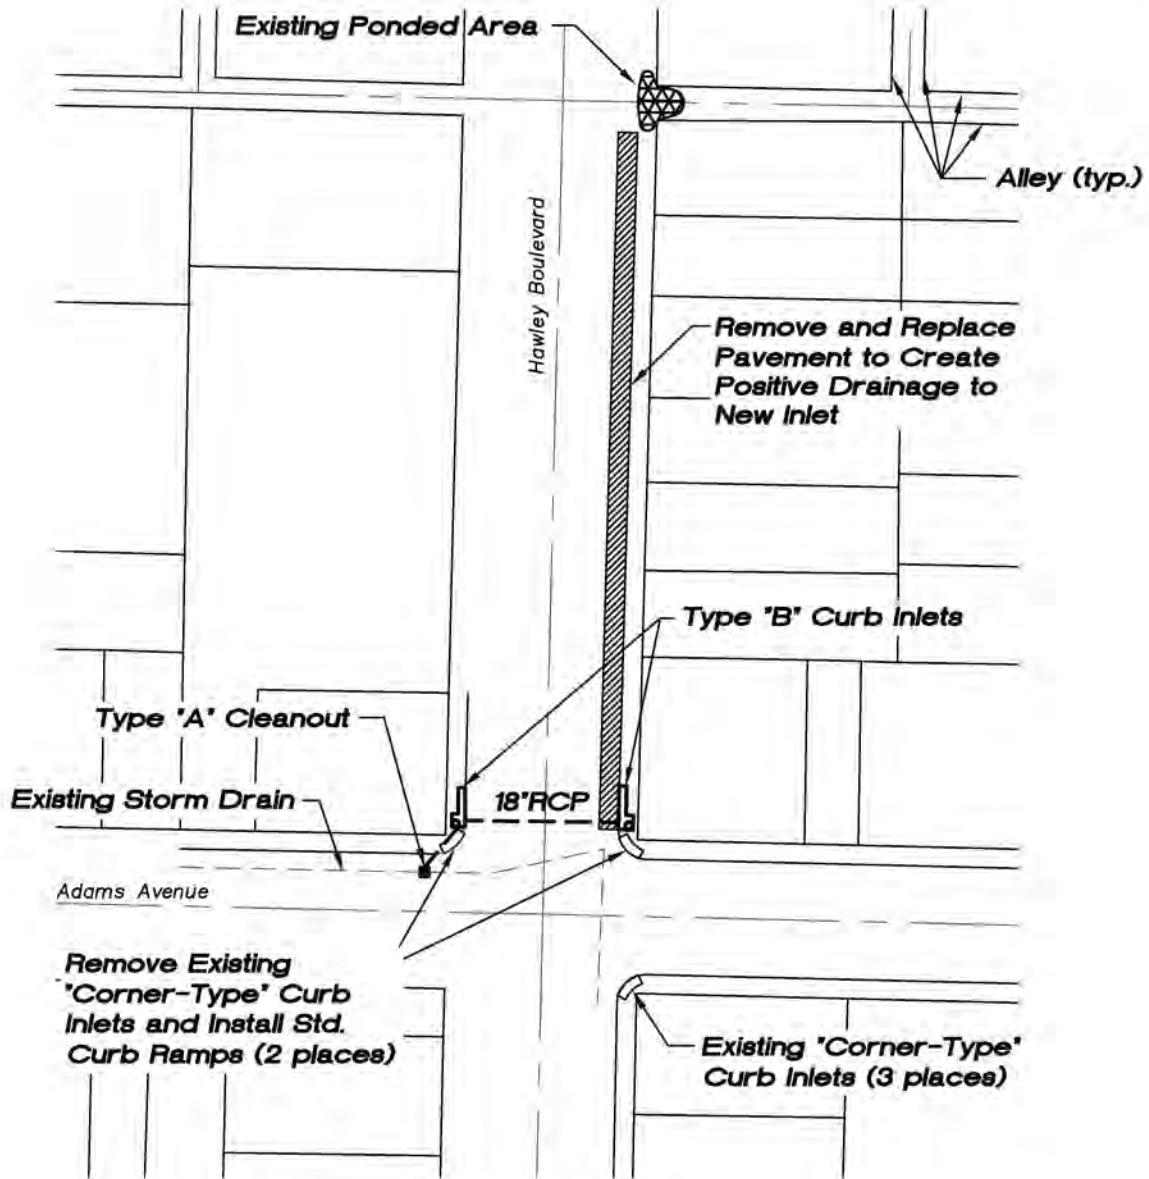
Figure 8

Existing curb heights are adequate on three of the four legs of this intersection, the exception being the north leg on Hawley Blvd., which has 3-5” curbs. However, further drainage improvements appear to be warranted here for the following reasons:

- All four segments are rated as “high” pedestrian demand
- Dry-weather ponding exists within the alley entrance on Hawley just north of Adams, which due to flat grades cannot be corrected by pavement grinding alone.
- Non-standard “corner-type” curb inlets exist on three of four corners (all but the southwest corner). Non-ADA-compliant curb ramps have been installed at each of these three corners.

Construction of new Type “B” curb inlets would permit installation of compliant curb ramps and safer crosswalks on all four legs of this heavily-used intersection. See **Figure 8, Adams Avenue Improvements**.

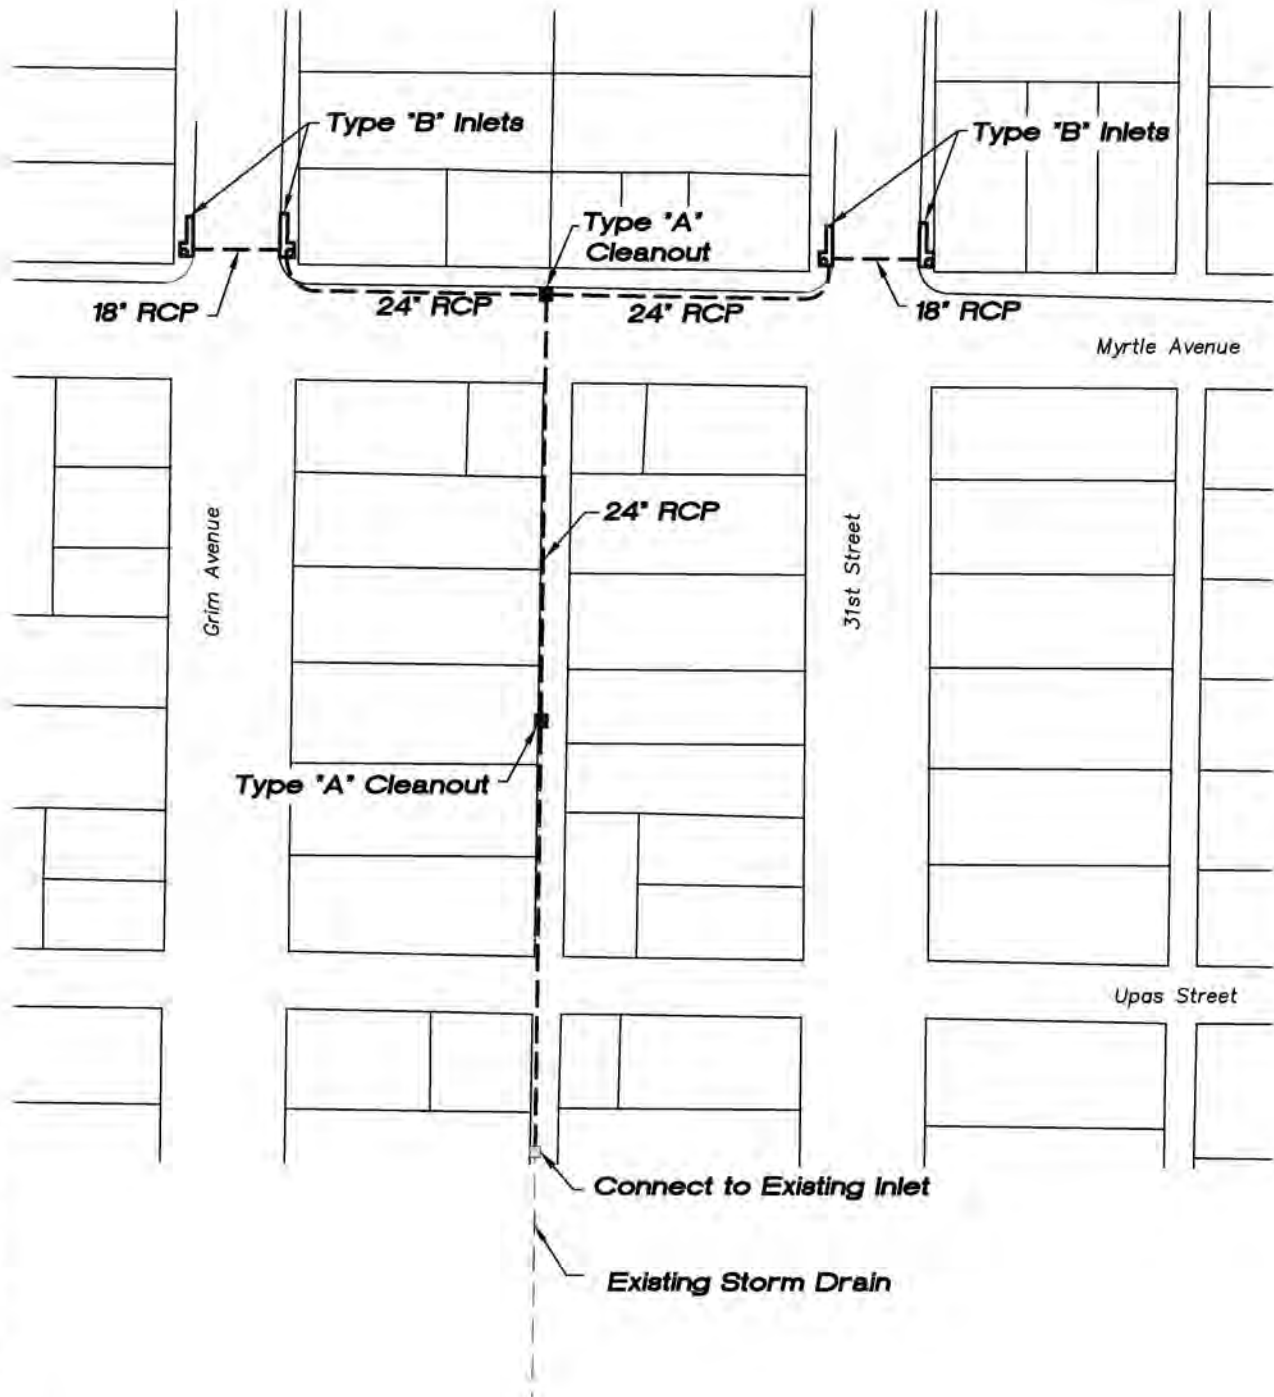
Figure 9

As shown on Fig. 2, the block of Myrtle Avenue between Grim Avenue and 31st Street receives runoff from two of large watersheds. The areas downstream of this point have been identified as having chronic drainage problems. This observation is reinforced by the runoff estimates shown in Table 5-3, which indicate that 31st Street has barely sufficient capacity for a one-year storm, and Grim Avenue has much too little capacity for even a one-year storm. A single underground culvert is proposed within the alleyway to capture and convey runoff from both of these streets to the existing downstream storm drain system, as shown on **Figure 9, Myrtle Avenue Drainage Improvement**. This improvement would provide benefits to several downstream blocks that are currently the subject of citizen complaints regarding drainage.

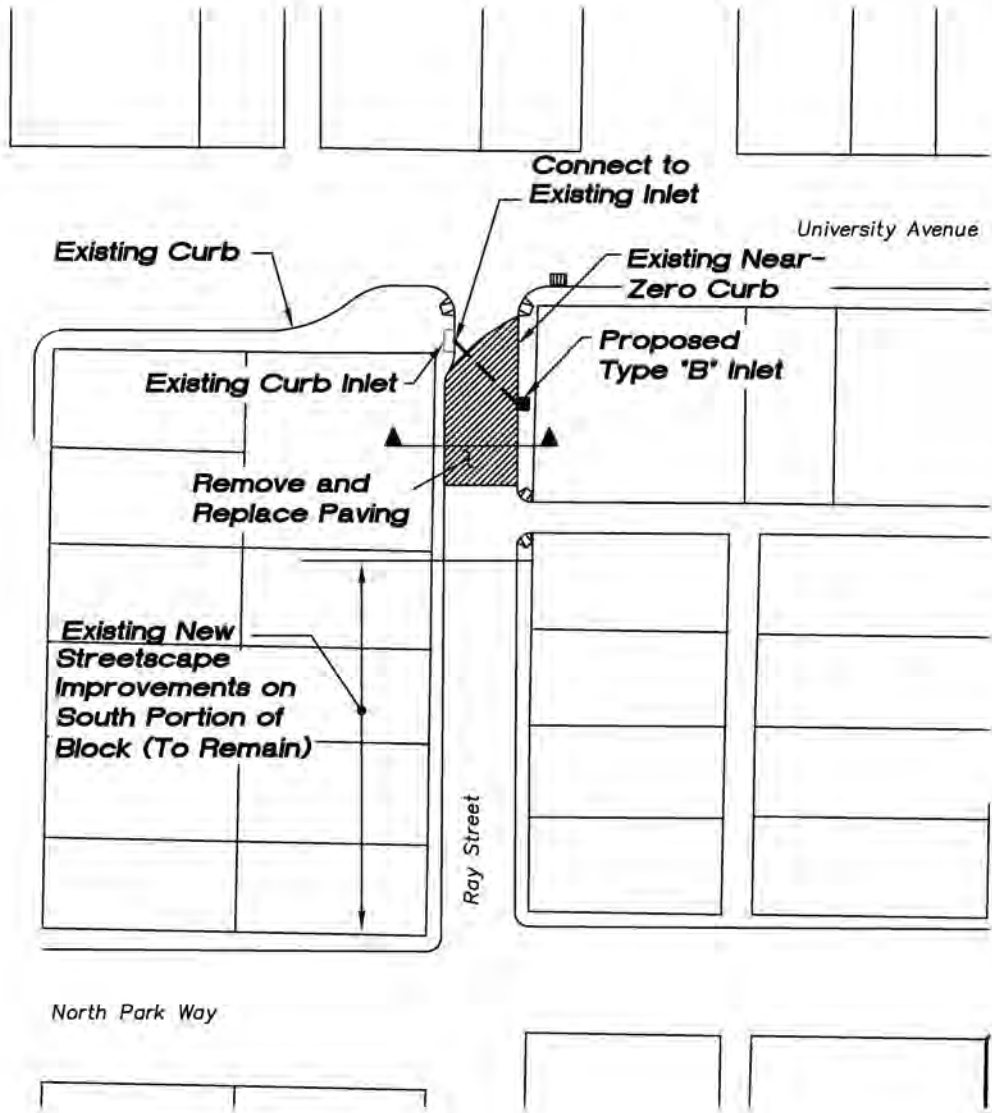
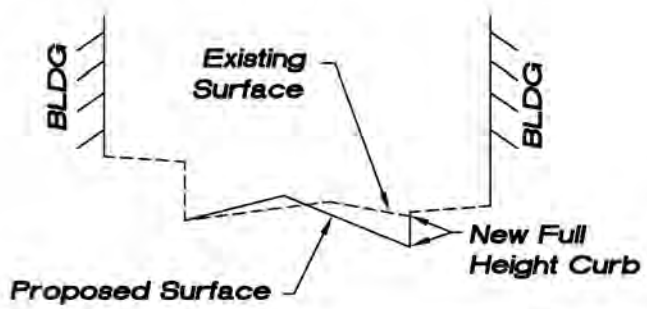
Figure 10

The northerly block of Ray Street, immediately south of University Avenue (segment NP77) has recently been extensively improved. The part of the block south of the alley entrances has mostly new streetscape and improved sidewalks. In addition, the streetscape along the adjacent portion of University Avenue has been extensively upgraded. However, the northern portion of the block remains in a substandard condition, with near-zero curb heights on the east side, and curb inlets that are not well positioned to capture the surface runoff. This area has recently become a significant venue for public events and experiences a high level of pedestrian traffic.

To close the gap in the upgraded streetscape here, and to provide for safe and proper sidewalk drainage, a small area of pavement replacement along with a new storm drain connection have been proposed. See **Figure 10, Ray Street Improvements**.
