Point Loma Ocean Outfall Annual Inspection Report

2015

SUBJECT: Point Loma Ocean Outfall 2015 Annual Inspection Report

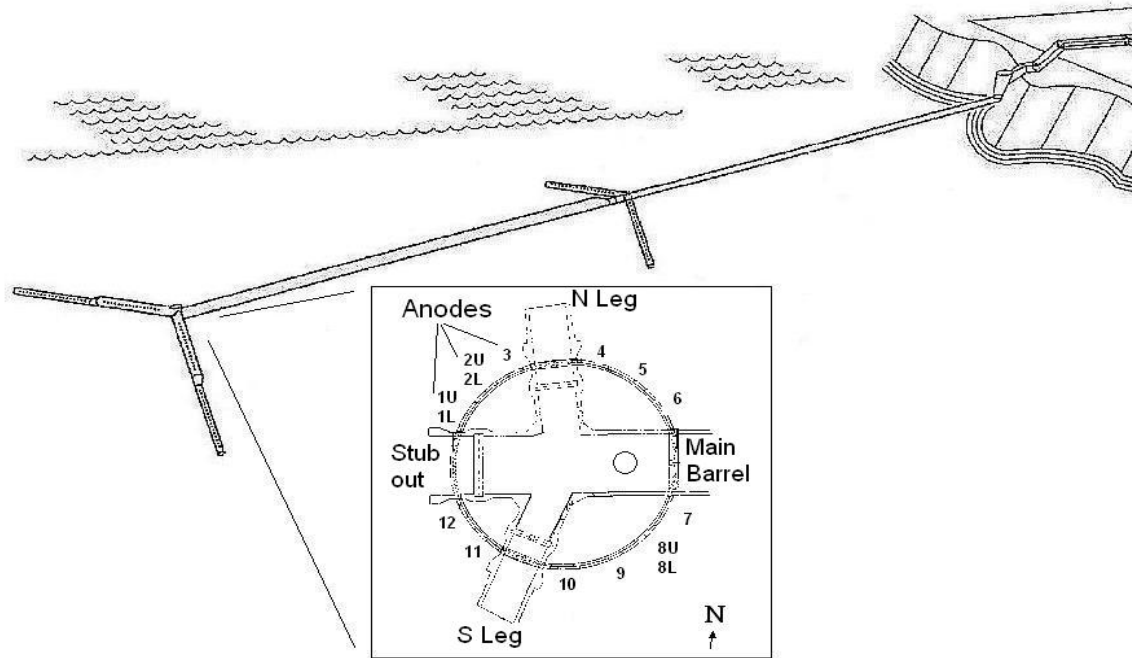
Figure 3: Anode Schematic

New Diffuser Wye: The structure continues to be in overall good condition. A schematic of the twelve pairs of anodes on the New Diffuser Wye is shown below in Figure 3. Lower anodes 1, 2, 8 and 9 are missing or consumed and the remaining nine were thought to have been buried with armor rock during construction, so no conclusion can be drawn regarding their condition. Upper anode 9 is missing this year. Damage to the protective wrapping on the remaining anodes of the upper ring has caused some of them to become active, but they all continue to retain much of their original mass. No corrosion of the metal crib structure was noted so it is assumed that the remaining anodes are providing adequate structural protection. Localized areas of leaking were observed emanating from the seams of all the gate covers. This observation is not new and may be a function of the time of day the survey is being performed and the accompanying pressure inside the pipe. Effluent continues to leak from different locations on the perimeter of Stubout Gate. All the leaks are of little consequence from a water quality standpoint as the initial dilution of the effluent escaping is much higher than that at the nearby diffuser ports.
