Point Loma Ocean Outfall Annual Inspection Report

2016

Point Loma Wastewater Treatment Plant
(Order No. R9-2009-0001; NPDES Permit No. CA0107409)

City of San Diego Ocean Monitoring Program
Environmental Monitoring & Technical Services Division

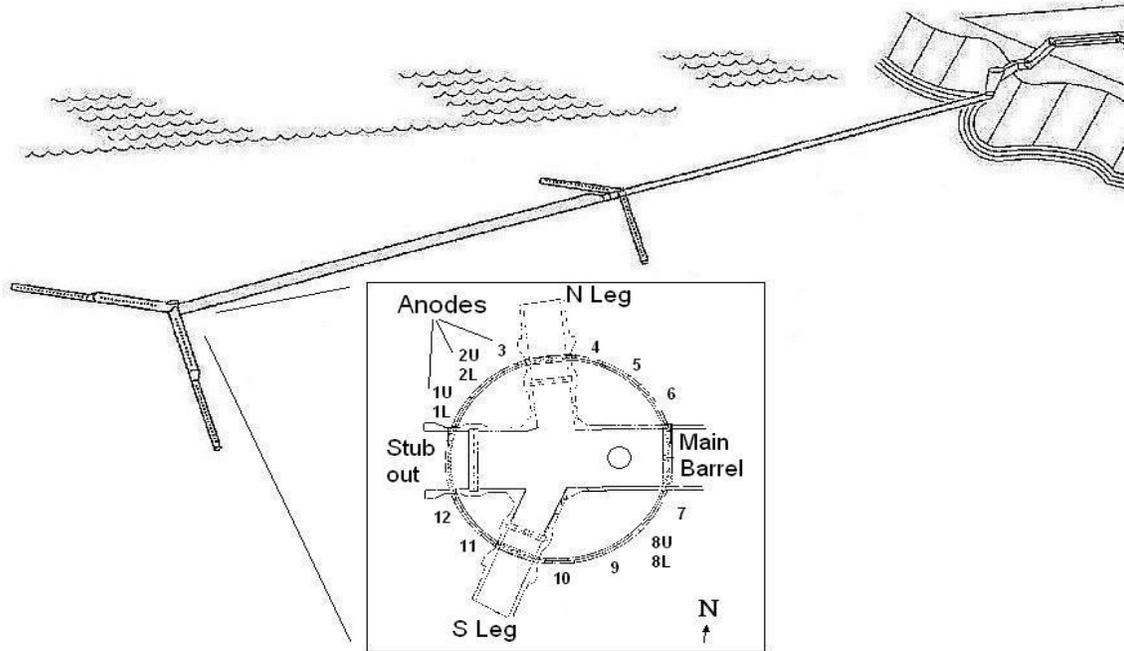
Figure 3: Anode Schematic

New Diffuser Wye: The structure continues to be in overall good condition. A schematic of the twelve pairs of anodes on the New Diffuser Wye is shown below in Figure 3. Lower anodes 1, 2, 8 and 9, and upper anode 9 along with its mounting bracket are missing or consumed. The remaining eight lower anodes were thought to have been buried with armor rock during construction, thus no conclusion can be drawn regarding their condition. The protective wrappings on the remaining anodes of the upper ring have loosened over time to varying degrees, which has caused them to become partially active. These eight anodes, however, have continued to retain much of their original mass. No corrosion of the metal crib structure was noted and it is assumed, therefore, the remaining anodes continue to provide adequate cathodic protection. Localized areas of leaking were observed emanating from the seams of all the gate covers. This observation is not new and is likely a function of the time of day the survey is being performed and the accompanying pressure inside the pipe. Effluent continues to leak from different locations on the perimeter of Stubout Gate. All the leaks are of little consequence from a

water quality standpoint as the initial dilution of the effluent escaping is much higher than that at the nearby diffuser ports.
