# **POINT LOMA OCEAN OUTFALL ANNUAL INSPECTION REPORT 2017**

## **POINT LOMA WASTEWATER TREATMENT PLANT**

NPDES PERMIT No. CA 0107409  
Order No. R9-2017-0007

SUBJECT: Point Loma Ocean Outfall 2017 Annual Inspection Report

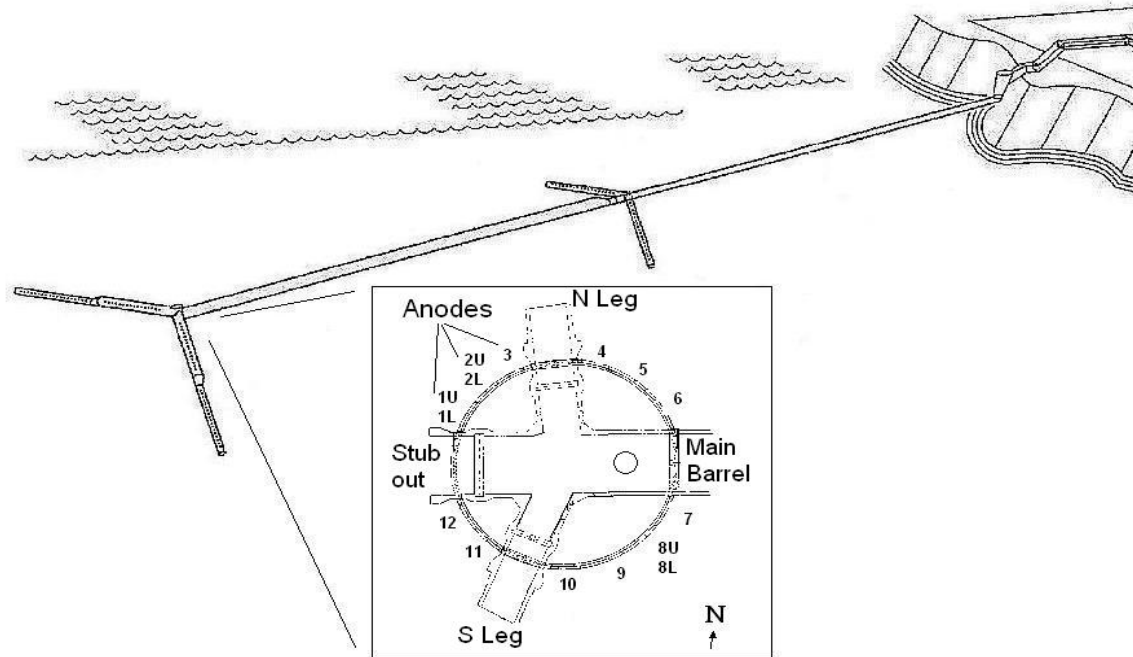
**Figure 3: Anode Schematic**

**New Diffuser Wye:** The structure continues to be in overall good condition. A schematic of the twelve pairs of anodes on the New Diffuser Wye is shown below in Figure 3. Lower anodes 1, 2, 8 and 9, and upper anode 9 along with its mounting bracket are missing or consumed. The remaining eight lower anodes were thought to have been buried with armor rock during construction, thus no conclusion can be drawn regarding their condition. The protective wrappings on the remaining anodes of the upper ring have loosened over time to varying degrees, which has caused them to become partially active. These eight anodes, however, have continued to retain much of their original mass. No corrosion of the metal crib structure was noted and it is assumed, therefore, that the remaining anodes continue to provide adequate cathodic protection. Localized areas of leaking were observed emanating from the seams of the South Leg Gate Cover and the Stubout Gate Cover. This observation is not new and is likely a function of the time of day the survey is being performed and the accompanying pressure inside the pipe. Effluent continues to leak from different locations on the perimeter of Stubout Gate. All the leaks are of little consequence from a water quality standpoint as the initial dilution of the effluent escaping is much higher than that at the nearby diffuser ports.
