# **POINT LOMA OCEAN OUTFALL ANNUAL INSPECTION REPORT**

## **POINT LOMA WASTEWATER TREATMENT PLANT**

# **2018**

SUBJECT: Point Loma Ocean Outfall 2018 Annual Inspection Report

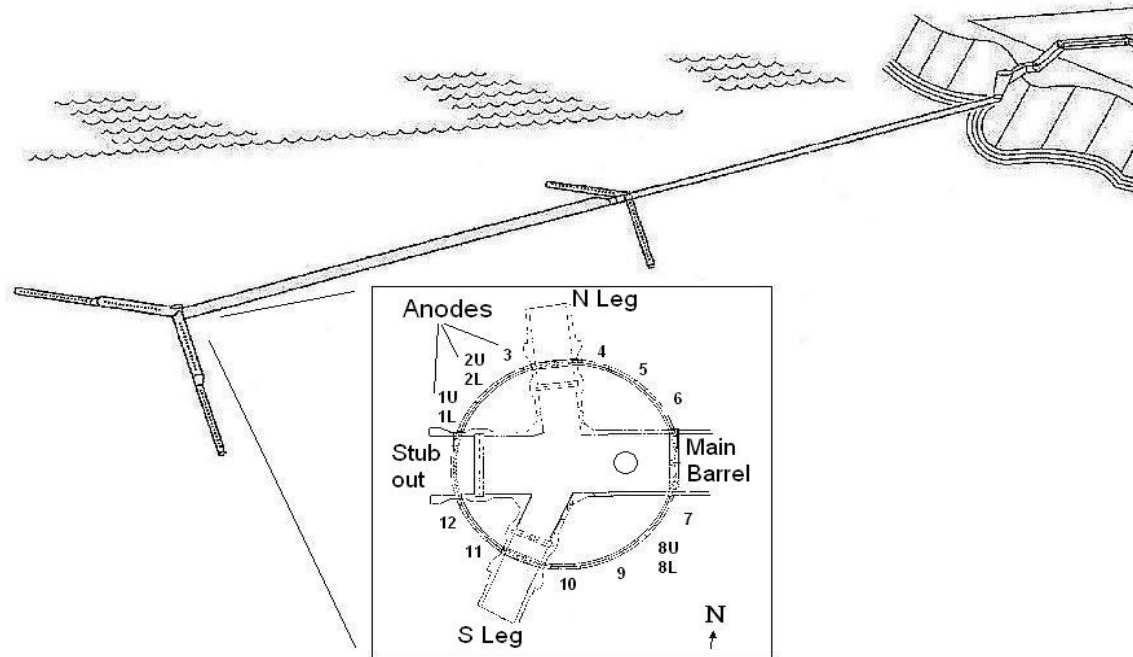
**Figure 3: Anode Schematic**

**New Diffuser Wye:** The structure continues to be in overall good condition. A schematic of the twelve pairs of anodes on the New Diffuser Wye is shown below in Figure 3. Lower anodes 1, 2, and 8, along with its mounting bracket are missing or consumed. The remaining eight lower anodes were thought to have been buried with armor rock during construction, thus no conclusion can be drawn regarding their condition. The protective wrappings on the remaining anodes of the upper ring have loosened over time to varying degrees, which has caused them to become partially active. These eight anodes, however, have continued to retain much of their original mass. No corrosion of the metal crib structure was noted and it is assumed, therefore, that the remaining anodes continue to provide adequate cathodic protection. Localized areas of leaking were observed emanating from the seams of the South Leg Gate Cover and the Stubout Gate Cover. This observation is not new and is likely a function of the time of day the survey is being performed and the accompanying pressure inside the pipe. Effluent continues to leak from different locations on the perimeter of Stubout Gate. All the leaks are of little consequence from a water quality standpoint as the initial dilution of the effluent escaping is much higher than that at the nearby diffuser ports.
