POINT LOMA OCEAN OUTFALL ANNUAL INSPECTION REPORT

2020

POINT LOMA WASTEWATER TREATMENT PLANT

NPDES PERMIT No. CA 0107409
Order No. R9-2017-0007

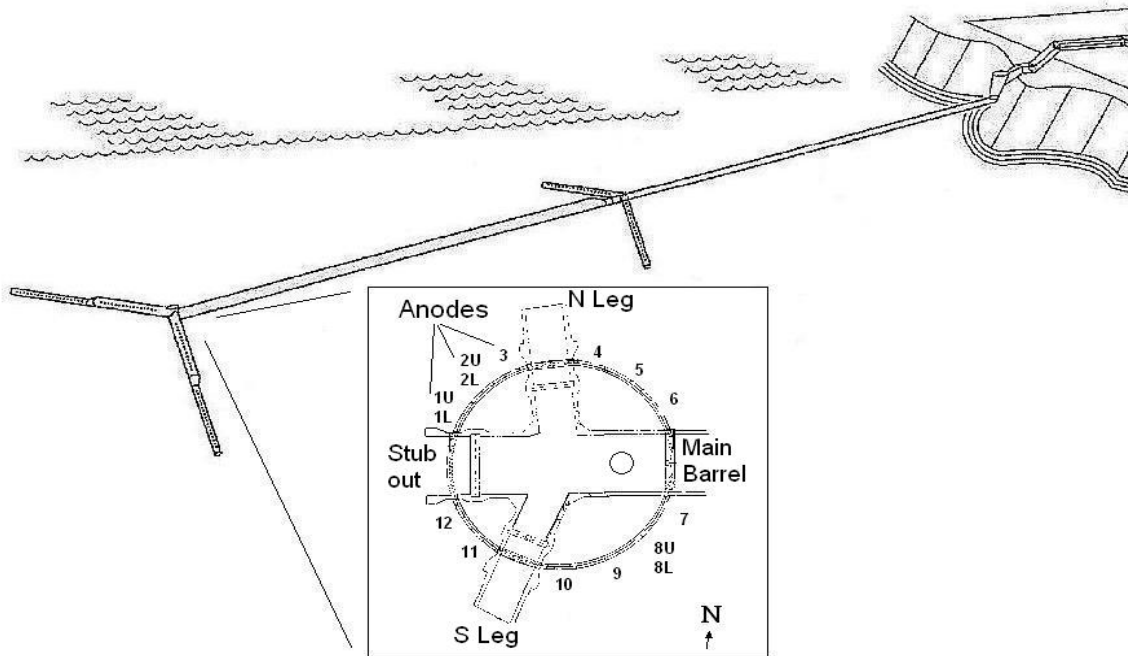
Appendix B.3

The structure continues to be in overall good condition. A schematic of the twelve pairs of anodes on the New Diffuser Wye is shown in Appendix B.3. Lower anodes 1, 2, and 8, along with its mounting bracket are missing or consumed. The remaining eight lower anodes were thought to have been buried with armor rock during construction, thus no conclusion can be drawn regarding their condition. The protective wrappings on the remaining anodes of the upper ring have loosened over time to varying degrees, which has caused them to become partially active. These eight anodes, however, have continued to retain much of their original mass. No corrosion of the metal crib structure was noted and it is assumed, therefore, that the remaining anodes continue to provide adequate cathodic protection. Localized areas of leaking were observed emanating from the seams of the North and South Leg Gate Cover as well as, the Stubout Gate Cover. This observation is not new and is likely a function of the time of day the survey is being performed and, thus, the accompanying pressure inside the pipe. Effluent continues to leak from different locations on the perimeter of Stubout Gate. However, these leaks are of little consequence, in regard to water quality, as the initial dilution of this low flow effluent escaping is much higher than that of effluent being discharged from the nearby Diffuser Ports.
