Subject: Point Loma Ocean Outfall Annual Inspection Report

POINT LOMA OCEAN OUTFALL ANNUAL INSPECTION REPORT

2021

POINT LOMA WASTEWATER TREATMENT PLANT

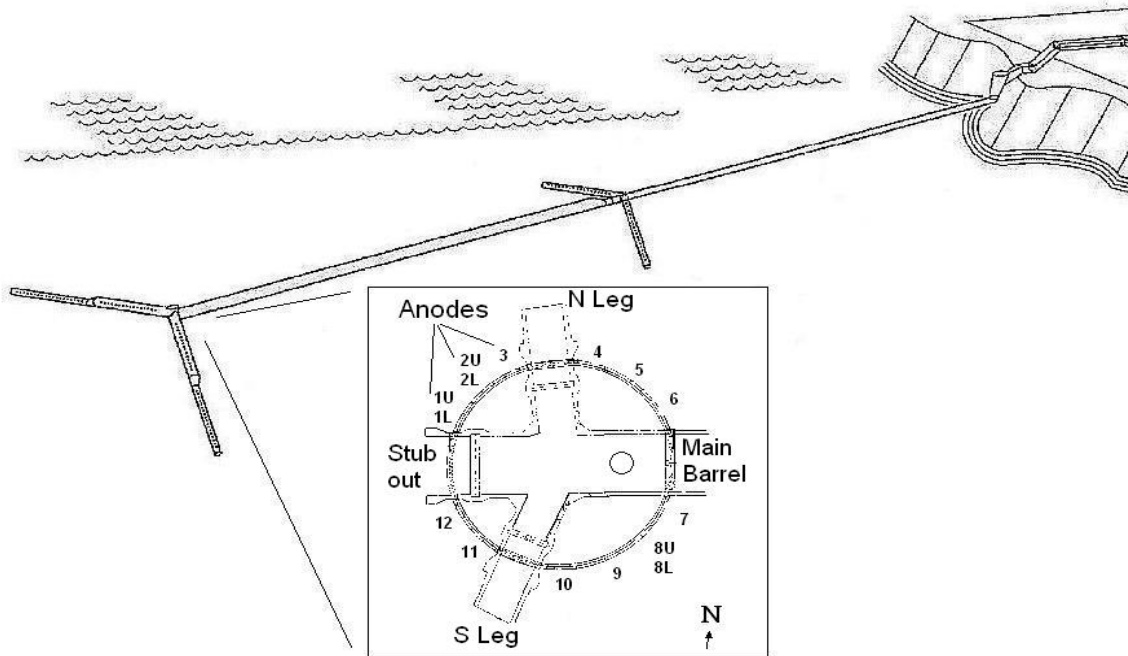
Appendix B.3

The structure continues to be in overall good condition. A schematic of the twelve pairs of anodes on the New Diffuser Wye is shown in Appendix B.3. Lower anodes 1, 2, and 8, along with its mounting bracket are missing or consumed. The remaining eight lower anodes were thought to have been buried with armor rock during construction, thus no conclusion can be drawn regarding their condition. The protective wrappings on the remaining anodes of the upper ring have loosened over time to varying degrees, which has caused them to become partially active. These eight anodes, however, have continued to retain much of their original mass. No corrosion of the metal crib structure was noted and it is assumed, therefore, that the remaining anodes continue to provide adequate cathodic protection. Localized areas of leaking were observed emanating from the seams of the North and South Leg Gate Cover as well as, the Stubout Gate Cover. This observation is not new and is likely a function of the time of day the survey is being performed and, thus, the accompanying pressure inside the pipe. Effluent continues to leak from different locations on the perimeter of Stubout Gate. However, these leaks are of little consequence, in regard to water quality, as the initial dilution of this low flow effluent escaping is much higher than that of effluent being discharged from the nearby Diffuser Ports.

Anode Schematic of PLOO extension.
