SAN YSDIRO HISTORIC RESOURCES SURVEY

City of San Diego Planning Department

Roth and Associates 2707 Congress Ave., Suite 2A San Diego, California 92110

14 August 1989

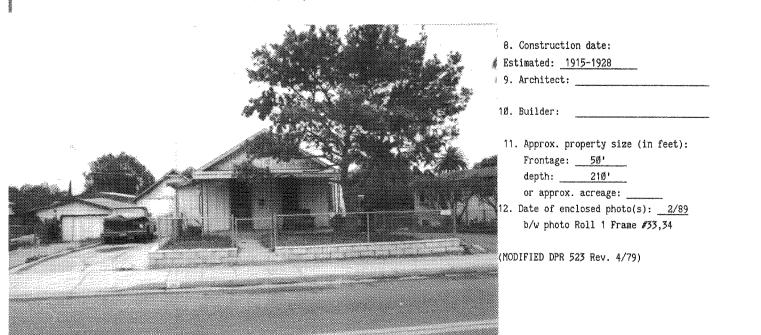
Narrow one story house located on a slope; house has a medium pitch front facing gable roof with slightly dropped shed extension to the sides, a dropped flat roof over a full front porch and at least 1 gabled roof addition to the rear ("shot-gun w/ additions"). Asymmetrical front facade. <u>STRUCTURAL AND DESIGN ELEMENTS</u>: WALL TREATMENT: board and batten; rear has lap siding; large louvered, rectangularly shaped boxed vent with slight sill under gable (in rear same element on 1 gable, screened horizontal boxed vent under other); partial concrete foundation. <u>ROOF</u>: composition shingles; slight overhang; exposed eaves; plain gableboard; front gable has plain cornice board as well. <u>CHIMNEY</u>: none. <u>WINDOWS</u>: single window in front (right of door); single light double hung covered with security screens; plain surrounding board trim; side windows combination wood sliders, double hung and louvered. <u>DOOR</u>: front facing, off-set to left, partially glazed with 1 large rectangular pane and 3 wood panes; security screen; plain surrounding board trim. <u>PORCH</u>: full width, open, flat roof overhang with wrought iron supports; 1 front facing step to porch.

| 13. Condition: Excellent Good Fair Deterioratedx No longer in existence |
| 14. Alterations:shed extensions to the sides |

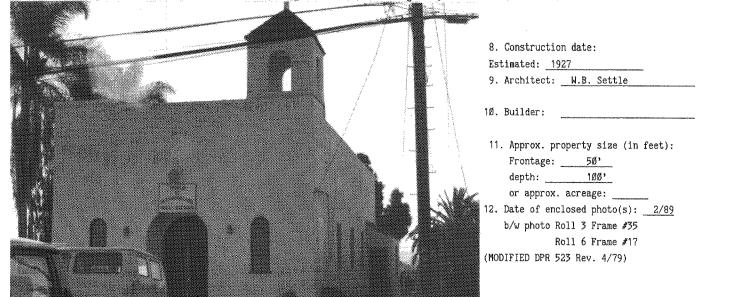
Overall appearance of building is stark with little or no design elements; little vegetation. Residents indicate that building was severely altered when the Catholic diocese sold the building. Original building could have been designed by Louis Gill (informant).

| 13. Condition: Excellent Good Fairx_ Deteriorated No longer in existence |

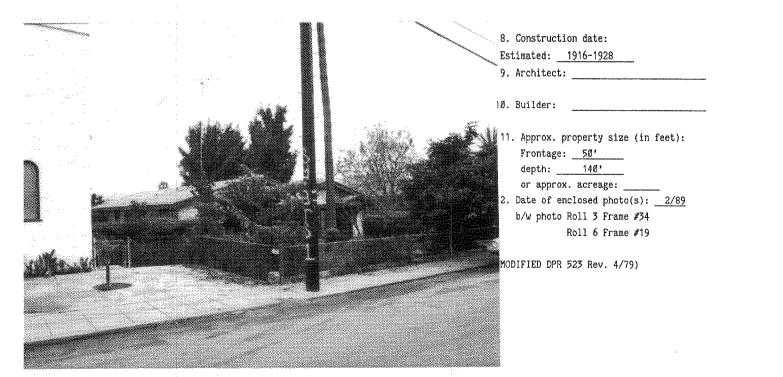
Long narrow house with 2 low pitch front facing gables and a small gable over front door. Asymmetrical front facade. <u>STRUCTURAL AND DESIGN ELEMENTS</u>: <u>WALL TREATMENT</u>: metal lap siding (over wood lap); decorative rock skirt around bottom 1/3 of structure. <u>ROOF</u>: composition shingle; moderate overhang; plain eaves fascia and gableboard. <u>CHIMNEY</u>: none. <u>WINDOWS</u>: 1 main front focal window: fixed with a narrow 3 vertical light casement abutting on either side; plain surrounding board trim. <u>DOOR</u>: plywood. <u>PORCH</u>: low pitch gable roof over front door entry; 2 stick, open triangle knee braces; no porch supports; 2 cement steps to door.

| | volution of the second se | Excellent | | Good | - | Fair | <u>x</u> | Deteriorated | | No | longer | in ex | istence | | |

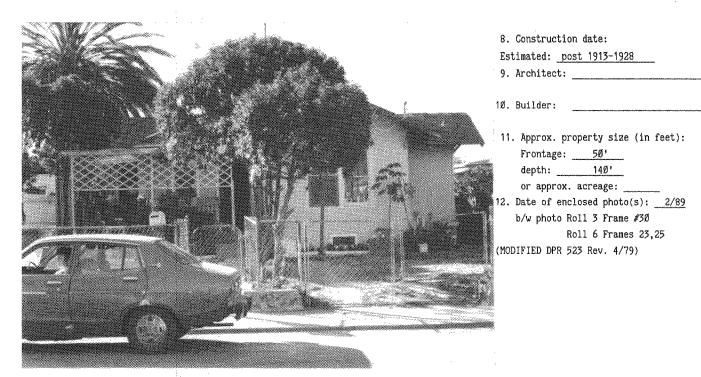
numerous alterations and additions to the main structure). Asymmetrical front facade. <u>STRUCTURAL AND DESIGN ELEMENTS</u>: WALL TREATMENT: stucco siding. <u>ROOF</u>: composition shingles with exposed eaves; plain wood knee braces at gable edges; two front gables are accented with two narrow strips forming an upside down "T" directly under the gable; plain undecorated gableboard. <u>WINDOWS</u>: double hung with single light; plain board trim on three sides, no board trim along bottom of the window. <u>DOOR</u>: two front doors, both have iron security screens; plain surrounding board trim. <u>PORCH</u>: 3/4 wrap-around porch with 1 by 1 porch supports; open metal rail system; lattice work extends from plastic awning roof to approximately 3' above porch floor (porch system is a recent addition to main structure); 3 front entry cement steps to door.

| 13. Condition: Excellent Good Fair _ x _ Deteriorated No longer in existence | |

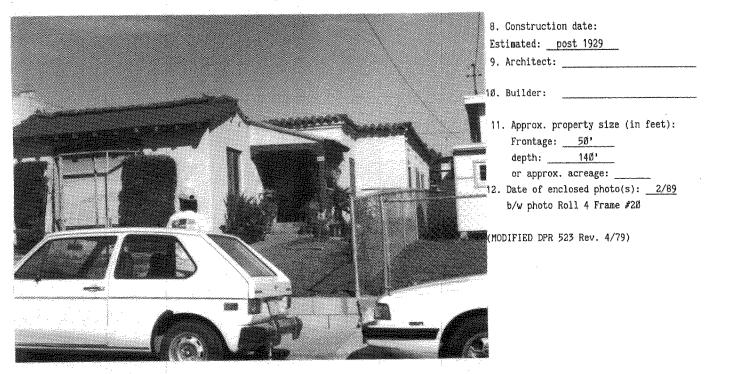
House currently being remodeled: front bay window added; new stucco siding; new roof

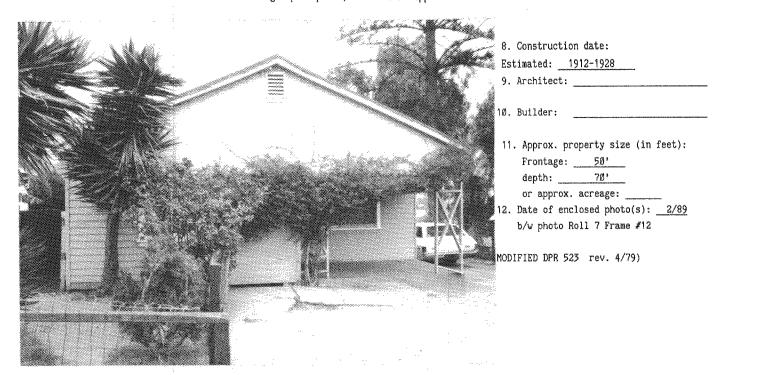
One story house with medium pitch front facing gable, open, 1/2 porch under principal roof. Asymmetrical front facade. <u>STRUCTURAL AND DESIGN ELEMENTS</u>: <u>WALL TREATMENT</u>: board and batten under gable; lap siding in the front, narrower lap siding on the side; plain corner boards; boxed and silled, rectangular louver under gable. <u>ROOF</u>: composition sheeting; extremely slight overhang; plain undecorated eaves fasica and gableboard. <u>CHIMNEY</u>: none. <u>WINDOWS</u>: two sets of front windows, sash bar pattern of 12 panes; side window double hung; all have plain surrounding board trim with sills extending slightly beyond window opening. <u>DOOR</u>: front inset; can not see door. <u>PORCH</u>: offset to the right, front facing, open porch under principal roof; simple scallop design used as trim along top of porch; stick work supports.

- 13. Condition: Excellent _____ Good _____ Fair _x Deteriorated _____ No longer in existence _____
- 14. Alterations: major alterations to the front and at least 1 side of the structure
- 15. Surroundings:(check appropriate boxes) Open land _____ Scattered buildings ____ Densely built-up _____ Residential _____ Industrial _____ Commercial _____ Other: ______
- 16. Threats to site: None known ____ Private Development ___ Zoning ___ Vandalism _____ Public Works Project ____ Other: ______
- 17. Is the structure: On its original site?: _____ Moved? _____ Unknown ? _____
- 18. Related features: _detached one car garage to side rear; older vegetation in yard; on 1929 aerial

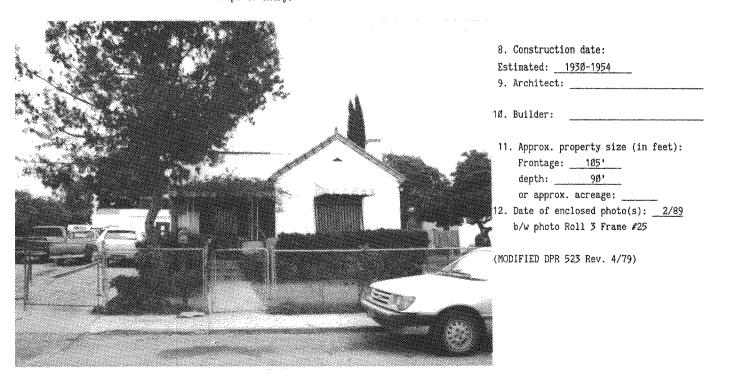
13. Condition: Excellent _____ Good _____ Fair __x Deteriorated _____ No longer in existence _____

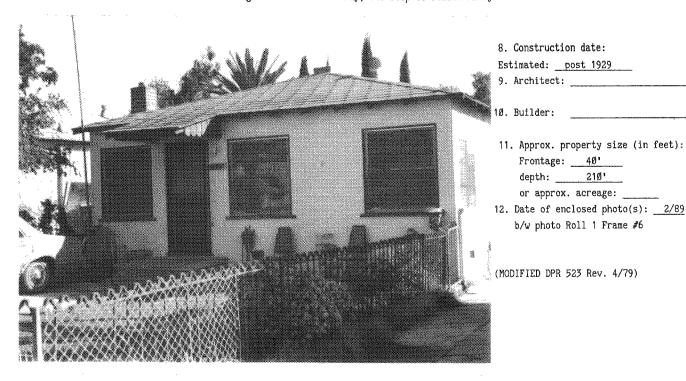
13. Condition: Excellent _____ Good ____ Fair _x Deteriorated _____ No longer in existence _____
