# **SOUTH BAY OCEAN OUTFALL ANNUAL INSPECTION REPORT**

## **2019**

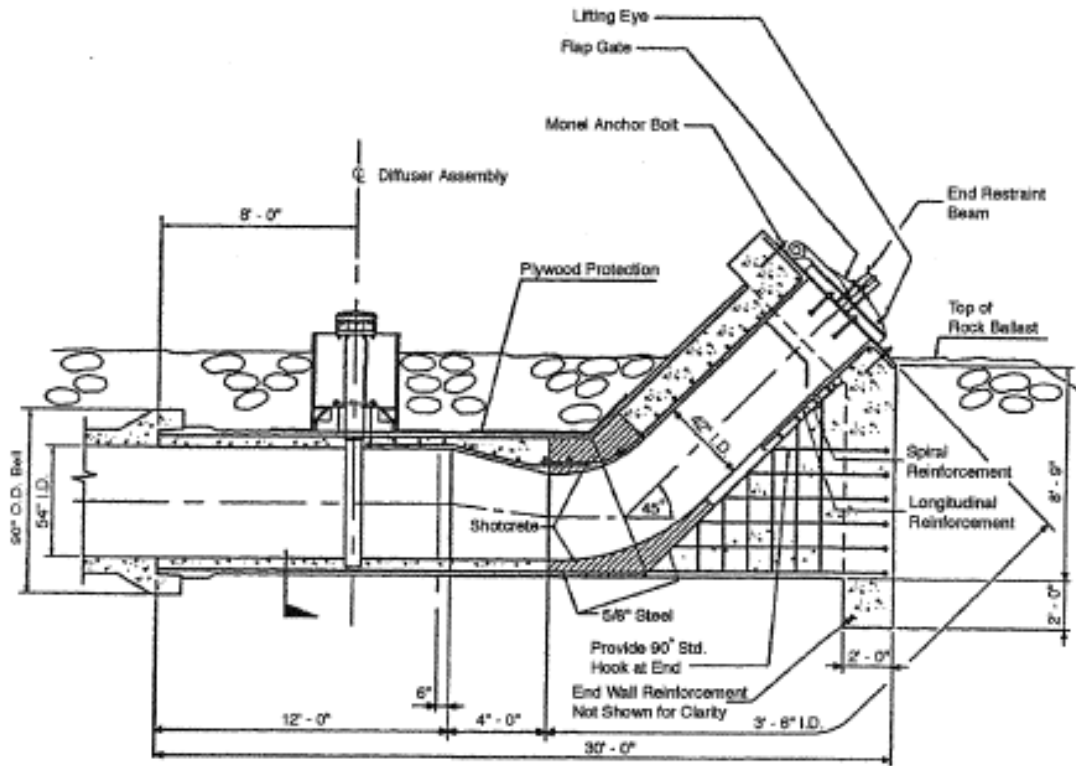
The Diffuser Wye structure for the SBOO.

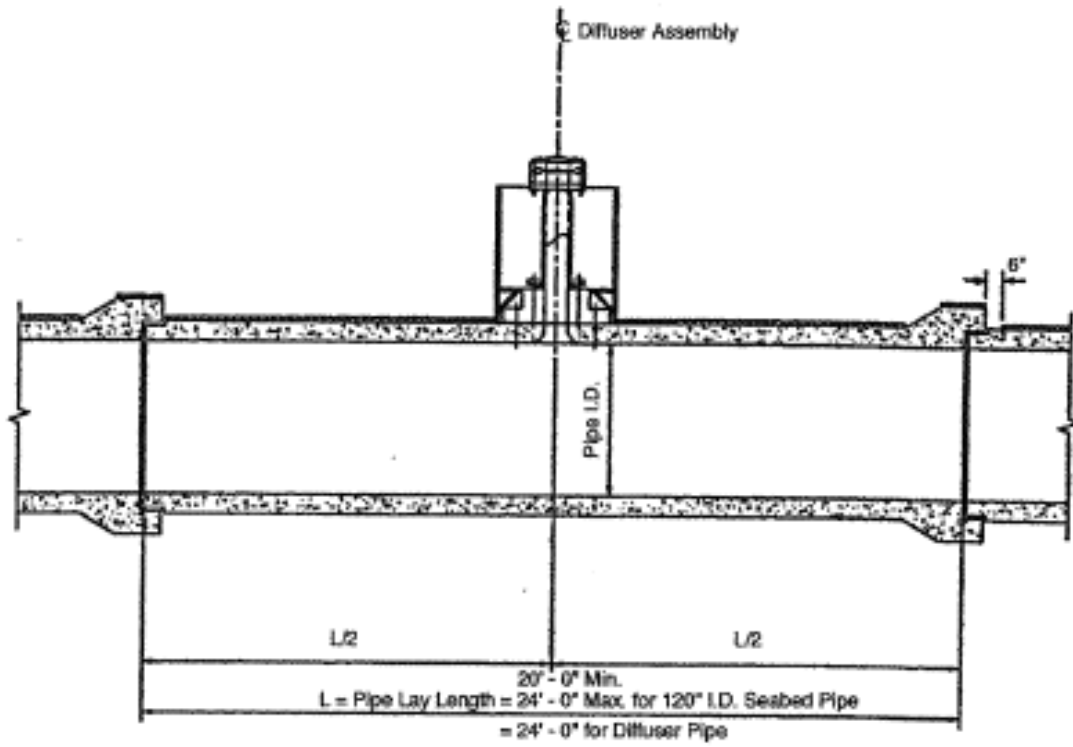
Termination structure found at the end of the SBOO Diffuser Legs.
