# **SOUTH BAY OCEAN OUTFALL ANNUAL INSPECTION REPORT**

## **2020**

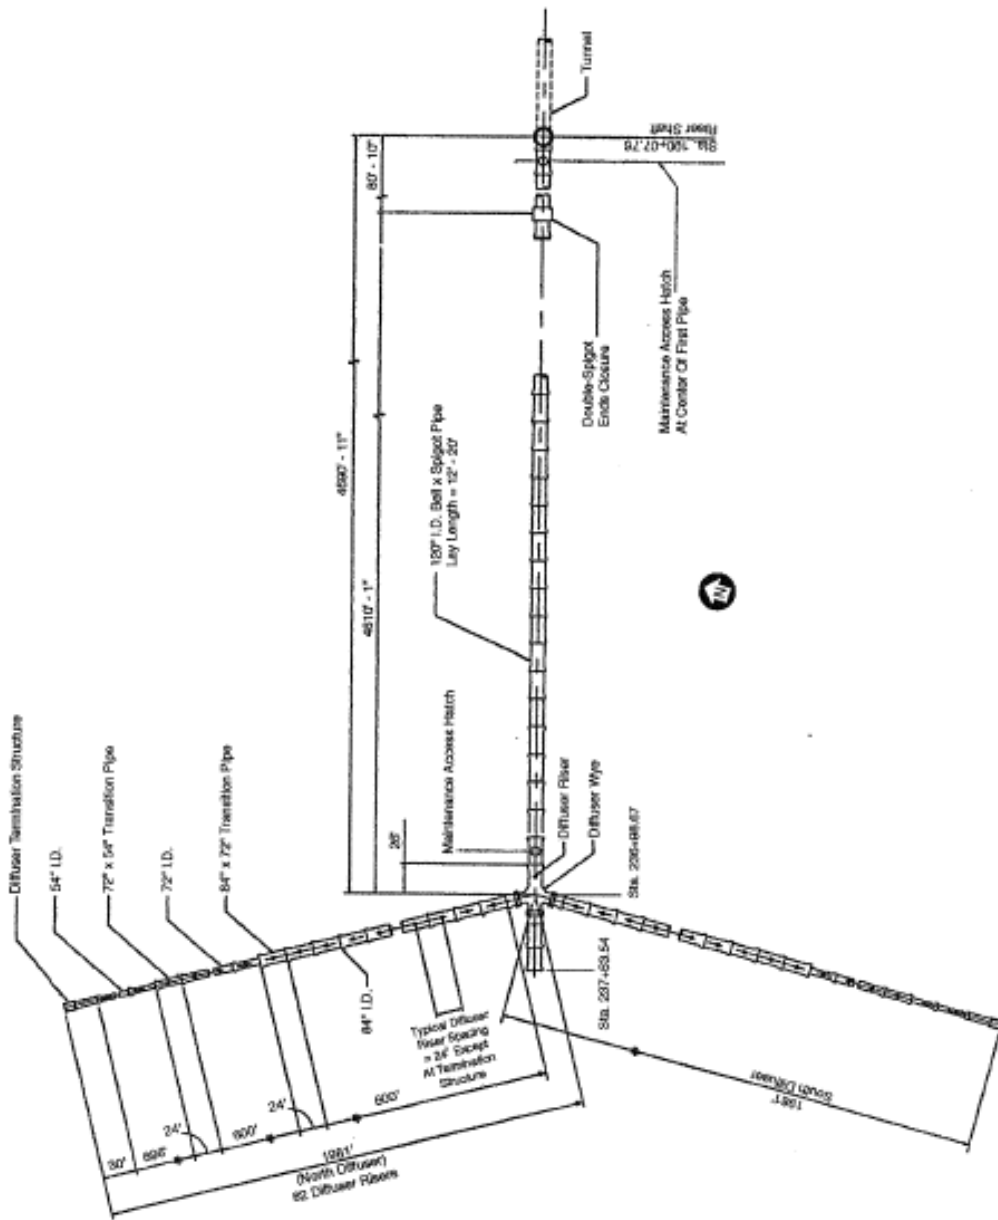
- 6 The upgrade to secondary treatment at the IWTP in January 2011 has continued to markedly improve the visible quality of discharged effluent and may have also been responsible for the virtual elimination of the bacterial mats seen near all points of discharge in the years predating the current review period.

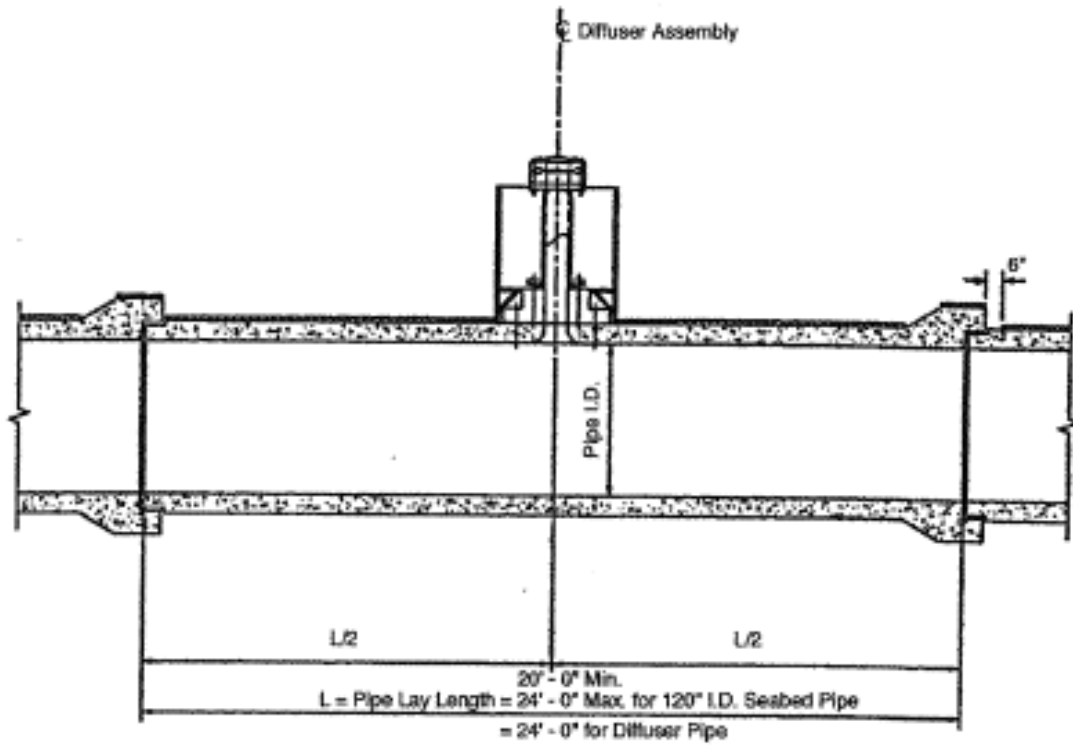
Termination structure found at the end of the SBOO Diffuser Legs.
