# **SOUTH BAY OCEAN OUTFALL ANNUAL INSPECTION REPORT**

## **2021**

### **South Bay Water Reclamation Plant**

### **USIBWC South Bay International Wastewater Treatment Plant**

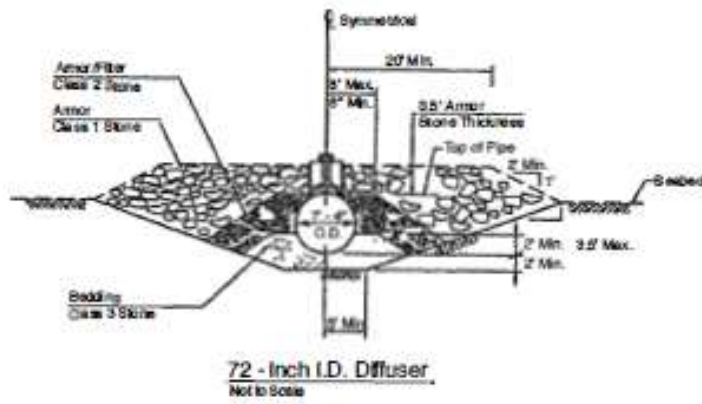
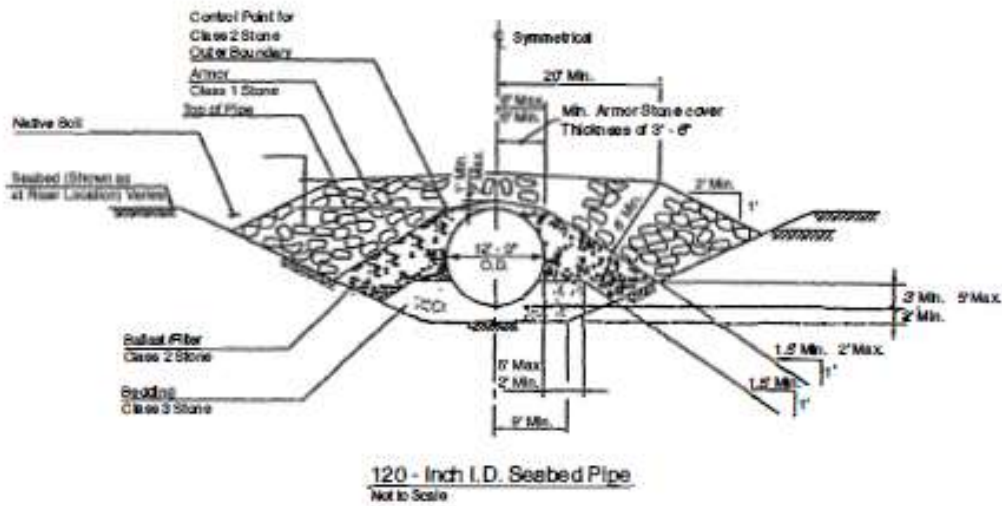
### Appendix A.3

The ballast coverage was complete and seemed no different from earlier surveys. The condition of all seven concrete access covers and their lifting eyes also appeared unchanged.

Cross section of the SBOO and ballast rock.

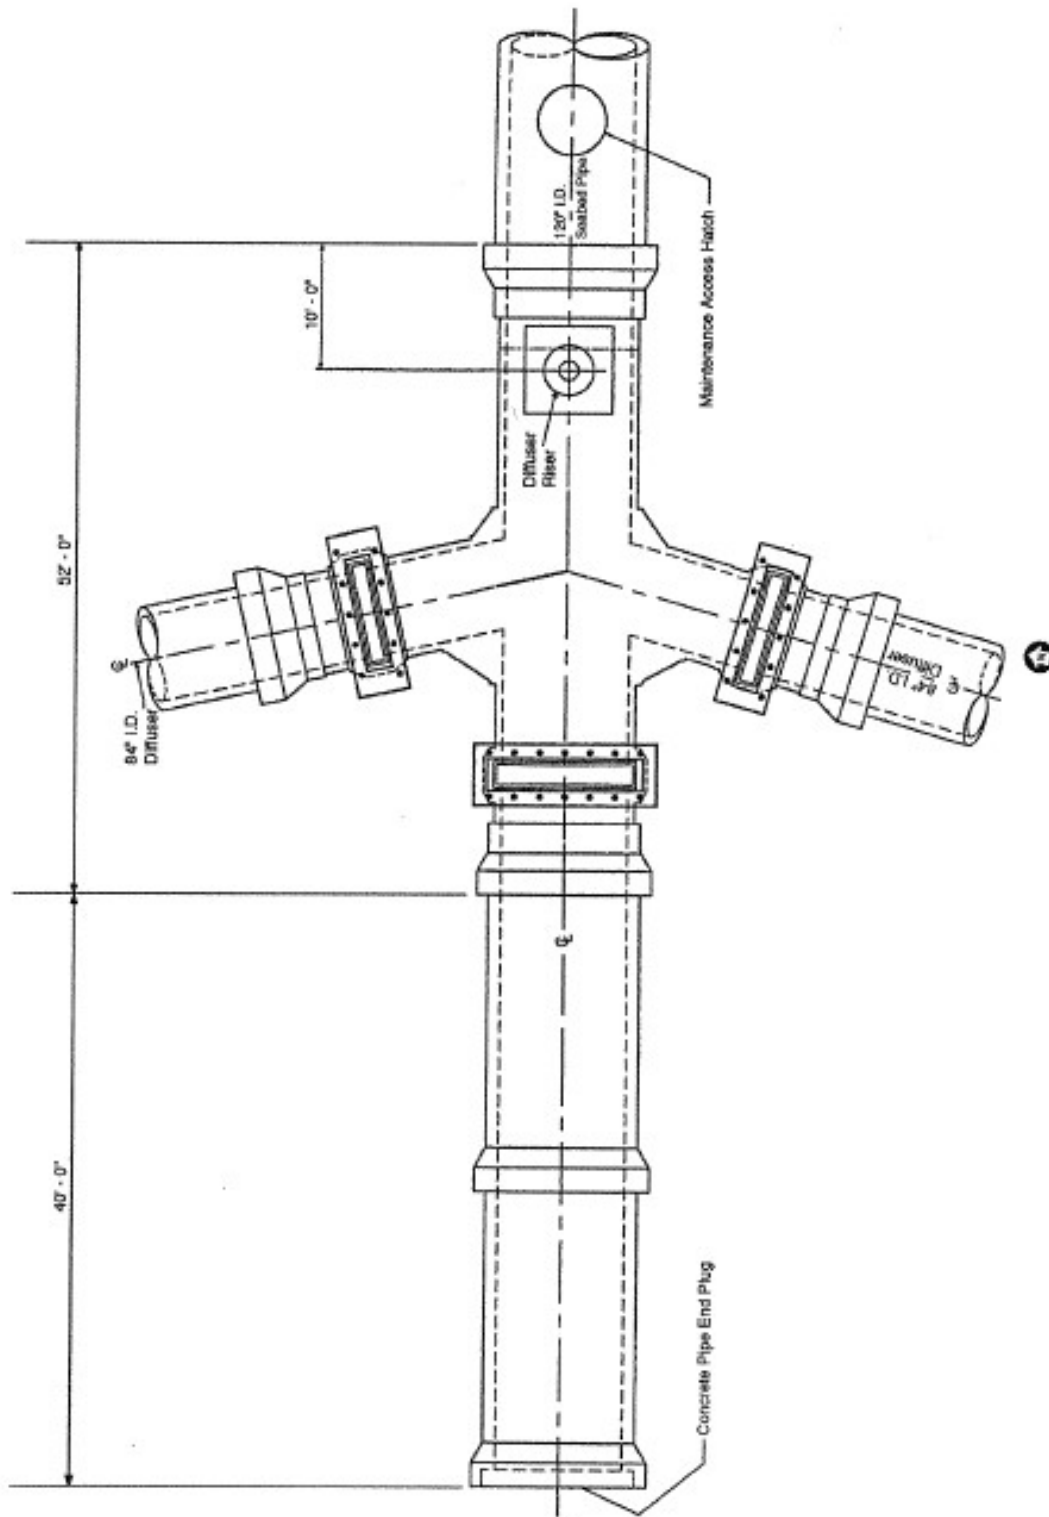
### Appendix A.6

The condition of the Wye was nearly identical to the previous surveys: the gate covers were in good condition and were sealed properly, except for a slight leak on the eastern edge of the north gate cover. The offshore rock pile was generally free of algal coverage, and the ballast coverage was complete with no visible bacterial mat. The one Riser “W” had accumulated more encrusting growth but was flowing freely.

The Diffuser Wye structure for the SBOO.

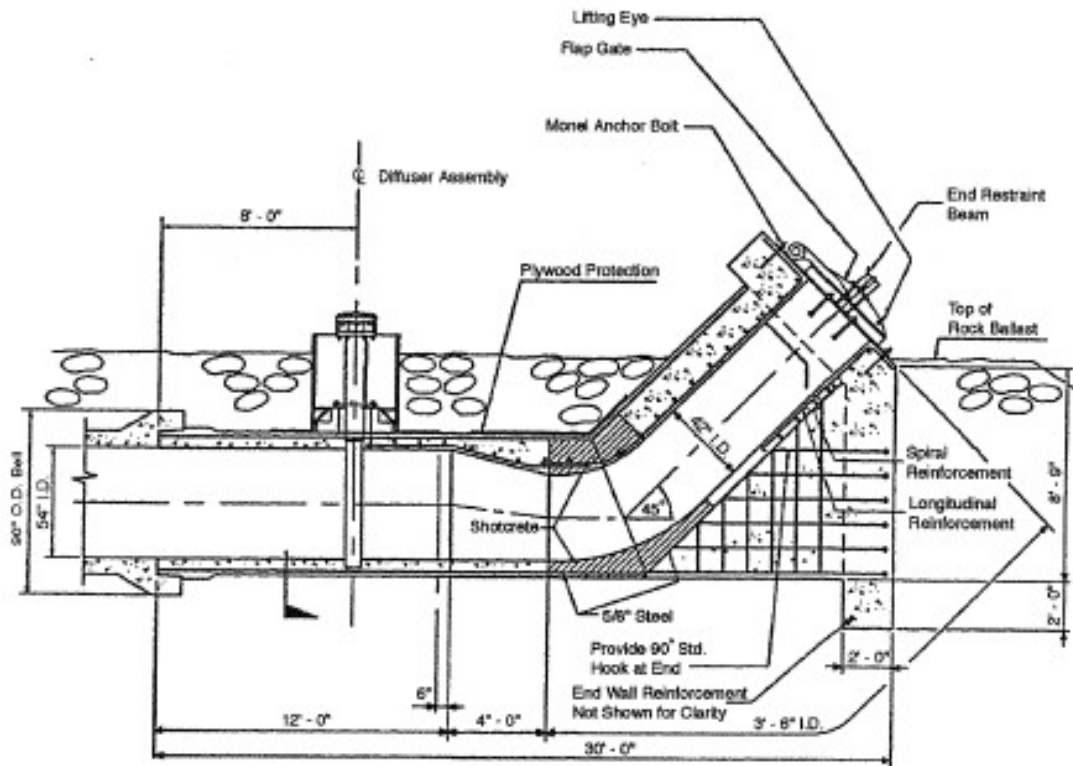
## Appendix A.7

As observed in last year’s survey, the Termination structure and the Flap Gate remained overgrown by algae and invertebrate, but overall it appeared to be in good condition. The Flap Gate did not exhibit any visible signs of leaking. The anode on the crossbar could not be evaluated because it continues to be obscured by encrusting marine growth. The southeast Diffuser Port on Riser S82, was completely blocked, but the other three ports were flowing normally. The other active diffuser heads had accumulated more invertebrate and algal growth since the last inspection, but their Diffuser Ports all looked to be flowing, it is possible some Risers have their flow restricted by the marine growth. The inactive Risers were all in good condition and appeared to be sealed properly. The ballast coverage along this structure was unchanged. Some of the Risers are not centered on their cans.

Termination structure found at the end of the SBOO Diffuser Legs.

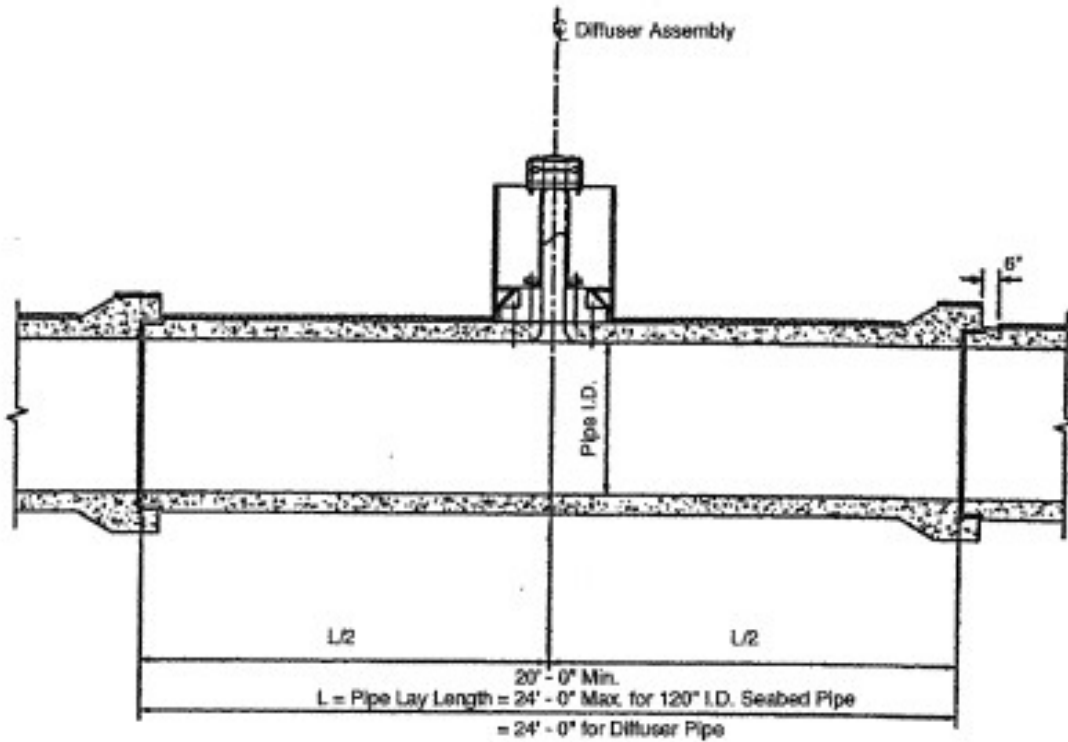
## Appendix A.8

The ballast covering this structure has not visibly changed since the last survey. The Risers were all in good condition and sealed properly except for Riser N69. This structure continued to exhibit the telltale signs of leaking, a white patina of bacteria and the absence of sediment in the Riser Can, but it otherwise looked to be structurally sound. The persistent intrusion of sand along the northern half of the Diffuser Leg seemed no different from past years. The Termination structure remained in good condition and was properly sealed. The anode on the crossbar was difficult to see due to encrusting organisms, thus its condition could not be evaluated. As observed in prior years the canting, or leaning of certain Riser Heads was observed (N9, N15 N33, N45, N51 and N61). As in the 2020 survey Riser N6 still had a lot of rope entangled on it but did not seem to be impacting the riser negatively. Unfortunately, due to poor visibility on the day of inspection, Risers N71-73 were missed during the inspection and thus their condition is not reported here.

- 3 As in past surveys, active Diffuser Heads continue to accumulate large colonies of invertebrate organisms, most of their Diffuser Ports have remained generally unobstructed and all appear to be functioning properly. However, some ports are showing signs of being obstructed by the marine growth. City engineers have developed a scope of services for divers to clean the Diffuser Ports of the encrusting organisms that is expected to be completed during the 2023 fiscal year.

Diffuser assembly on the SBOO Diffuser Legs.
