INDIVIDUAL WATER QUALITY ASSESSMENT REPORT

Siempre Viva and Bristow Channels

Maps 126 and 127

March 21, 2017; Revised April 28, 2017

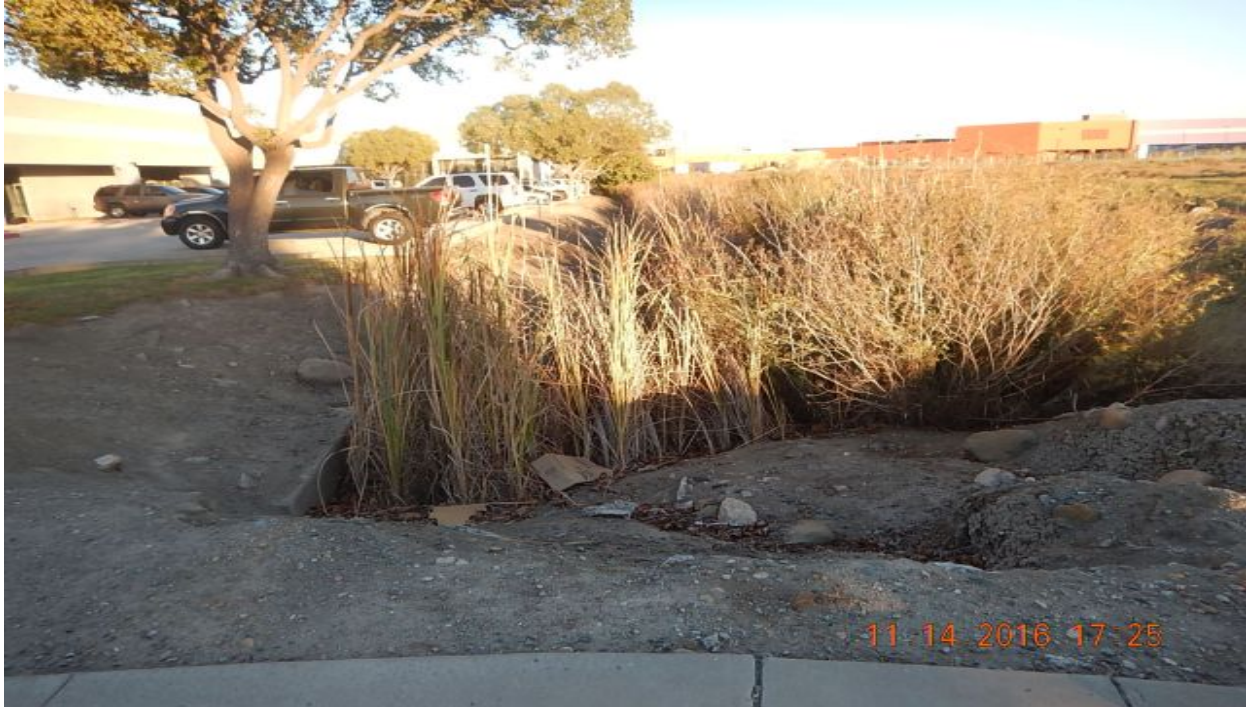
1.

Upstream end of Siempre Viva Channel Reach 3 facing east at the end of Britannia Court. No dry weather flows and dense vegetation was observed in Reach 3.

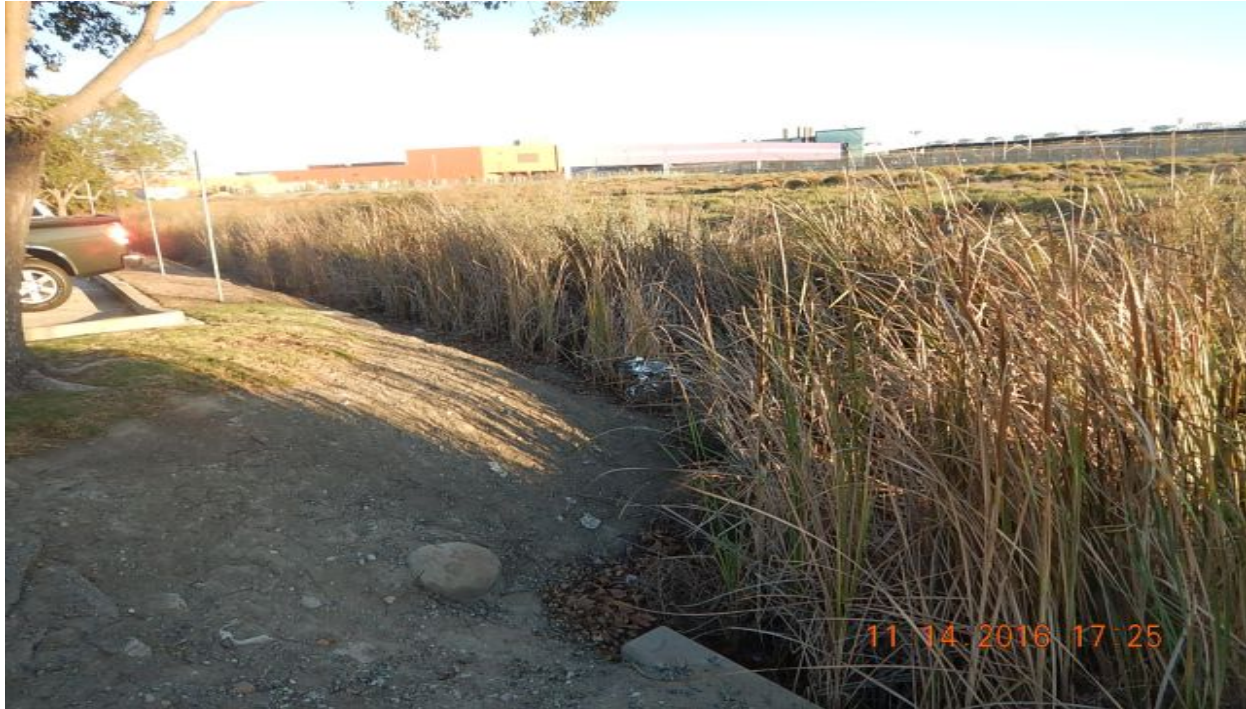
2.

Upstream end of Siempre Viva Channel Reach 3 facing east at the end of Britannia Court. No dry weather flows and dense vegetation was observed in Reach 3.

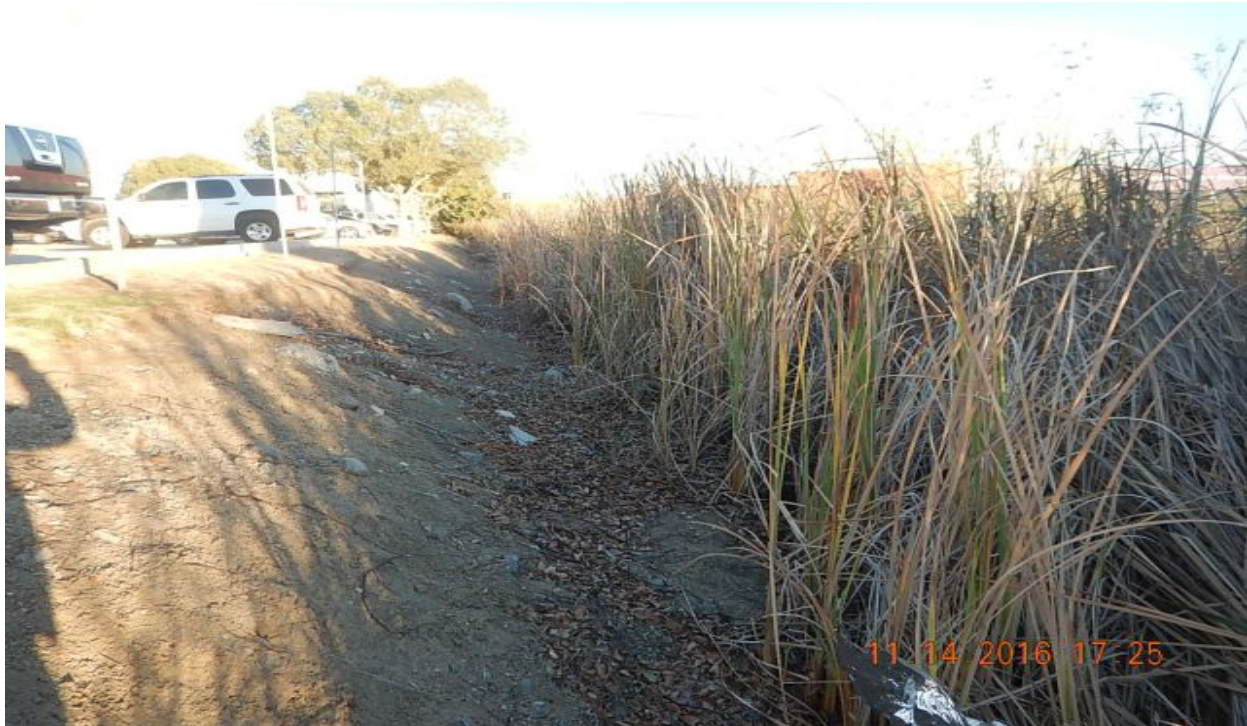
Upstream end of Siempré Viva Channel Reach 3 facing east. No dry weather flows and dense vegetation was observed in Reach 3.

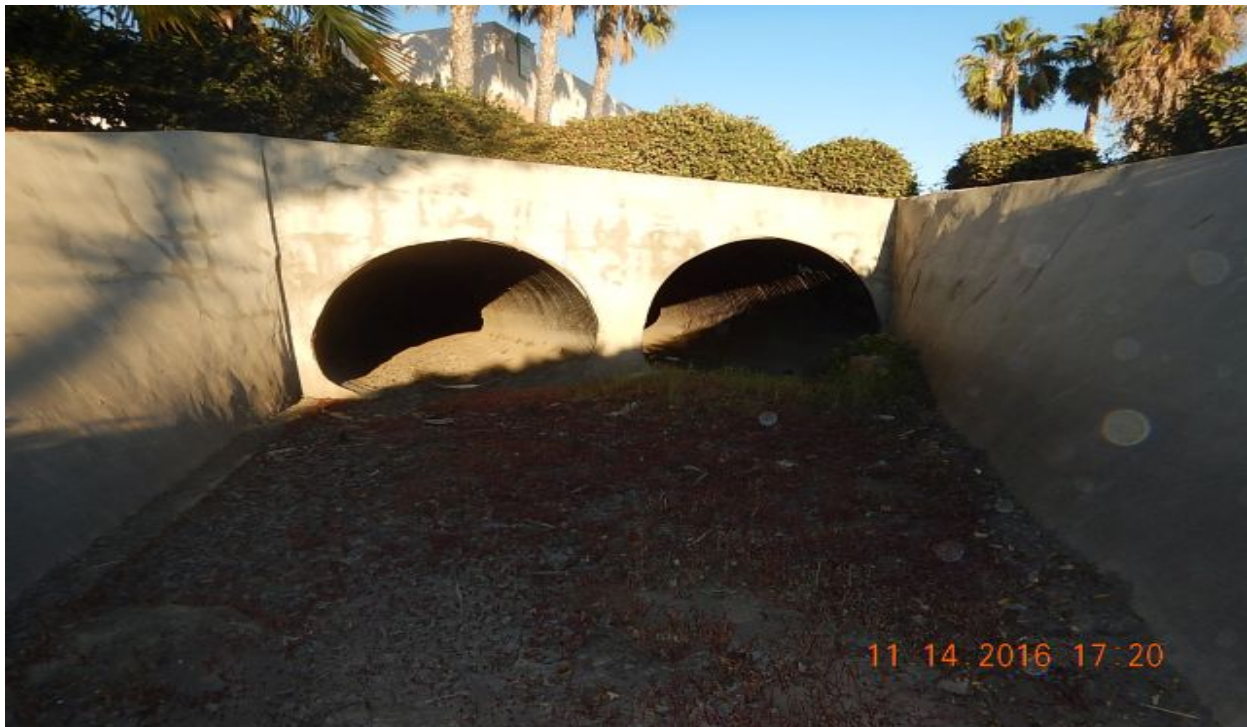
4.

Downstream end of Bristow Channel Reach 2 facing east. No flowing water was observed in Bristow Channel Reach 2.

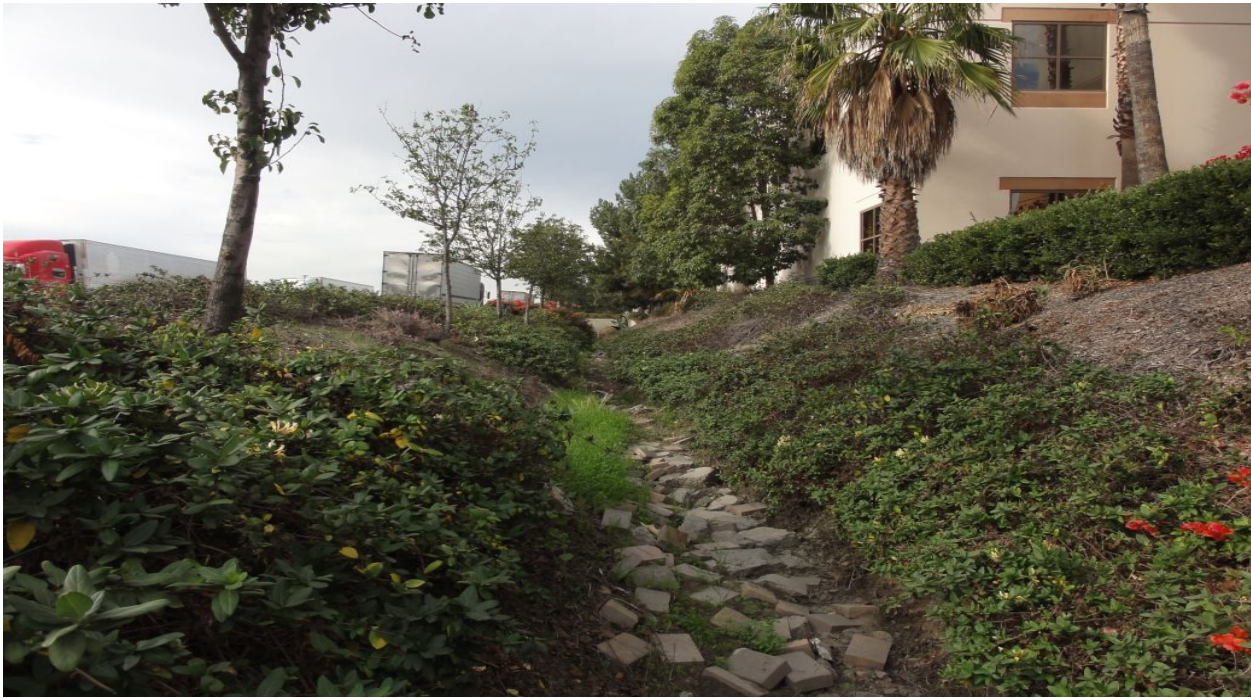
5.

Downstream end of Bristow Channel Reach 2 facing west. No flowing water was observed in Reach 2.

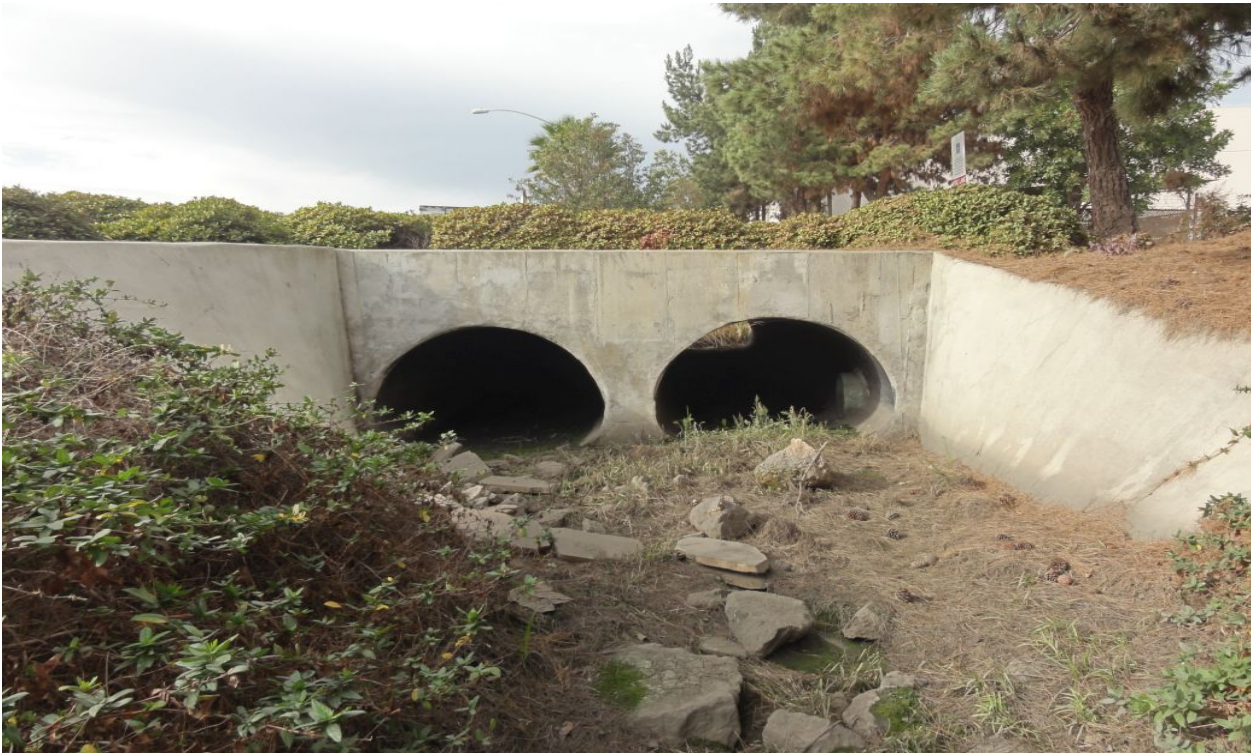
6.

Central portion of Bristow Channel Reach 2 facing west. No flowing water was observed in Reach 2.

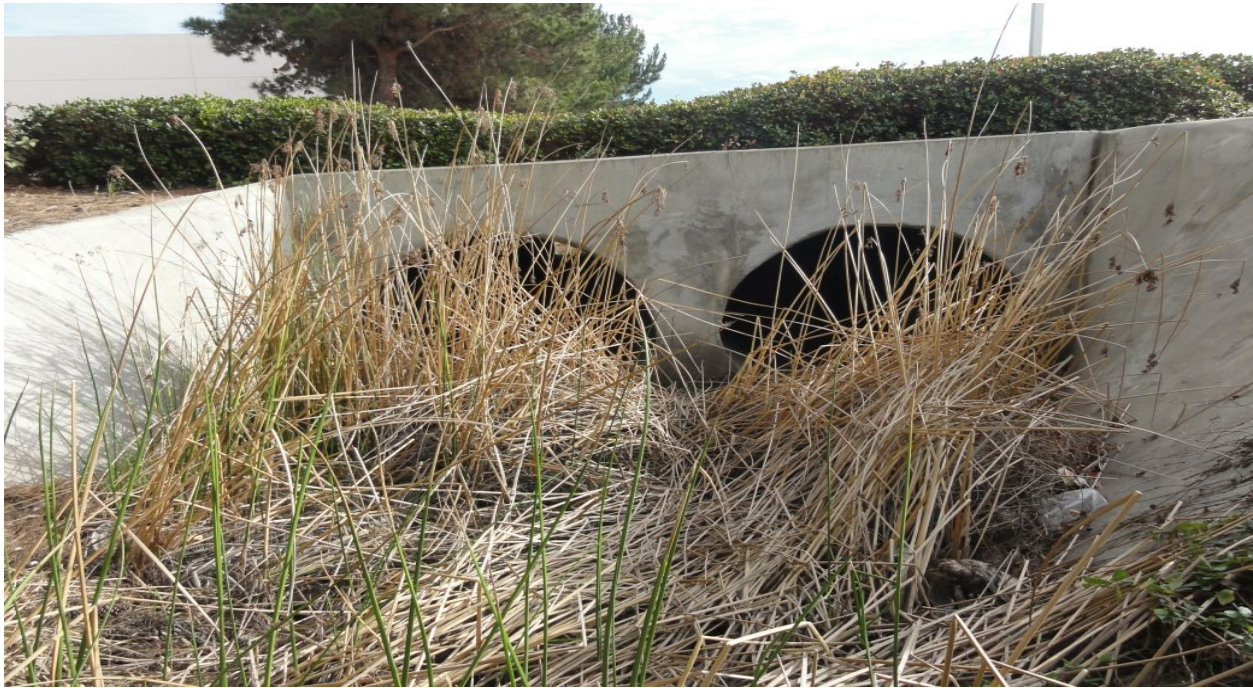
7.

Central portion of Bristow Channel Reach 2 facing east. No dry weather flows and dense vegetation was observed in Reach 2.

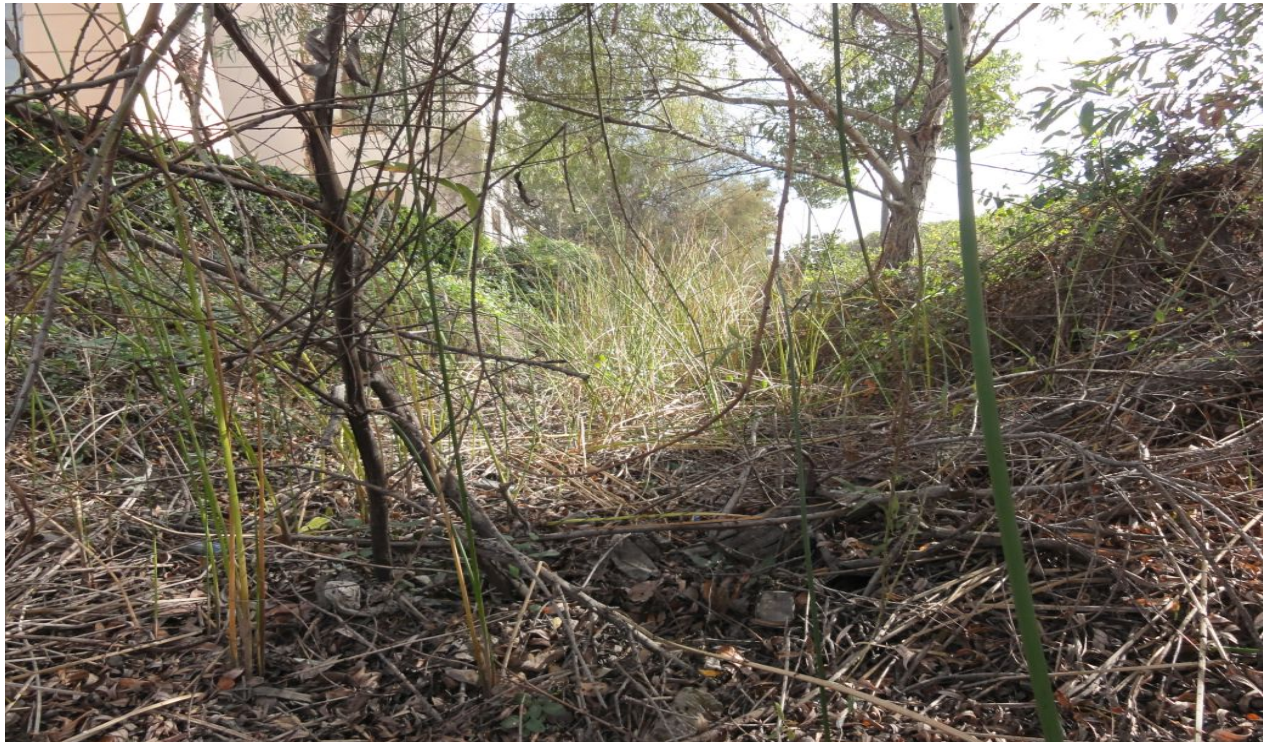
8.

Upstream end of Bristow Channel Reach 2 facing west. Light vegetation was observed throughout the upper end of Reach 2. No flowing water was observed.

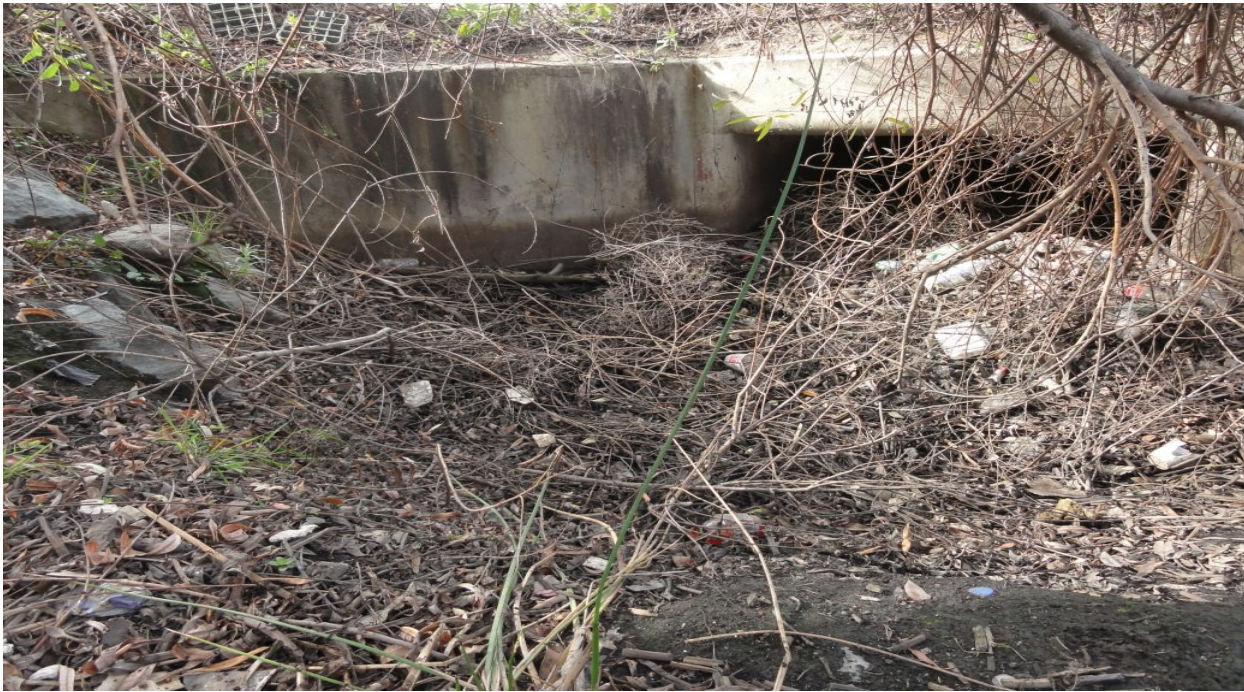
9.

Upstream end of Bristow Channel Reach 2 facing west. No flowing water was observed in Reach 2.

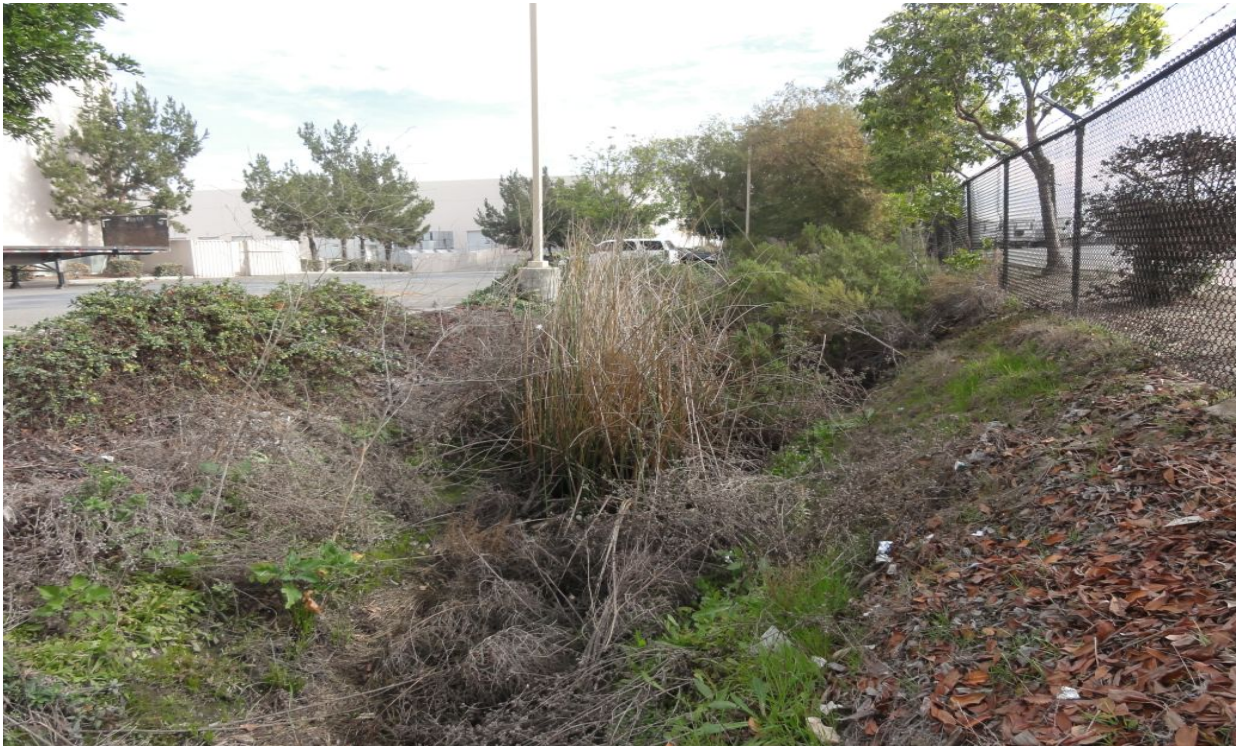
10.

Upstream end of Siempre Viva Channel Reach 1 facing east at the end of Bristow Court. No dry weather flows and dense vegetation was observed in Reach 1.

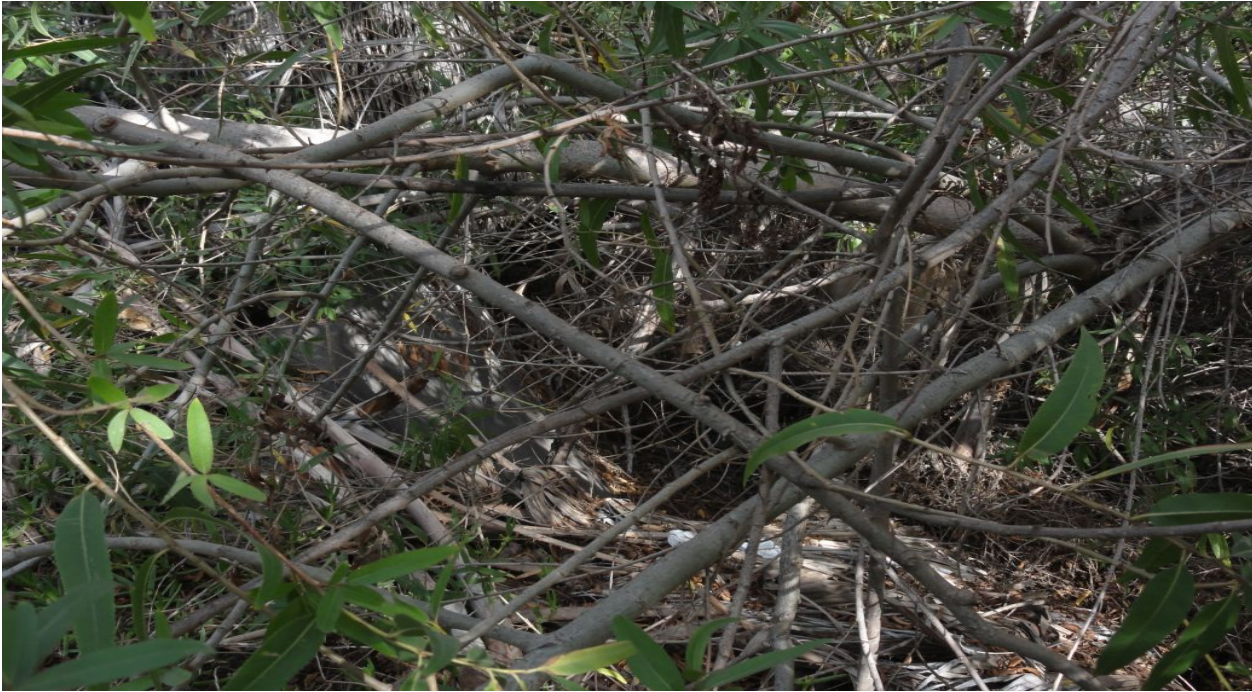
11.

Upstream end of Siempre Viva Channel Reach 1 facing northeast. No dry weather flows and dense vegetation was observed in Reach 1.

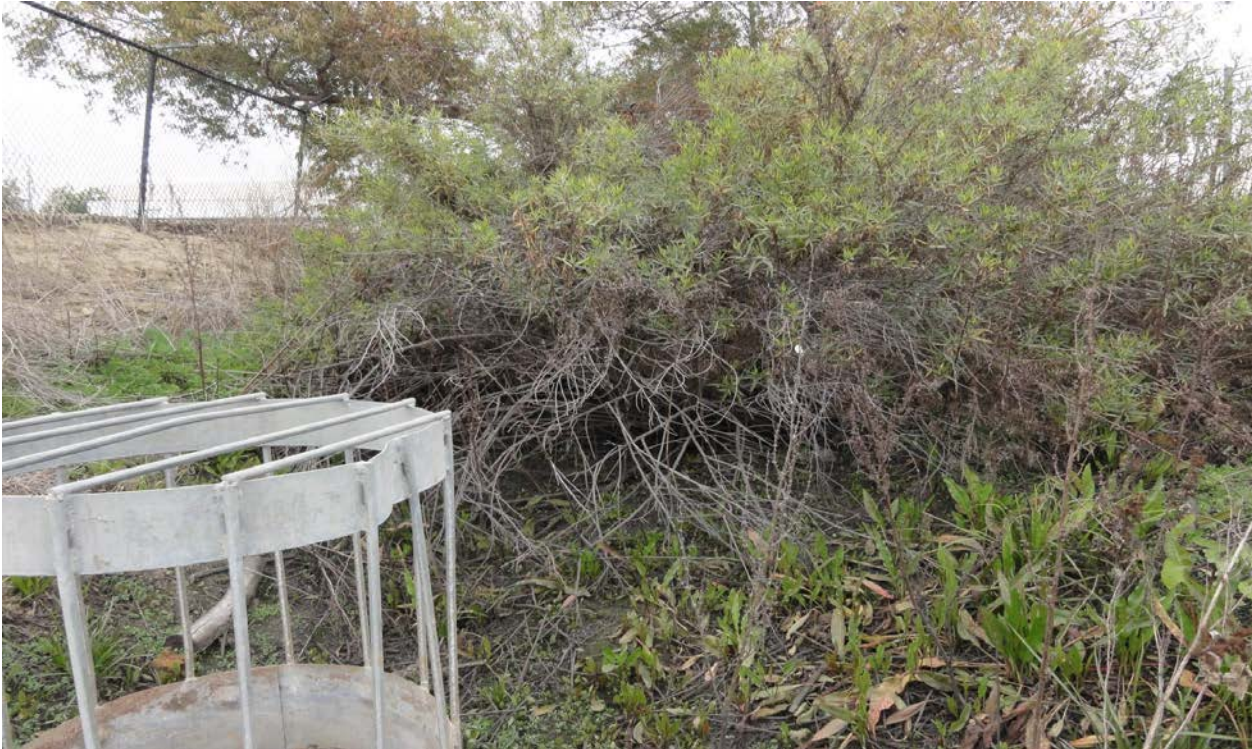
12.

Downstream end of Siempre Viva Channel Reach 1 facing north. No dry weather flows and dense vegetation was observed in Reach 1.
