W:\18187-B-FY18_Channel_Prioritization\GIS\Appendix_E_Culverts\Map81_Layout.mxd, 04/2018

Assessment Results

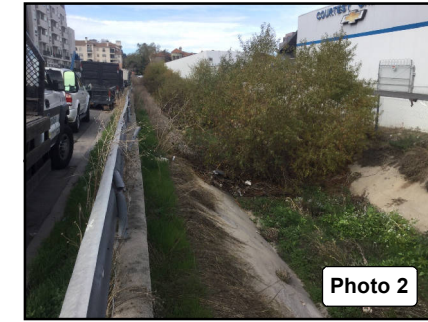
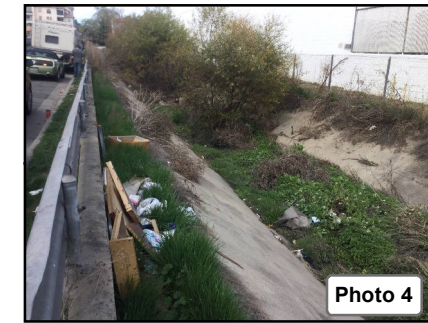
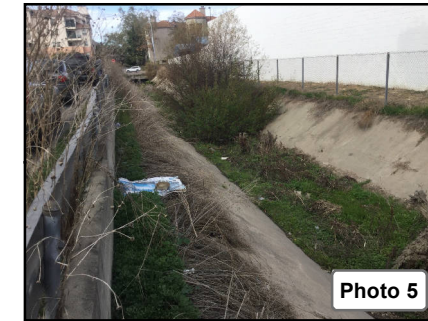
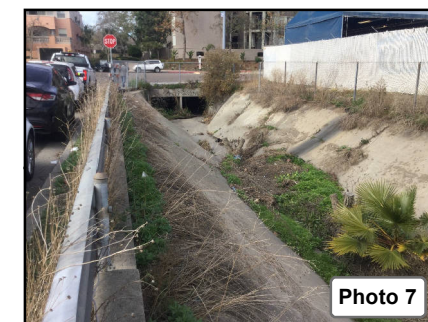
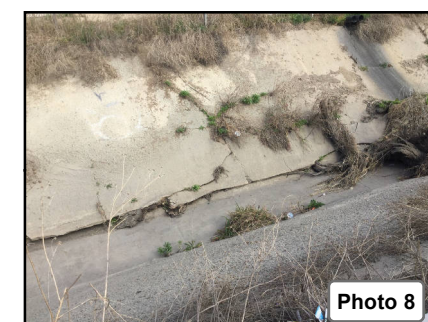
Photos:

- Channel Prioritization Score: **56.2 out of 100**
- Capacity Prior to Maintenance: **2-year storm event**
- Capacity After Maintenance (As-built Capacity): **100-year storm event**
- Clogging Potential: **MEDIUM**
- Approximate Invasive Vegetation Coverage: **LOW**
- Surrounding Area: **Residential**
- Infrastructure Failures: **Broken concrete**
- Site Evaluation Date: **March 8, 2018**
- Notes/Comments: **The channel has broken concrete from the trees on the channel bottom.**
