W:\18187-B-FY18_Channel_Prioritization\GIS\Appendix_F_Culverts\Map77_04.2018

Assessment Results

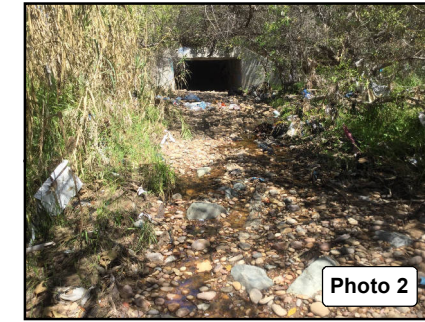
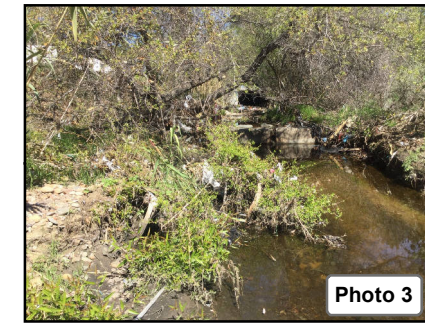
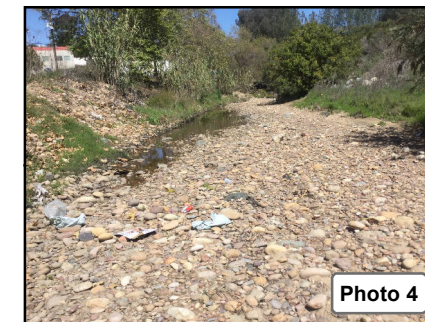
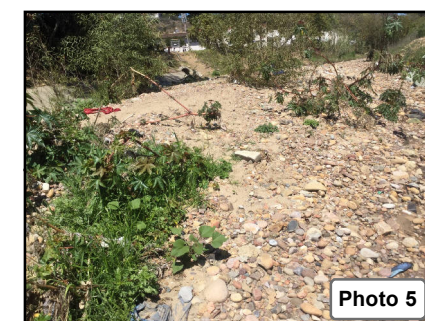
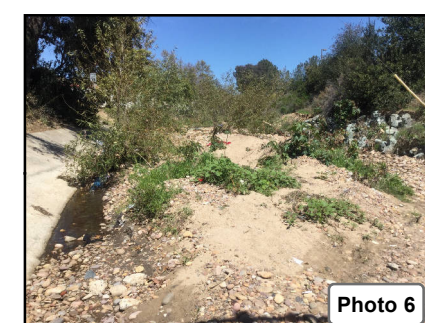
Photos:

- Channel Prioritization Score: **26.2 out of 100**
- Capacity Prior to Maintenance: **100-year storm event**
- Capacity After Maintenance (As-built Capacity): **100-year storm event**
- Clogging Potential: **LOW**
- Approximate Invasive Vegetation Coverage: **LOW**
- Surrounding Area: **Roads**
- Infrastructure Failures: **NONE**
- Site Evaluation Date: **March 15, 2018**
- Notes/Comments: **The downstream end of the channel has accumulated approximately 4 feet of sediment.**
