Assessment Results

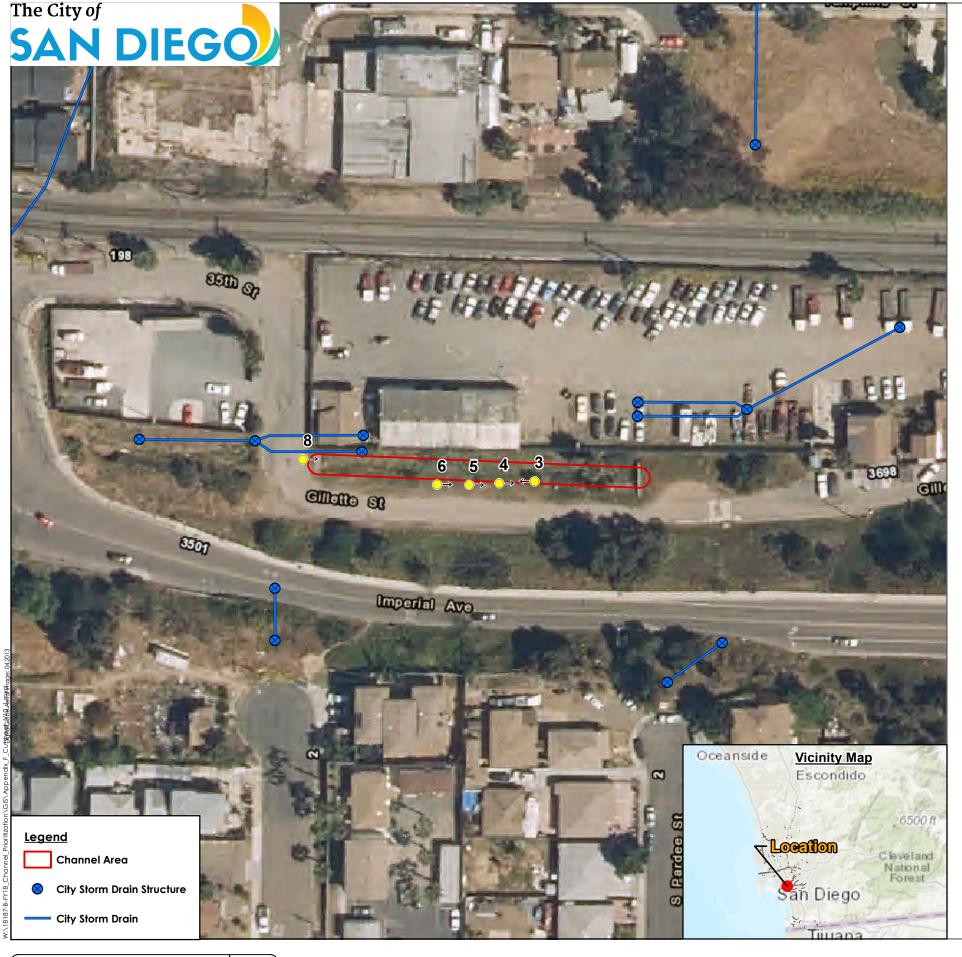
- Channel Prioritization Score: 50.5 out of 100
- Capacity Prior to Maintenance: Less than 2-year storm event
- Capacity After Maintenance (As-built Capacity):
 Less than 2-year storm event
- Clogging Potential: LOW
- Approximate Invasive
 Vegetation Coverage: HIGH
- Surrounding Area: Commercial
- Infrastructure Failures: NONE
- Site Evaluation Date: March 13, 2018
- Notes/Comments: This channel is relatively small and has a portion of channel with dense arundo.
