## SUNSET CLIFFS NATURAL PARK

Drainage Study

September 2012

**PREPARED BY**  
Dudek  
605 Third Street  
Encinitas, CA 92024  
800.450.1818  
[www.dudek.com](http://www.dudek.com)

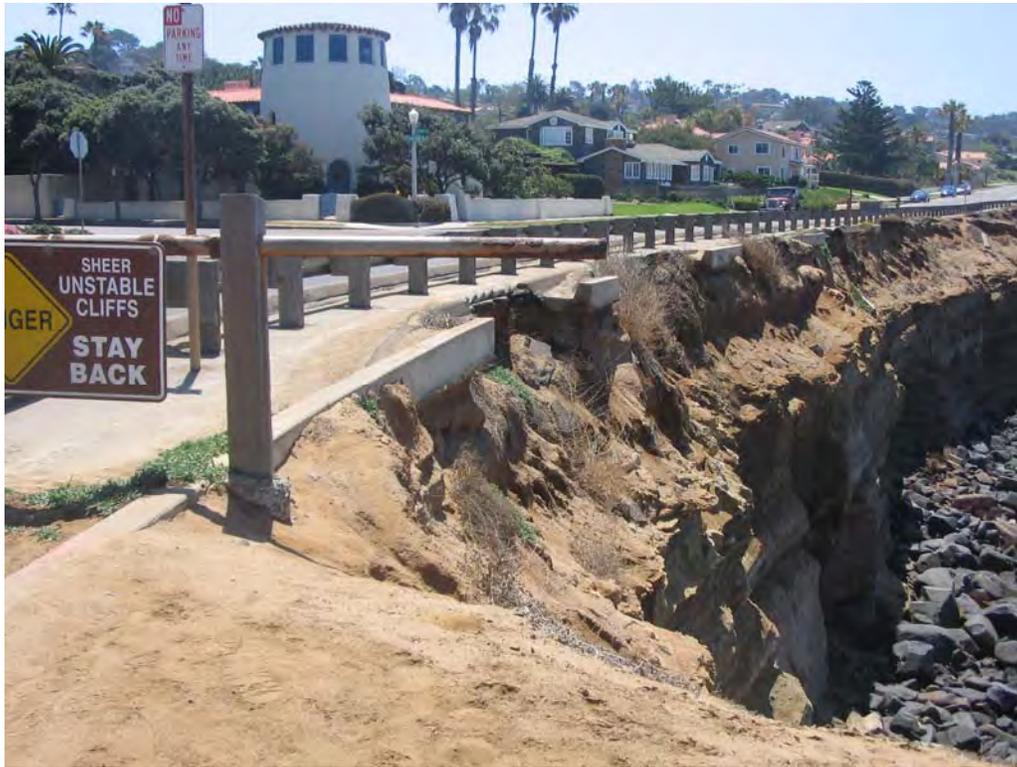
Photo 8 – Top of Bluffs, showing damage to curb, Site 7.

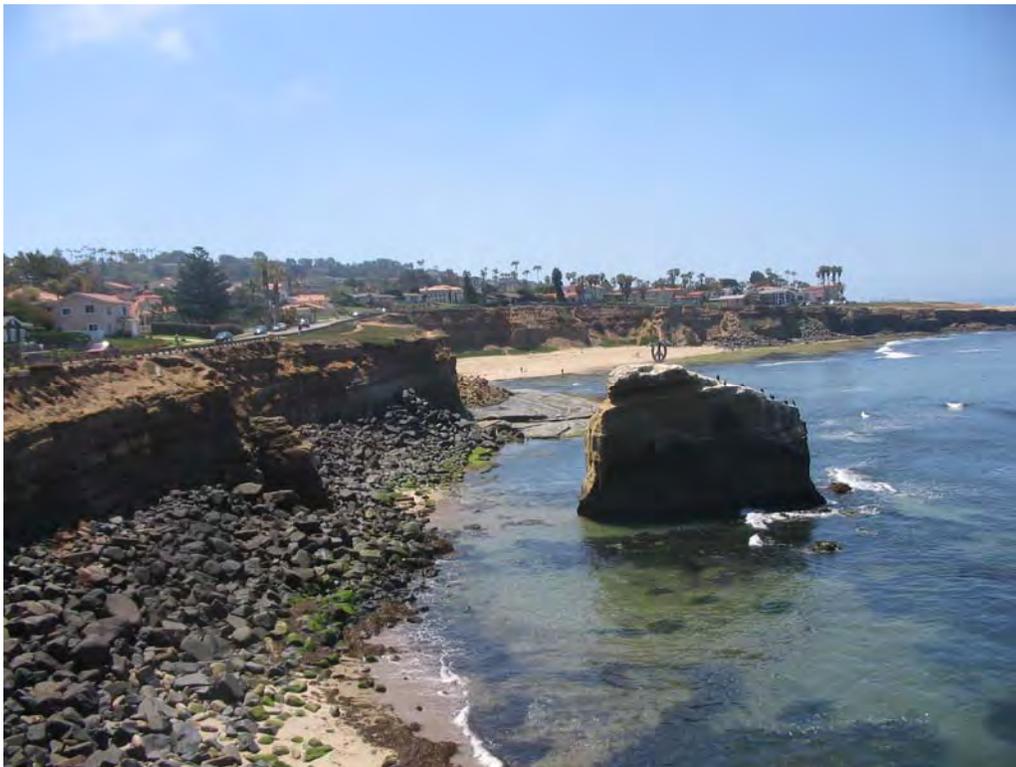
PH5: Site of the April 2007 Bluff failure fronting Dedi's house.

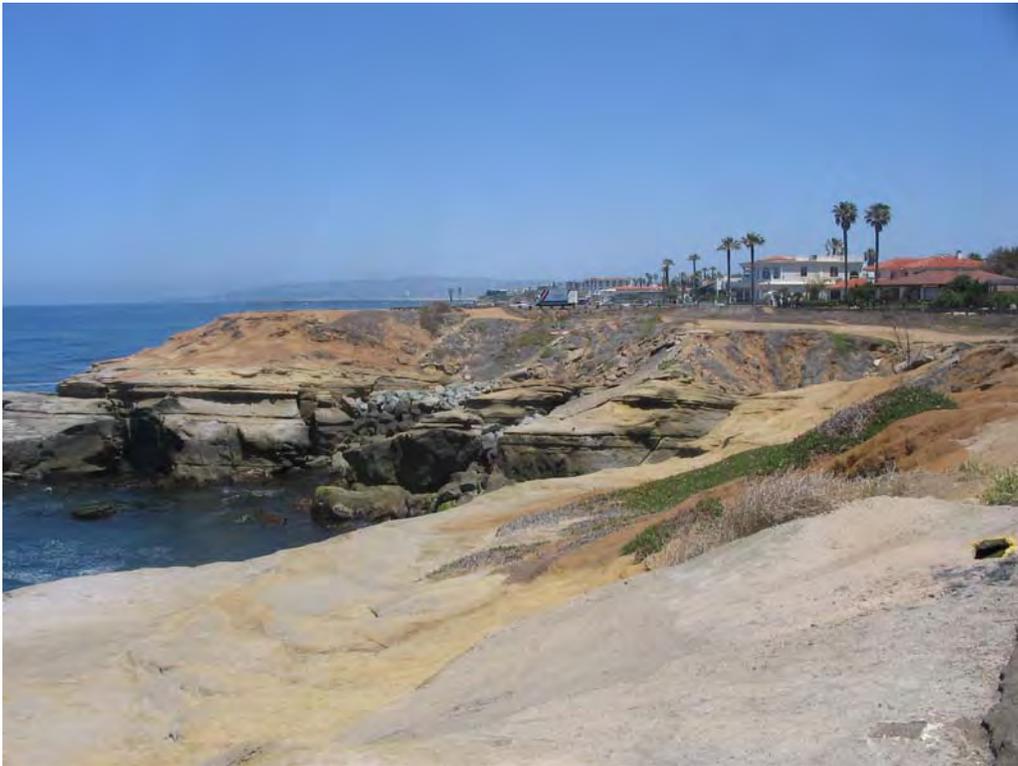
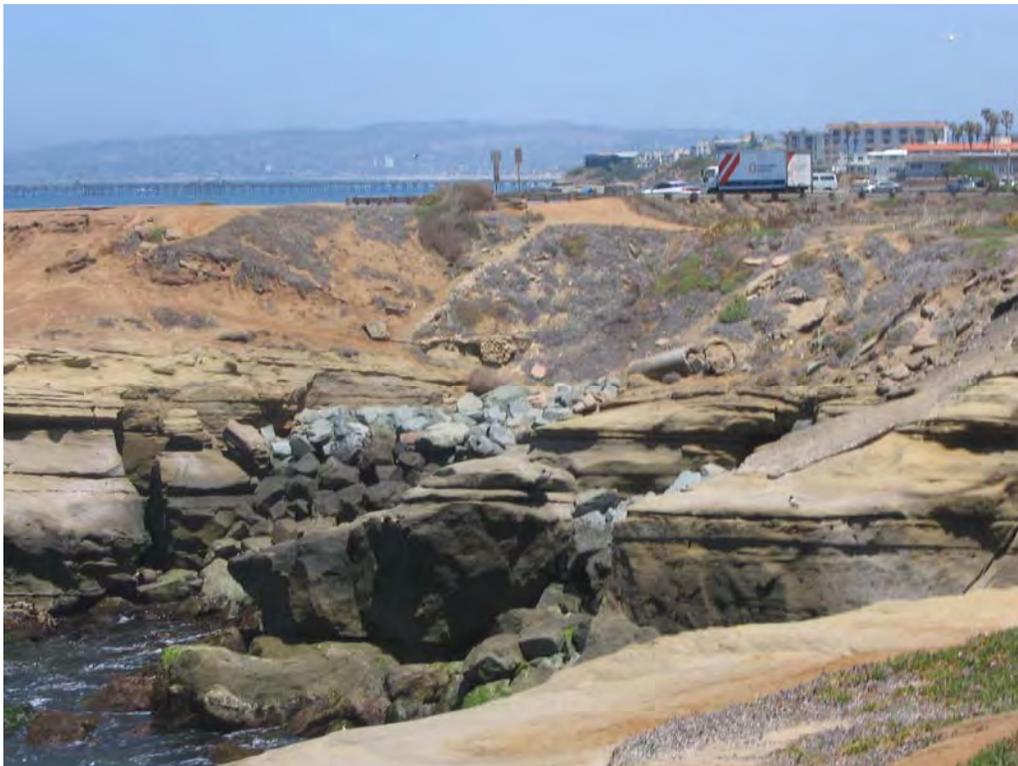
PH17/18: Fill on cliff face the end of Osprey.

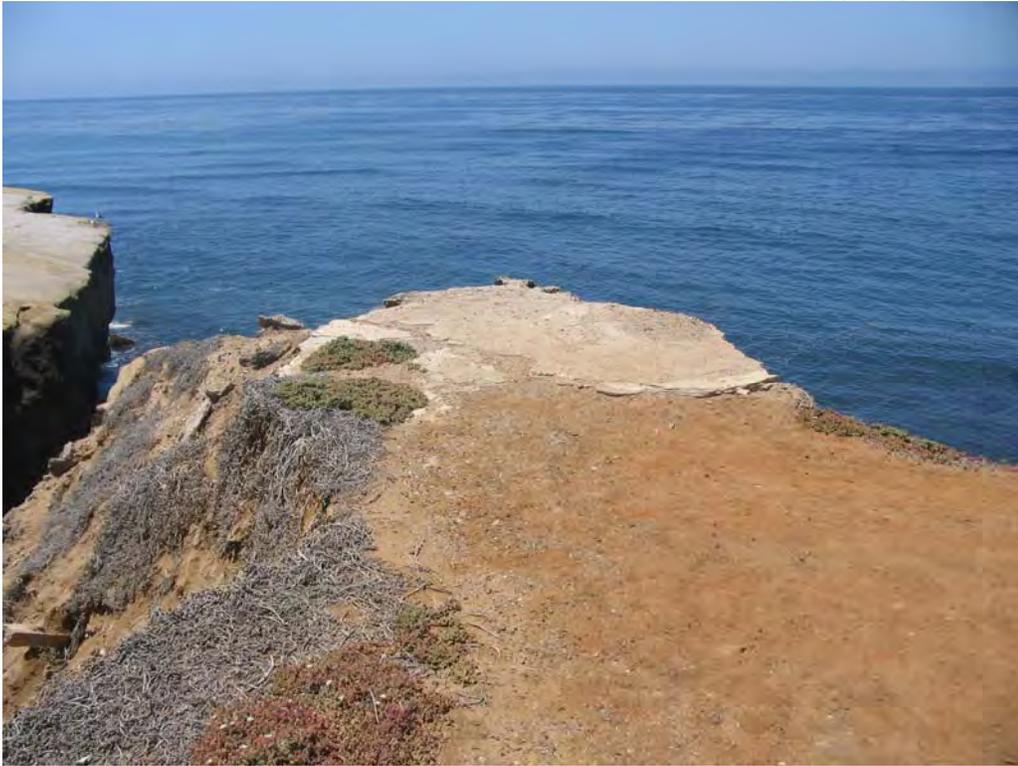
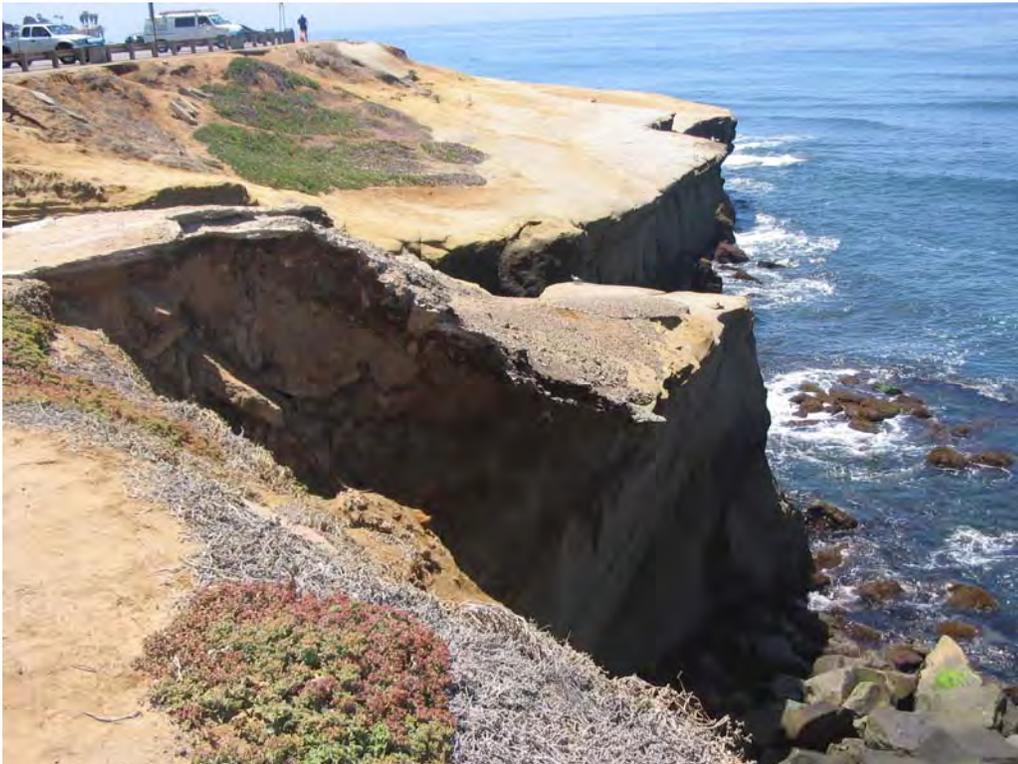
PH21/22: Another “failed” attempt to control runoff erosion of bluff, by pouring a concrete slab over the top of the point. These things need to be removed.

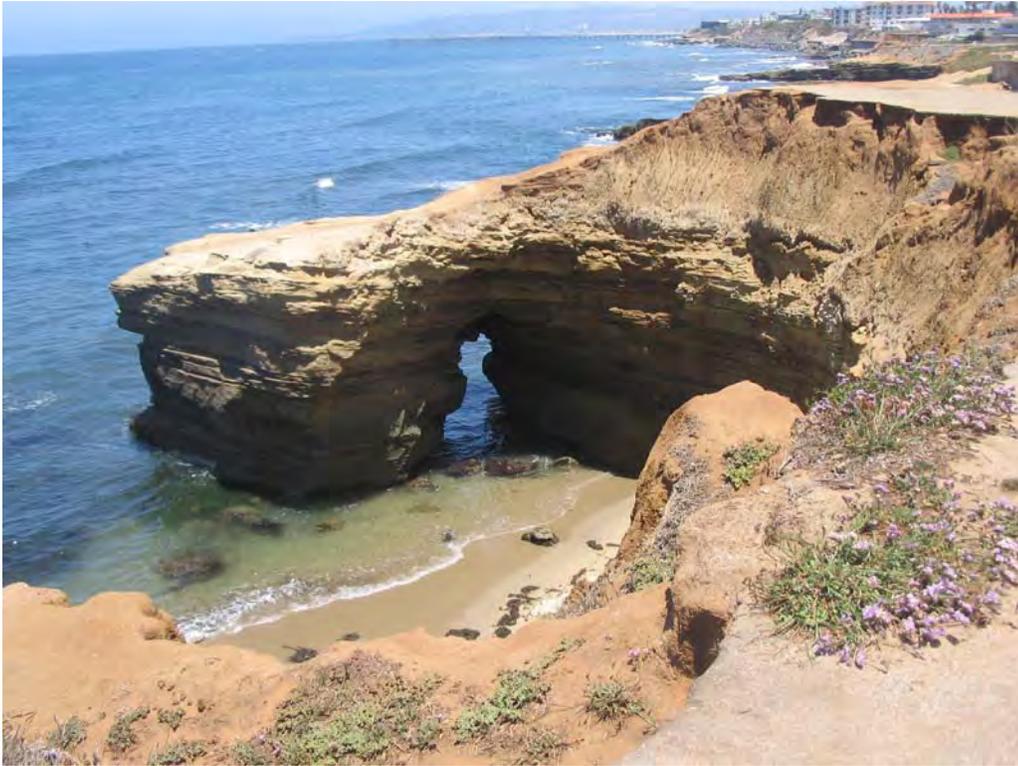
PH23: sea arch formed over last >20 years; caused by natural erosion (waves, wind).

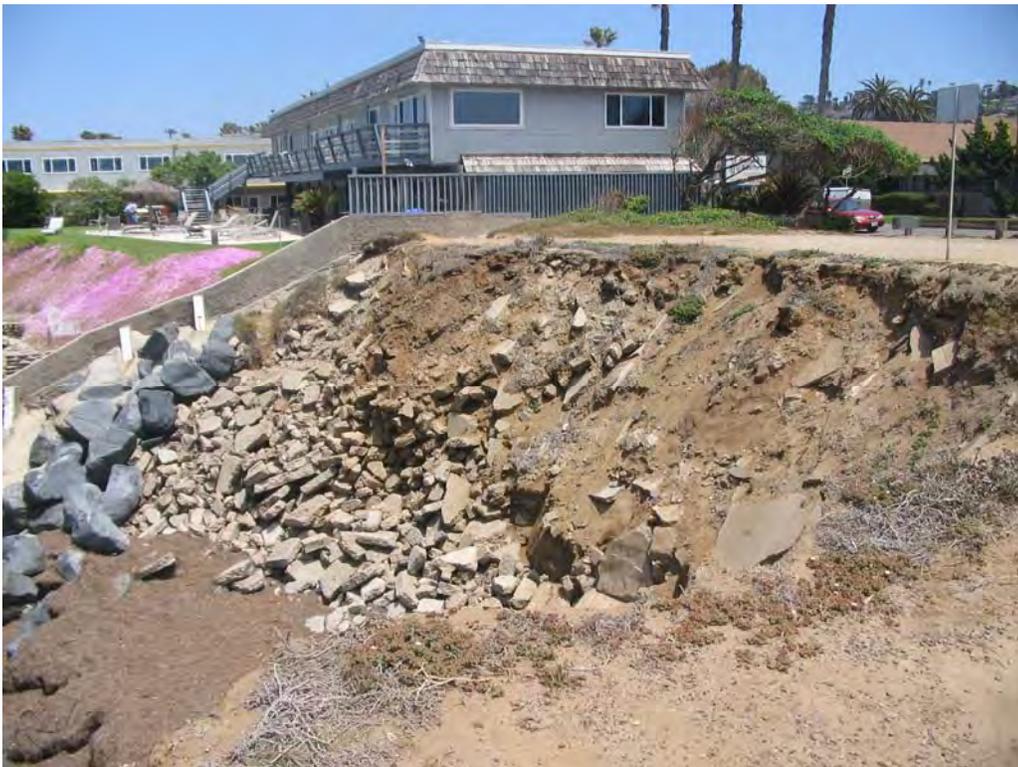
PH28: construction fill, concrete rubble. 1930 whole caved in and rubble fill was placed.

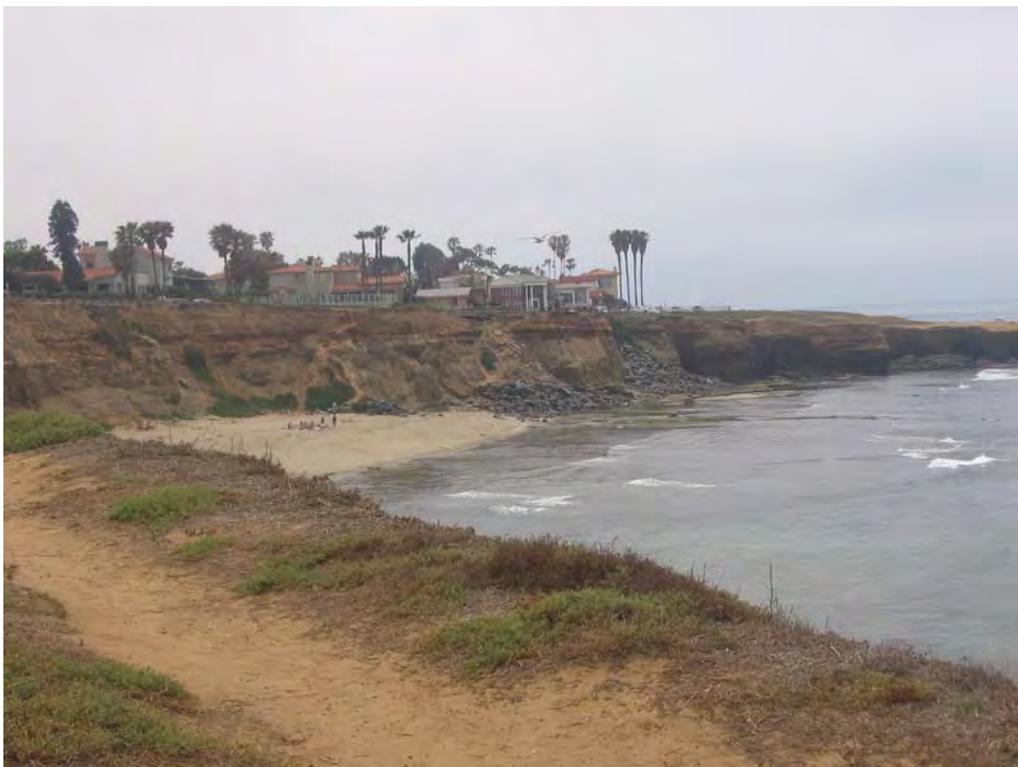
P33: No surf beach, no recommendations for beach access (no parking/restrooms/etc.) in Master Plan. However, it is a popular spot and foot traffic is causing erosion via paths and seeping water.

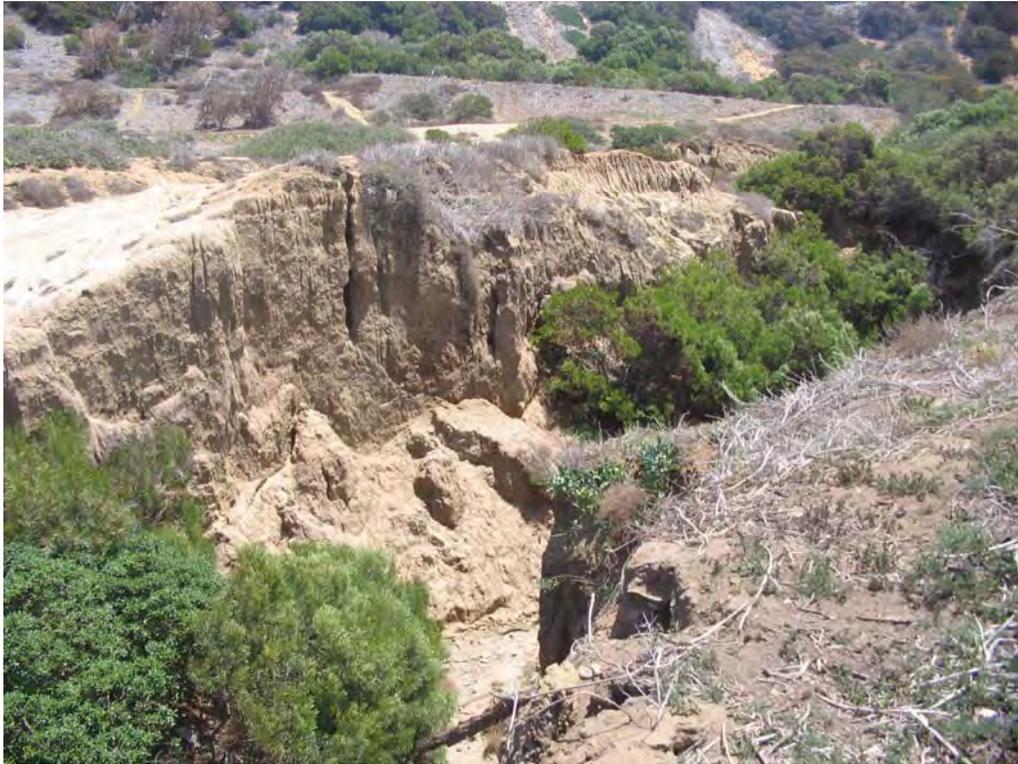
Grand Canyon (No man's Land). How to repair this erosion so park can be restored after new pipe is layed in the crevice?

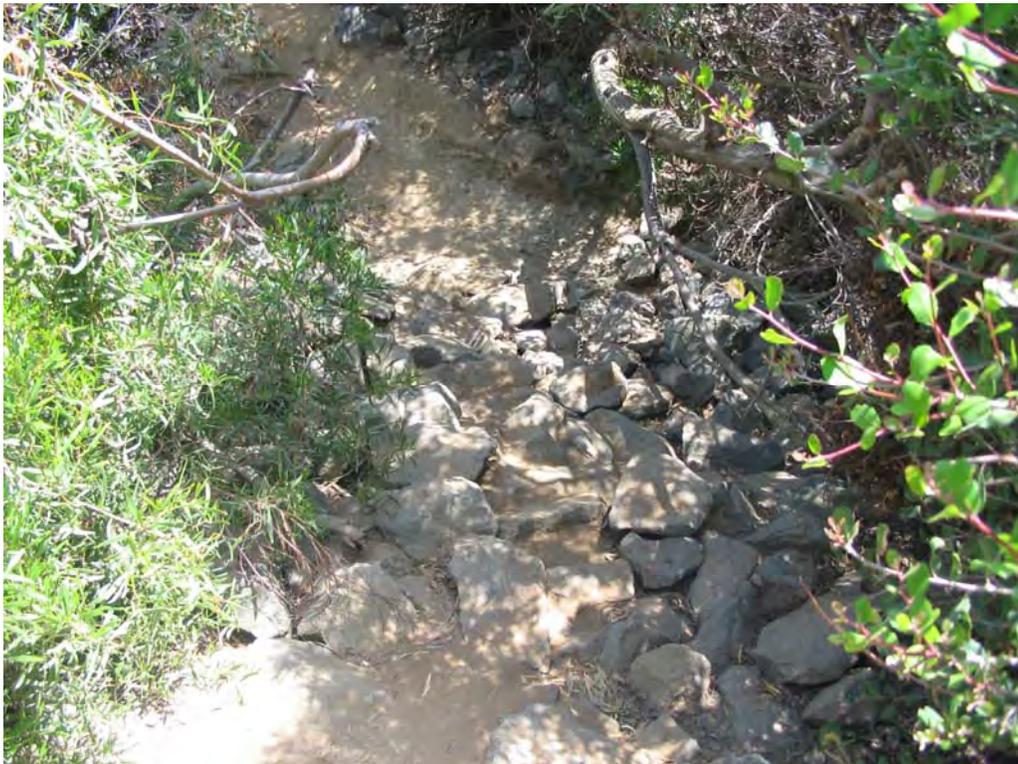
This is the sink hole described on Page 4 of this memo.

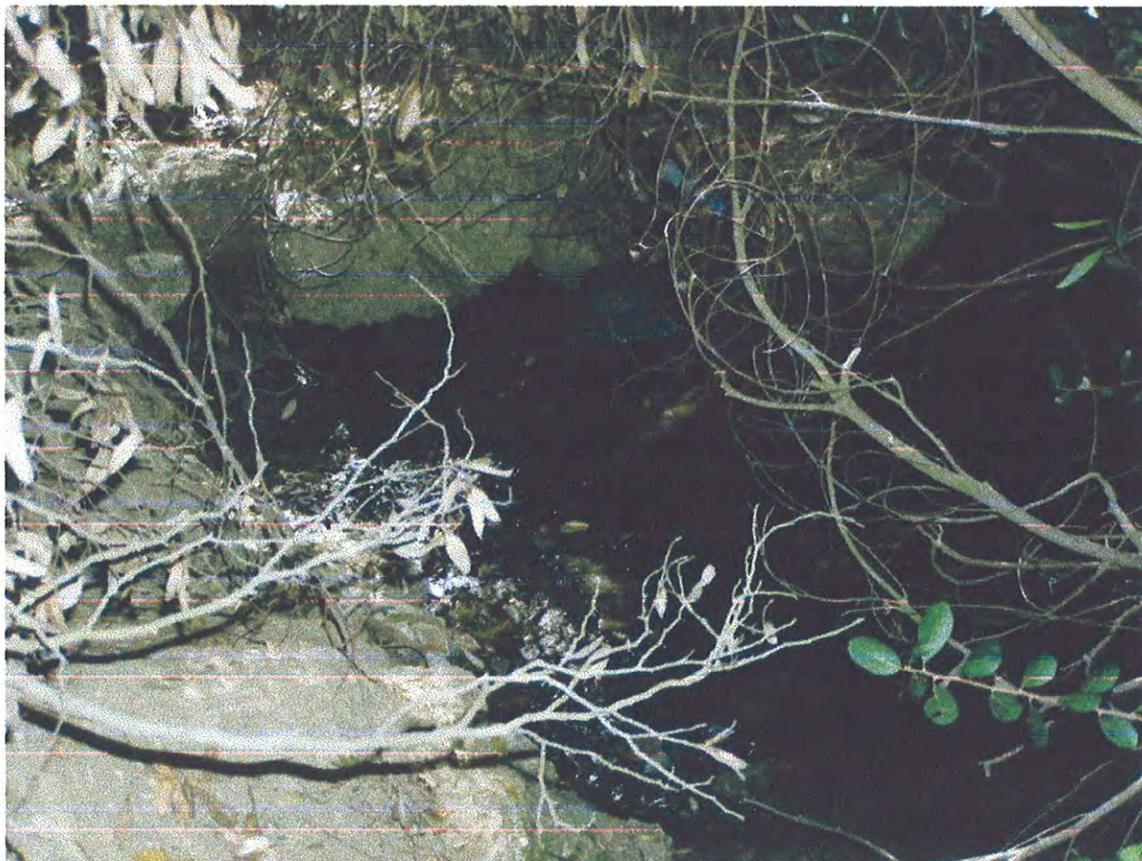
During periods of heavy rain, the 24 inch diameter outfall pipe, that is located where the white piece of pipe can be seen in the picture below, discharges over the pond and into the non-native shrubbery below that should be removed per the Master Plan.

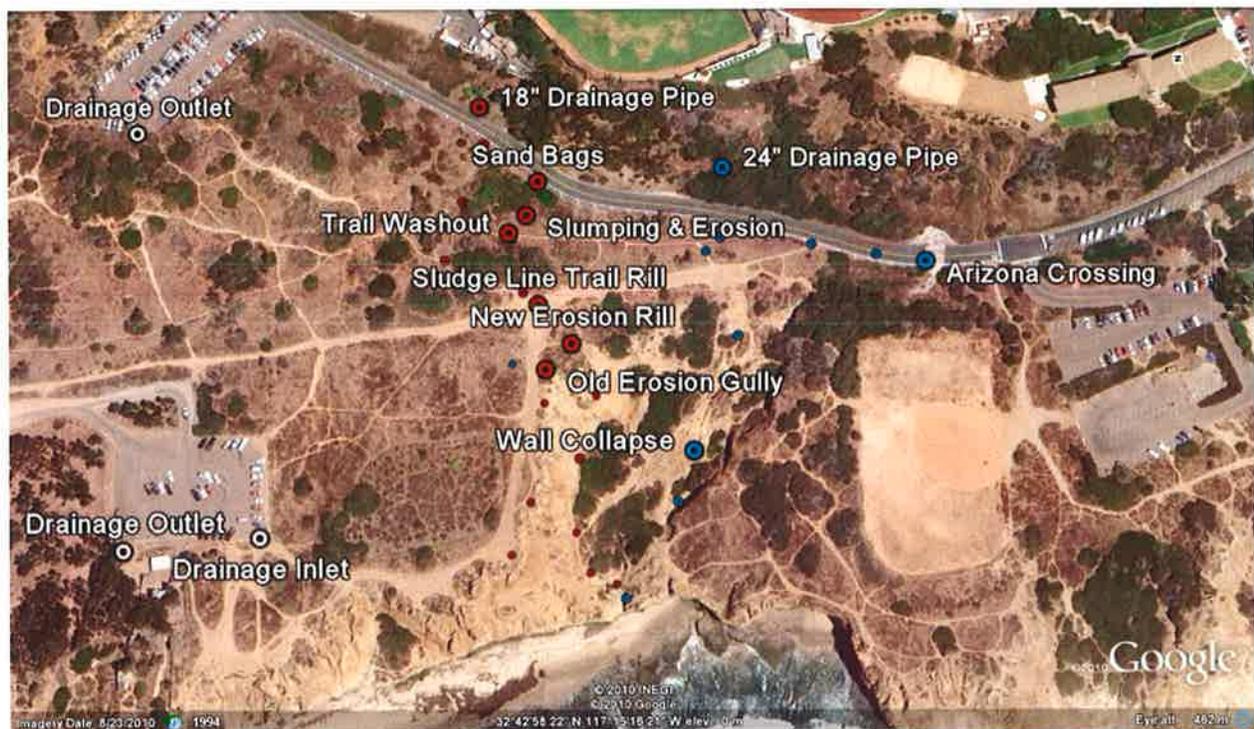
**Figure 3.** Areas in the Hillside Park where erosion and mass wasting problems can be corrected, by constructing curbs along the Western Loop Road. Features, both constructed and due to erosion, associated with discharge from the 18" drainage pipe are shown with red dots and those with the 24" drainage pipe with blue dots. The Lower Parking Lot's main features are shown in white.

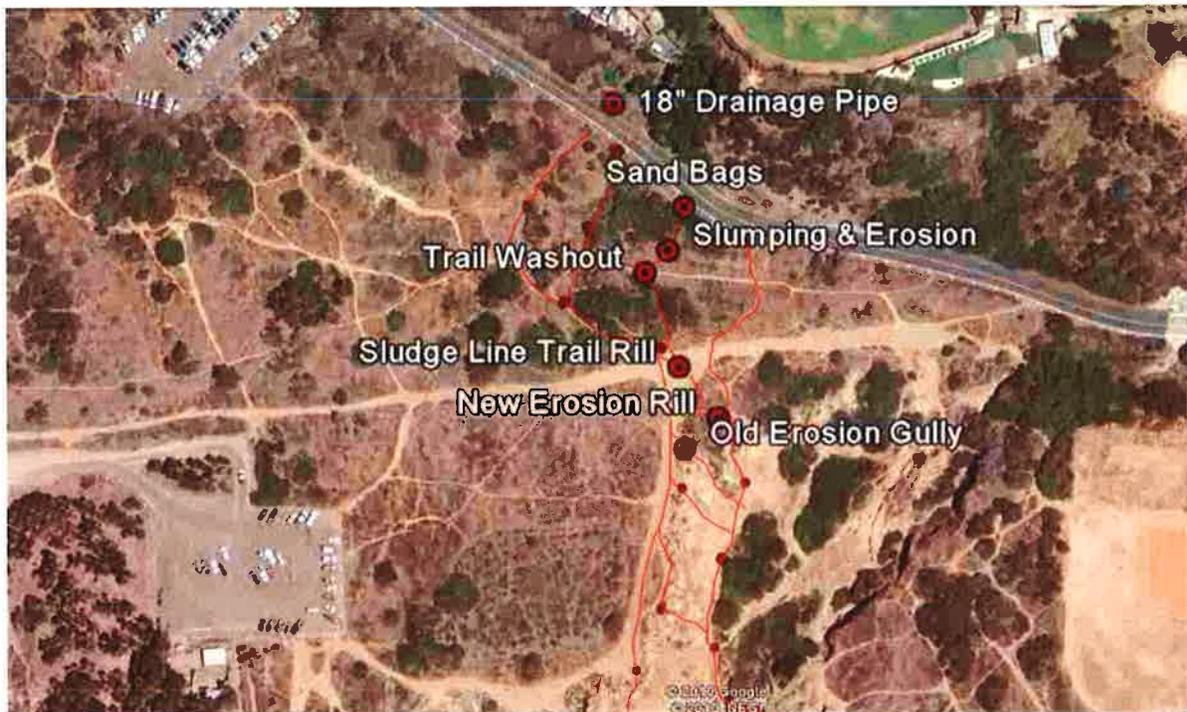
**Figure 6.** Runoff and erosion features associated with the 18" PLNU drainage pipe that discharges onto the Loop Road at the marked location. The large red dots show the location of features, and the small dots and streamlines show where evidence of watercourses transporting runoff that ponds on the Loop Road due to discharges from the 18" pipe can be seen after major rainfall events.

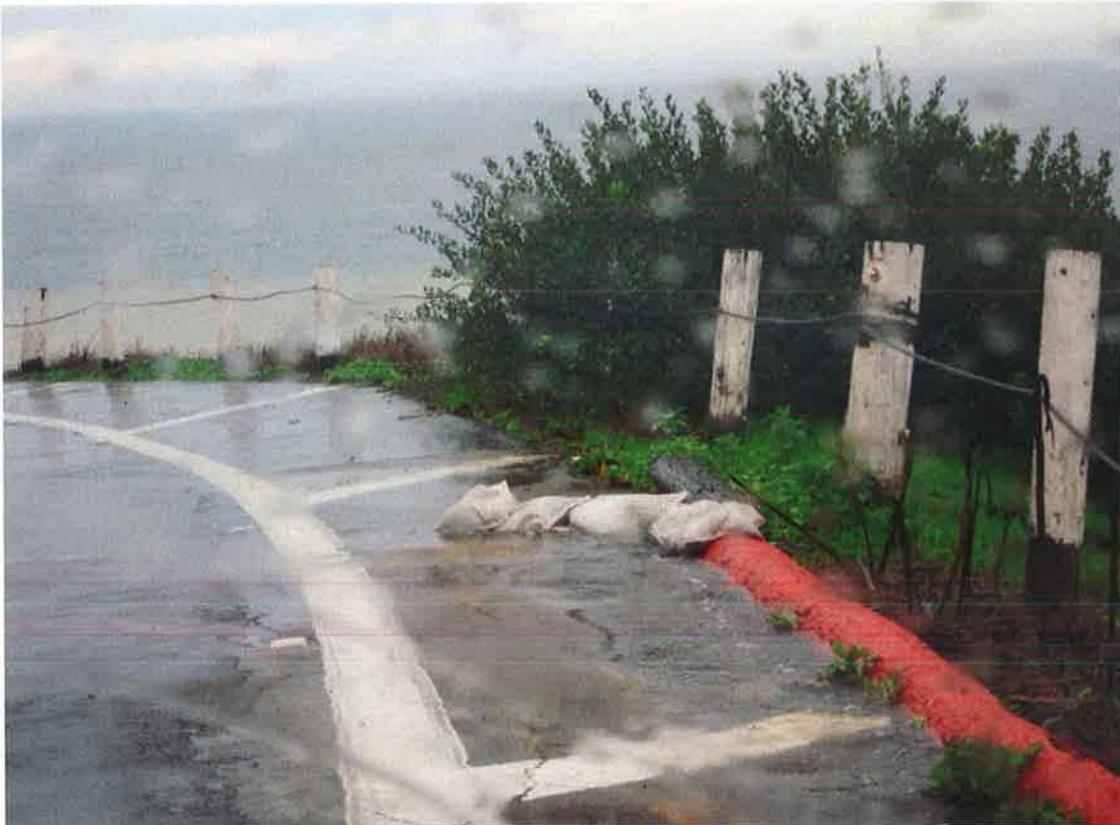
**Figure 8.** The curb down slope from the 18" storm water discharge pipe is only about 3" high in places, and ends at the sand bags. Runoff flows over the 3" curb and the area without a curb. It should be built up to 6". The runoff to this point does not include runoff from the PLNU 24" storm drain. The few sand bags seen, demarcate the location where there is no longer a curb on the western edge of the road, but the water flows off the road starting where the curb height is reduced to 3". A consistent 6" high curb placed along the western edge of the Loop Road would minimize water going off the road and onto parkland. Potholes and cracks are developing along the loop road, and these should be resealed to minimize seepage under the roadbed.

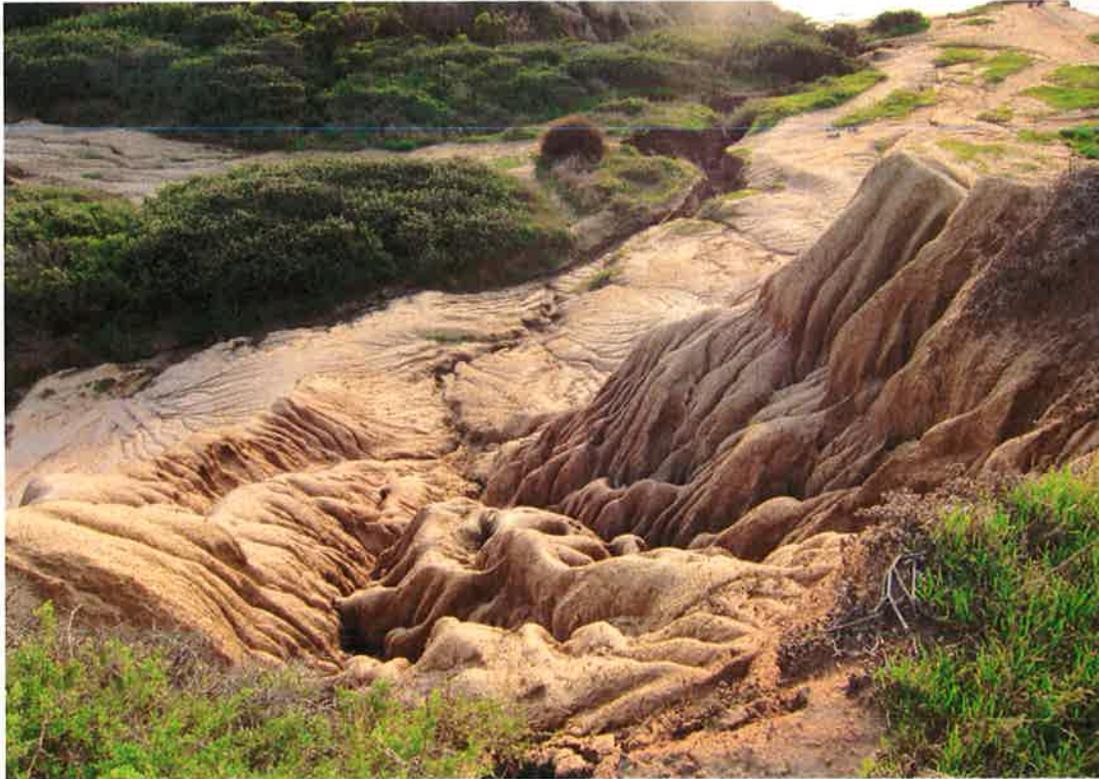
**Figure 18.** Further erosion on the western portion of the Badlands due to runoff from the 18" pipe. The runoff joins the erosion gully in the bottom which joins the runoff from Culvert Canyon before it exits over the cliffs. This damage to the park would not occur if curbs were added all along the Loop Road.

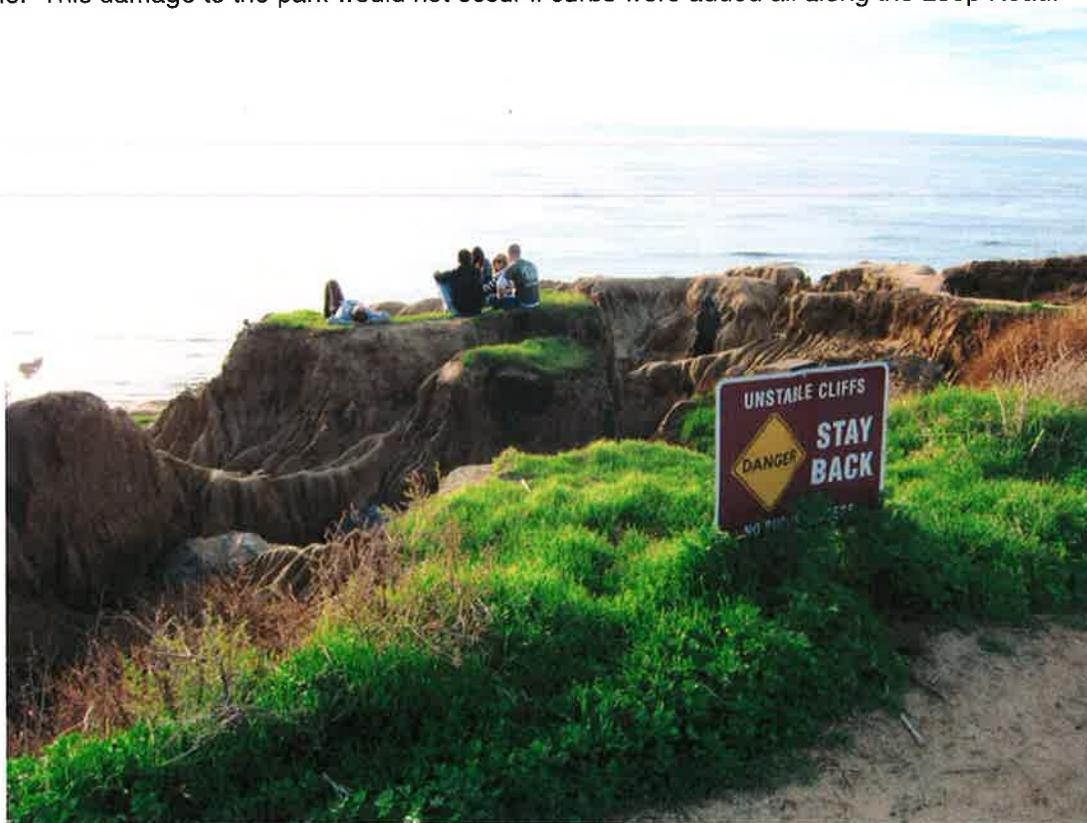
**Figure 19.** Runoff from both the 18" pipe and the Upper Parking Lot are likely responsible for this massive loss of cliff.

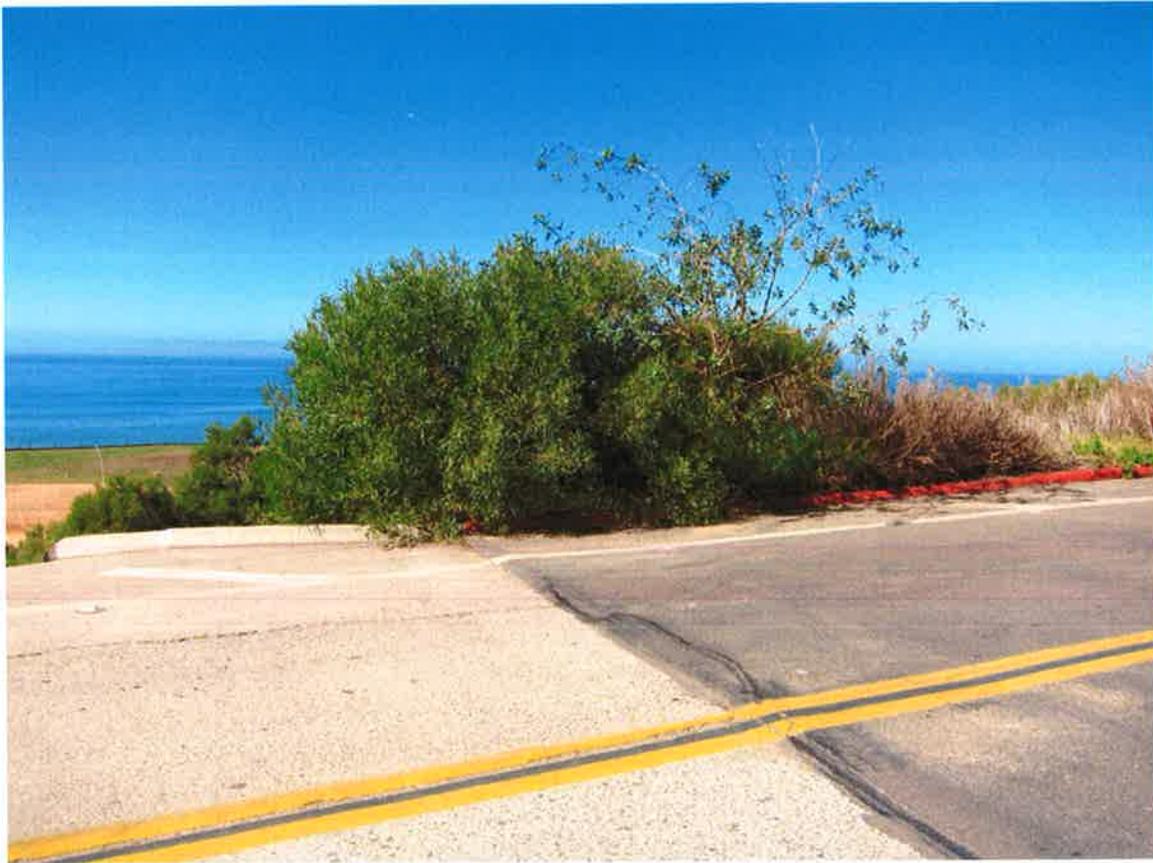
**Figure 24.** Due to low curb height at the northern edge of the Loop Road Arizona Crossing, runoff during moderate to high flow periods tends to flow around the northern edge of the Arizona Crossing apron and undermine it. The black Acacia branches cover the point where the runoff goes off the road.

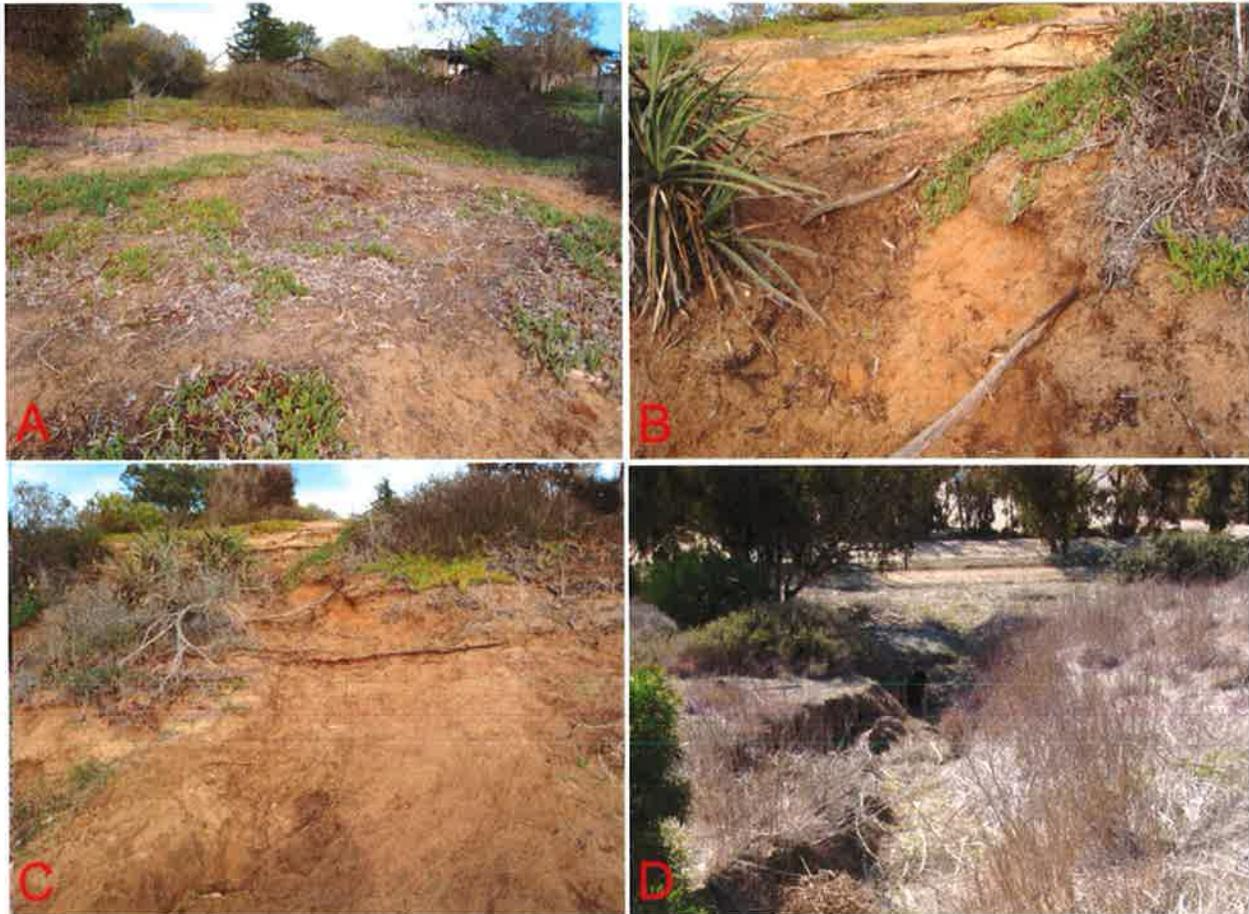
**Figure 27.** Area of Park where pedestrian traffic appears to have denuded the hillside (see A, B and C). Without a good cover of native plants, rainfall doesn't sink into the ground resulting in runoff generation that is causing erosion down slope, just before the runoff enters the Lower Parking Lot (see D).

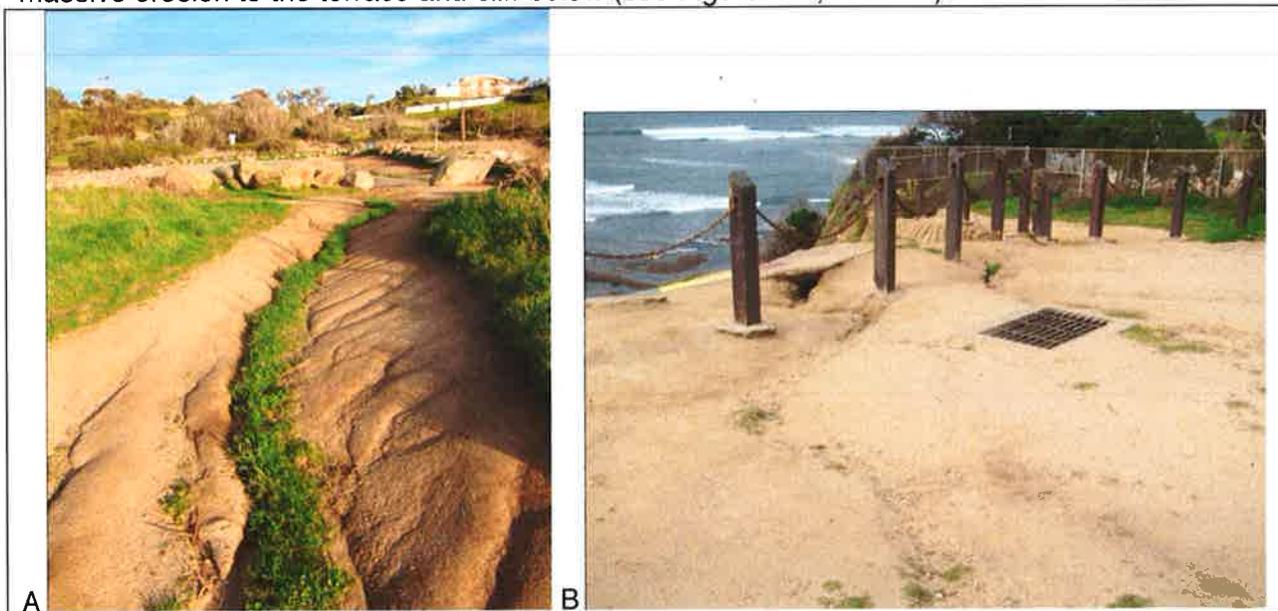
**Figure 29A & B.** Runoff gully from the southwest corner of the Lower Parking Lot leading an inlet on the bluff above the Gunite swale. The inlet and swale are higher than the erosion gullies cut around them, therefore the runoff continues to bypass the drainage system and is undermining the Gunite drainage swale. These maintenance problems should be addressed before the system is irreparably damaged.

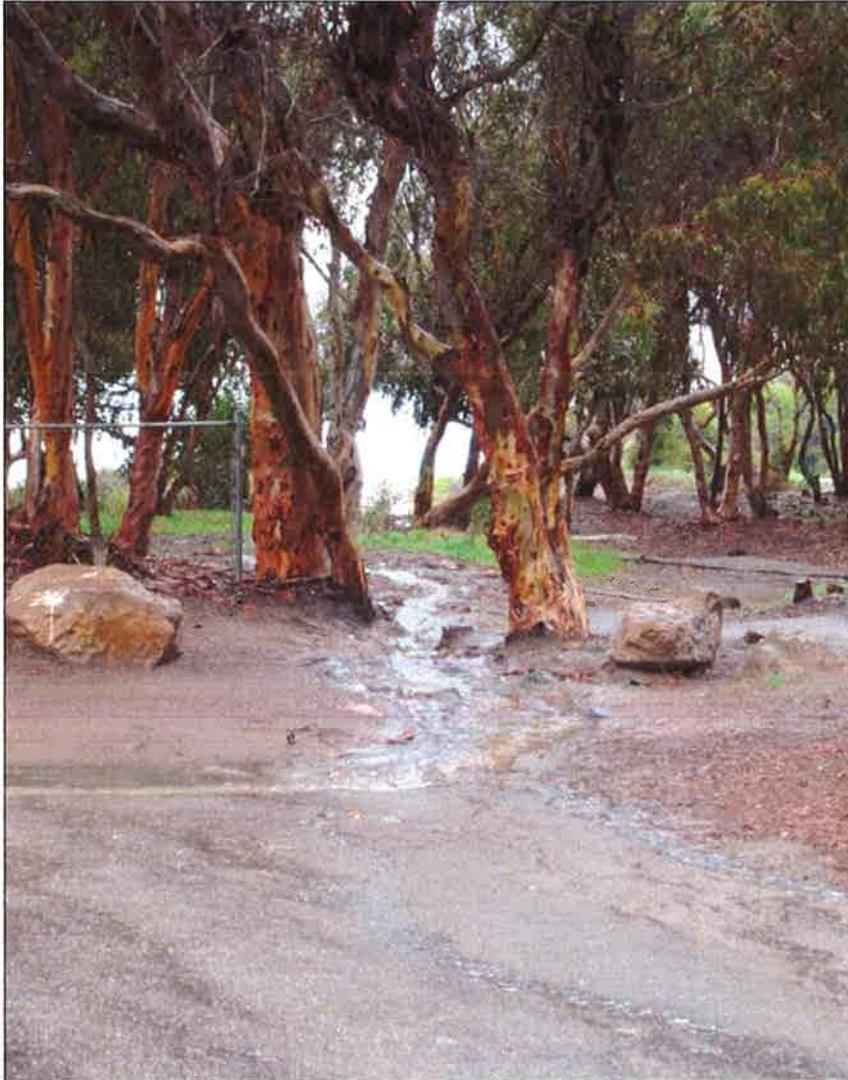
**Figure 34.** Runoff exiting the northwest corner of the Lower Parking Lot.
