THE CITY OF SAN DIEGO
Historical Resources Board

DATE ISSUED: July 11, 2013 REPORT NO. HRB-13-038

SUBJECT: **ITEM #9 – 1515 West Lewis Street**

Photo Exhibit – Porch Alterations Observed by Staff – 1515 West Lewis Street

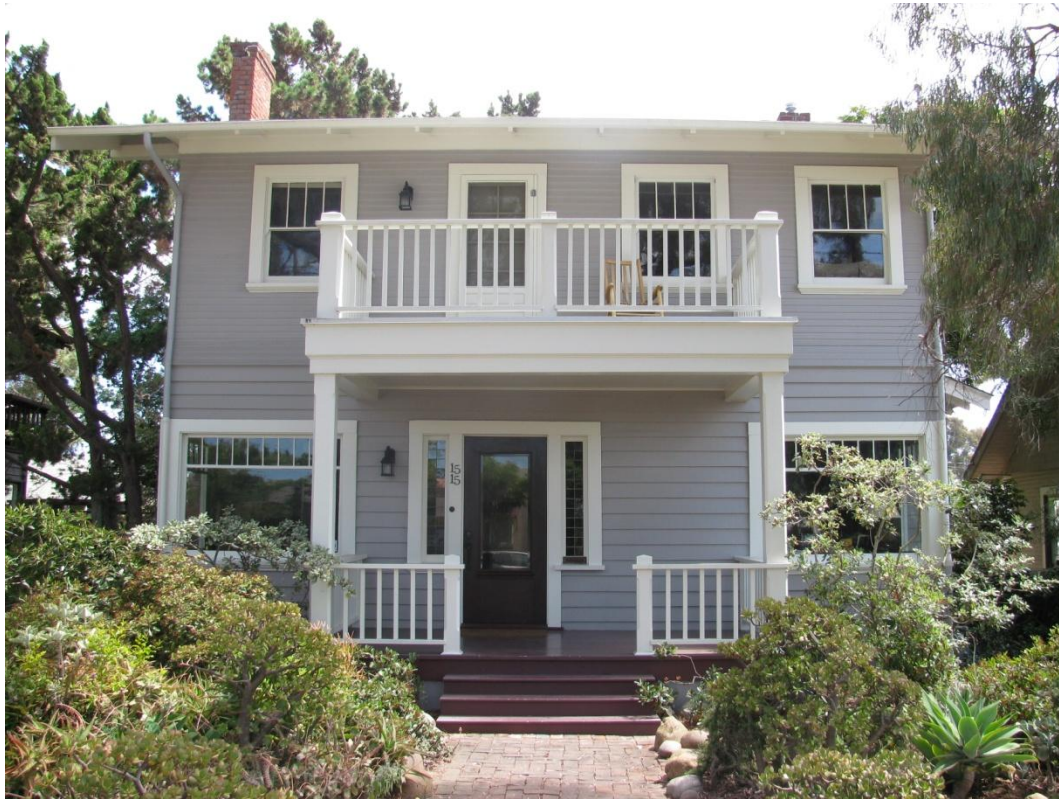
Although not addressed in the applicant's report, historic photographs and field conditions observed by staff that include scarring and replacement siding reveal a significant alteration to the front elevation that drastically impacts the building's integrity as it relates to the 1910 date of construction and period of significance (Attachment 1). The front porch has been modified at least twice – once between the 1940s and 1951, and again after the late 1960s. The original front porch was in fact much wider and covered a greater portion of the front elevation than the porch that exists presently. Originally, the front porch covered a portion of both of the first story windows in the front, and spanned nearly the entire length of the 28-foot façade. Today, the porch no longer covers the front windows and only covers half the length of the façade. The 1921 Sanborn Map also shows the original front porch with a much longer footprint. Furthermore, the porch headers originally sat lower and the balustrade was of wood lap siding rather than of a more open design as seen today. Although likely, it can only be speculated that a second floor balcony originally existed above the front porch. The alteration of the front porch footprint and design is a significant adverse impact to integrity of design, materials, workmanship and feeling.

North (front) elevation, June 2013

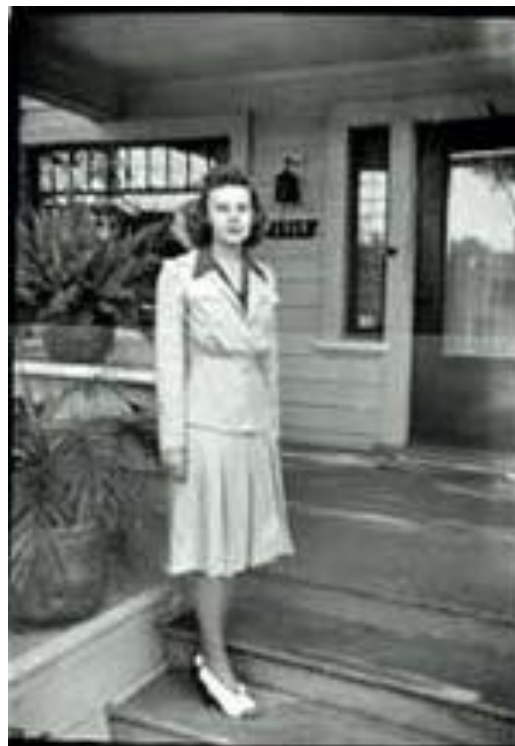
The loss of the original front porch is an alteration to a character defining feature that significantly impairs the design, materials, workmanship and feeling aspects of integrity as it relates to the 1910 date of construction. The front porch of the subject building is integral to its design, and the proportions and massing of the façade are now considerably different from their historical appearance. As a result, the building can no longer convey its historic significance. Therefore, staff does not recommend designation of the subject property under HRB Criterion C due to a lack of integrity.

Front porch – circa 1940s

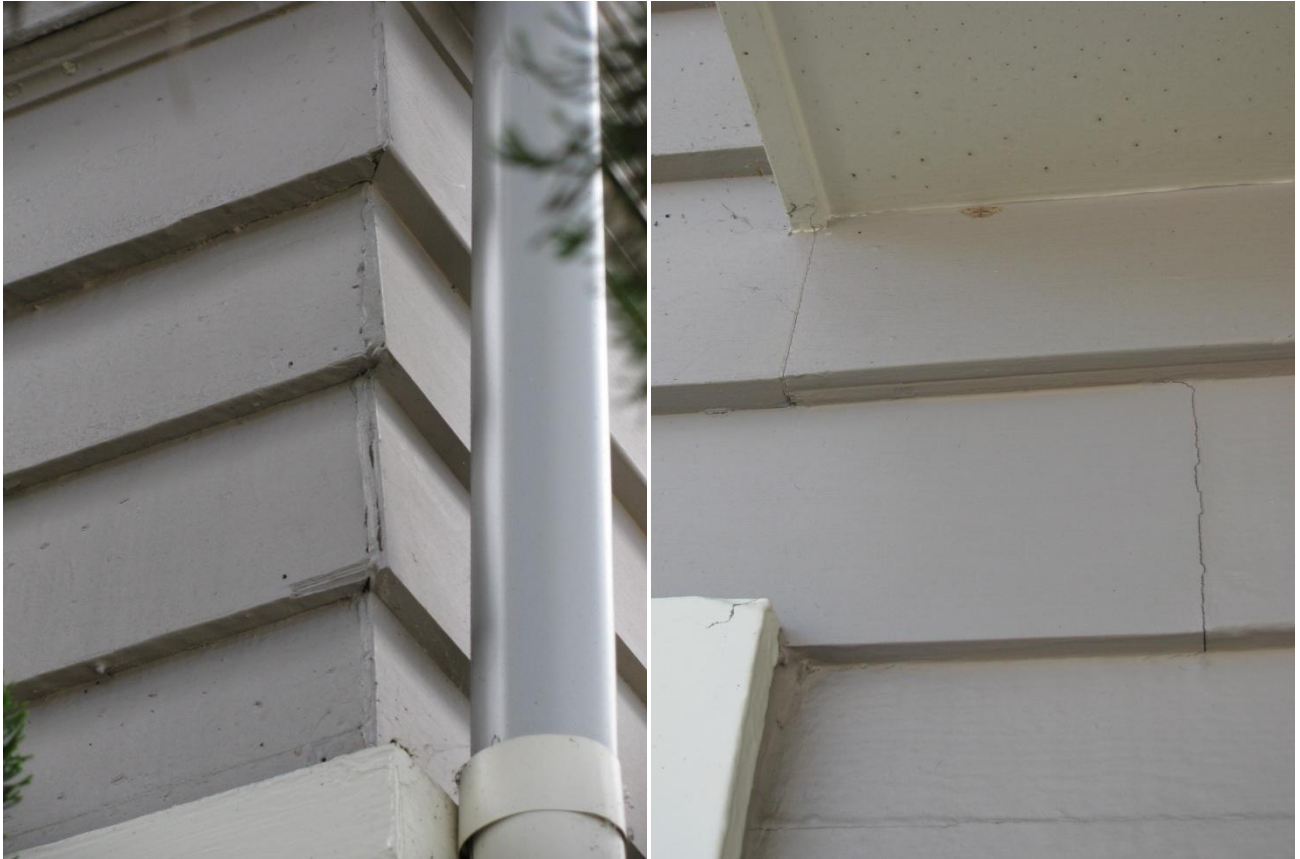
New siding above left side 1st story window, June 2013

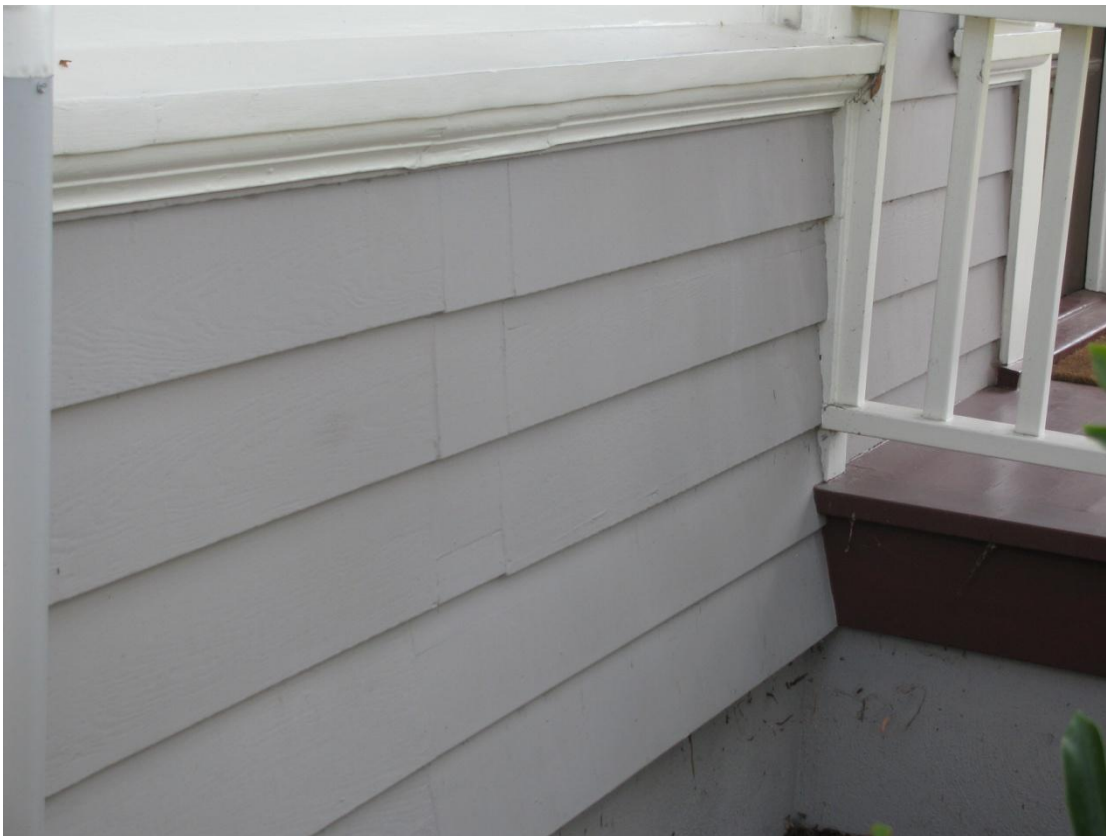
Scarring below left side 1st story window, June 2013

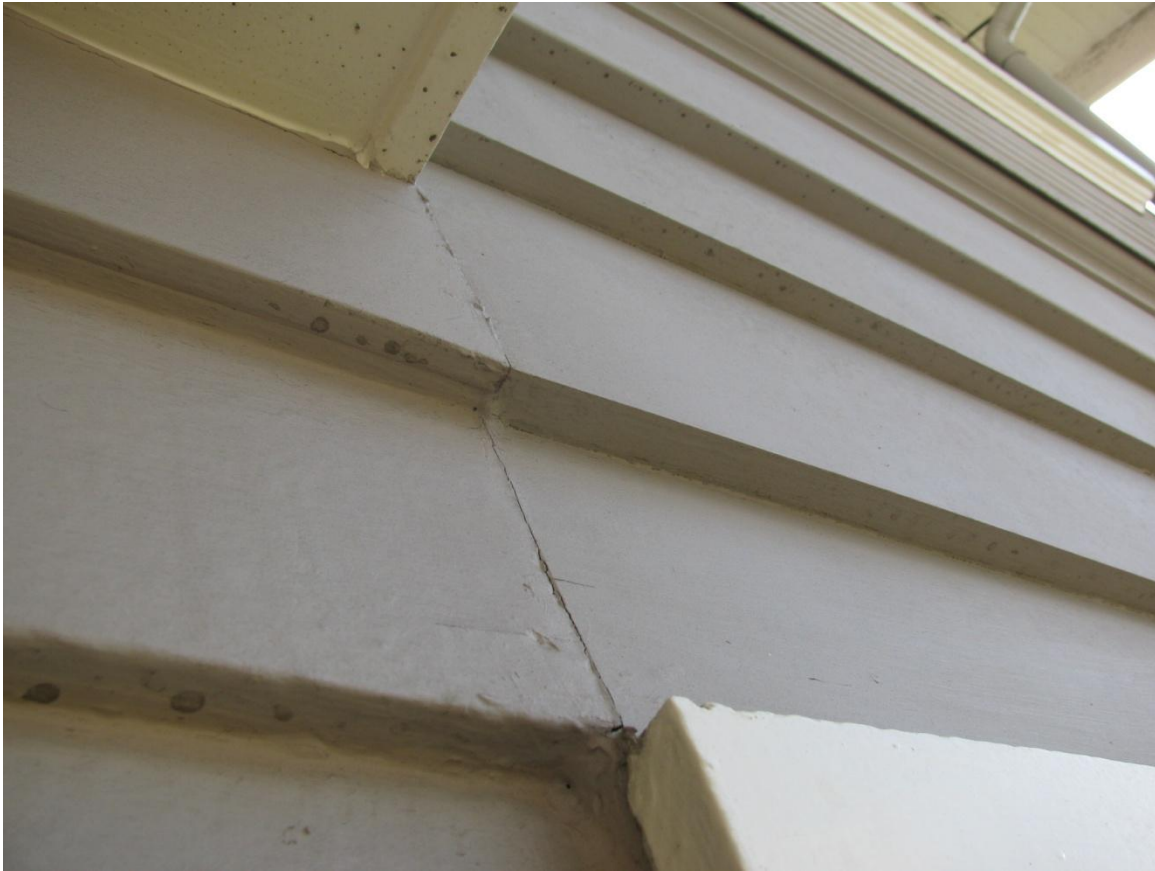
New siding above right side 1st story window, June 2013

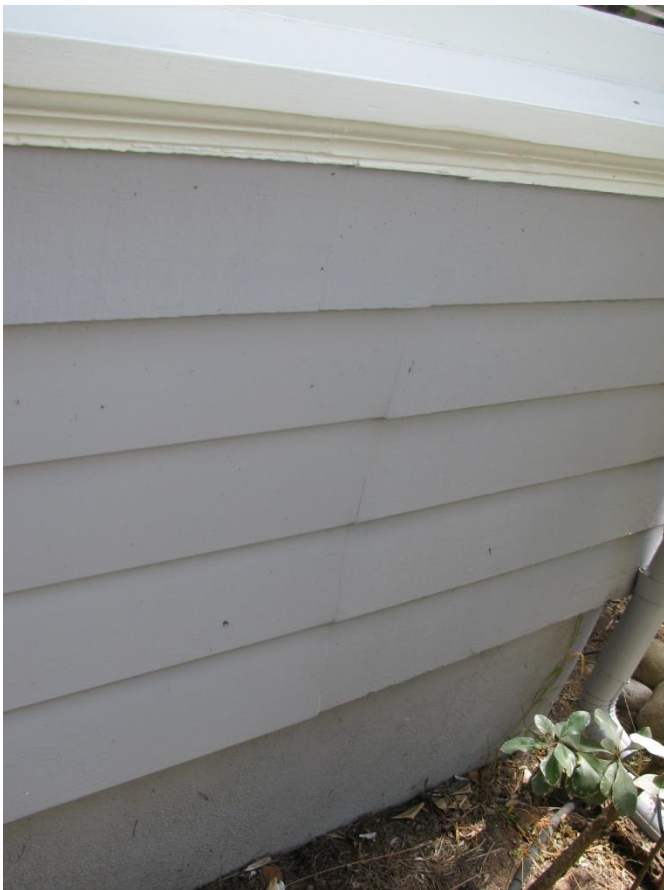
Scarring below right side 1st story window, June 2013
