THE CITY OF SAN DIEGO

MEMORANDUM

SUBJECT: Item 5 – 4186 Jackdaw Street

DATE: June 25, 2009 REPORT NO. HRB-09-040

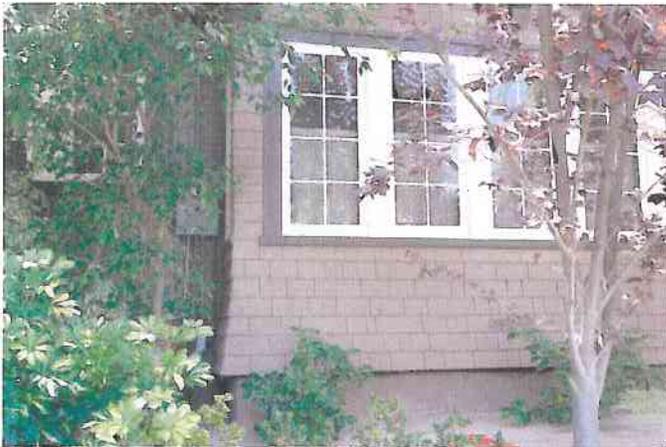
As noted elsewhere, a previous owner had replaced the original shingles and vertical slats with asbestos shingles some decades ago. The current owner subsequently replaced those asbestos shingles with wood shingles. The current shingles are consistent with other Melhorn homes of the period and specifically with the nearby 1913 Melhorn King House (HRB #318) which has a similarly flared foundation (see photos below).

Left: 3201 Washington Place

Bottom: 4186 Jackdaw

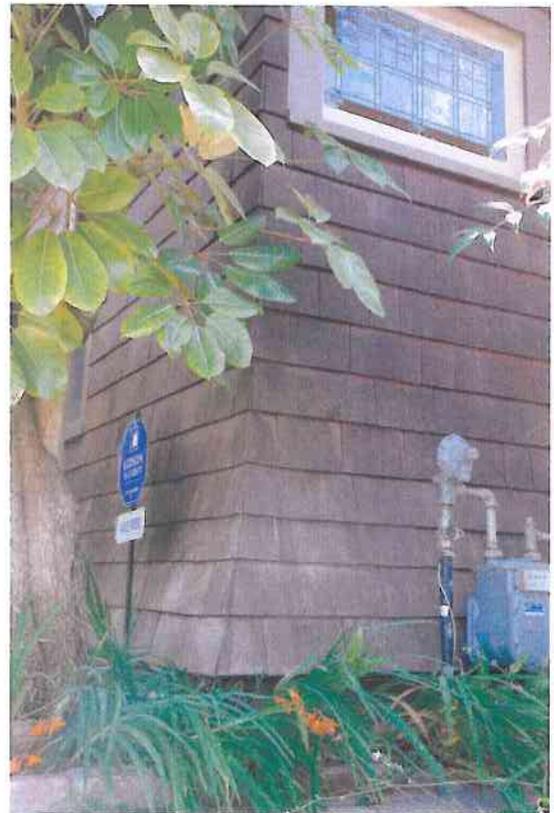
Staff also notes that the current siding includes a band of decorative circular shingles. The current owner recognizes that as a designated home this property would, in future, require siding and slats similar to those in the Stineman photo.

For the present, it should be noted that only three or four feet of this decorative band is visible from the street. And given the darkness of the wood, the decorative band is difficult to see and certainly has little affect on the home's overall appearance.

Almost all of the durable, original fabric (windows, doors, and fascia) on this home remain intact and in excellent condition. Nondurable fabric (roofing, siding, and paint) have been replaced, but this should not disqualify the home from designation.

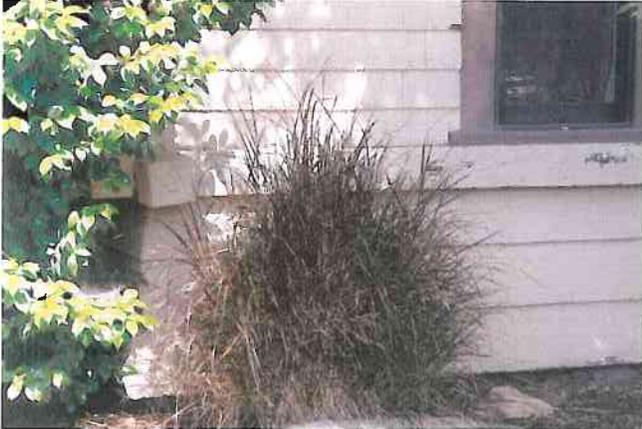
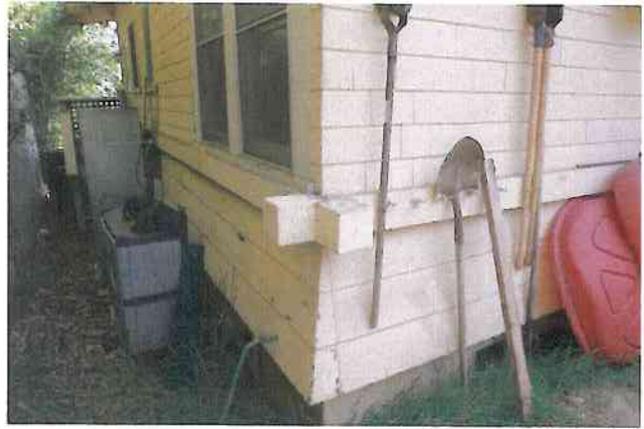
Staff notes the absence of horizontal wood boards above and below the windows. This again relates to difficulties in replacement of the non-durable shingles and slats. These boards are superficial fascia. Similar boards can be seen on a neighboring Melhorn home at 4201 Jackdaw. As can be seen in the attached photos (photos #2) the boards are attached to the surface of the wall. These are simple squared timbers which could be easily replicated when the current siding needs replacement.

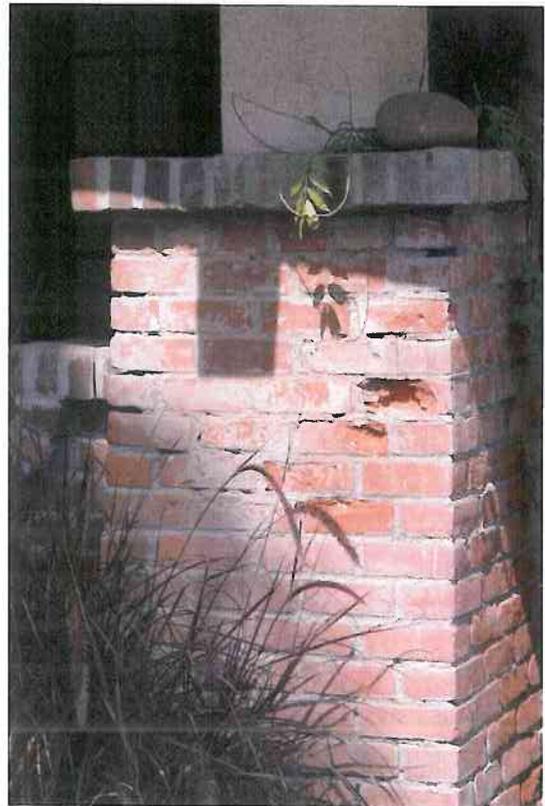
Staff notes that the brick chimney and porch columns are currently painted, but appear unpainted in the Stineman photo.

This paint has almost certainly helped preserve the original brick. Compare again the neighboring Melhorn home at 4201 Jackdaw. This porch is very similar in style and construction. It was built at the same time, perhaps from the same batch of brick. However the bricks and mortar at 4201 Jackdaw, never having been painted, are so badly eroded, that they have required replacement (please see photos to the right).

The owner of the candidate house, himself a builder, believes removing the paint would expose the original brickwork to damage.
