APPENDIX C
Treatment Plan

TREATMENT PLAN

<p>PROJECT: CASA DE LOS AMIGOS</p> <p>HRB# 1481 6110 CAMINO DE LA COSTA LA JOLLA, CA 92037 357-141-05-00</p> <p>PROJECT #: 106610</p>	<p>ARCHITECT: JONATHAN SEGAL FAIA</p> <p>3000 UPAS STREET SUITE 101 SAN DIEGO, CA 92104 619-993-6269 www.jonathansegalarchitect.com</p>	<p>DATE: 07/2023 10:30AM</p> <p>SCALE:</p> <p>COVER SHEET</p>	<p>TP.0</p> <p>COVER SHEET</p>											
	<p>REVISIONS:</p>

6110 Camino De La Costa
Casa De Los Amigos
HRB #1481
TREATMENT PLAN
May 5th 2024

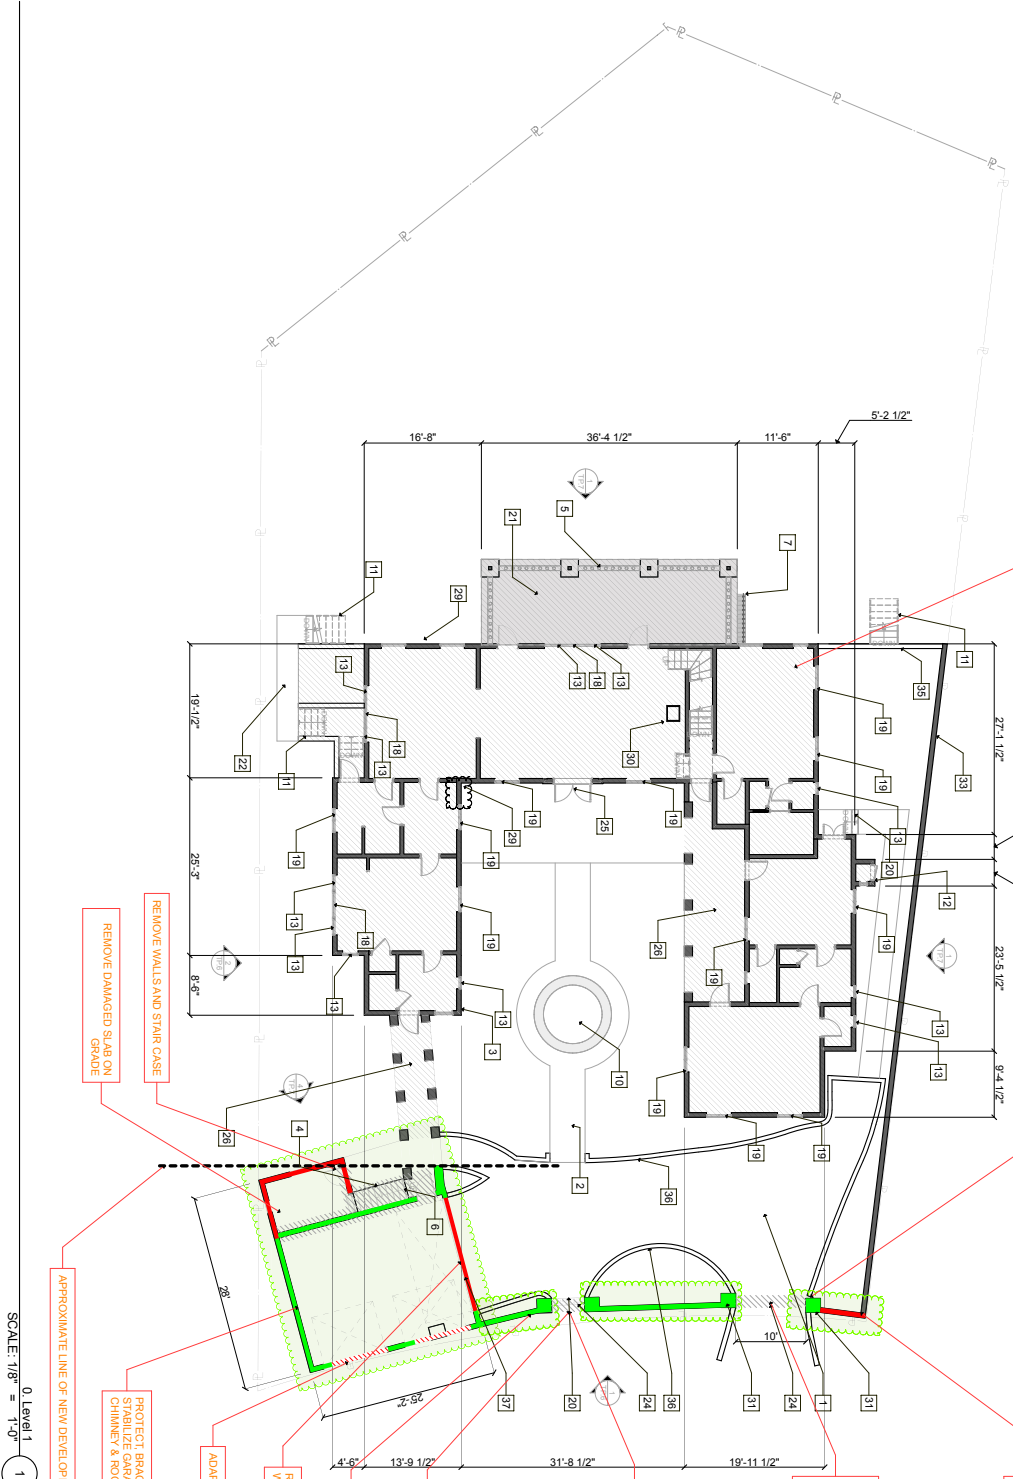
0 Level 1
 SCALE: 1/8" = 1'-0"

REMOVE WALLS AND STAIR CASE
 REMOVE DAMAGED SLAB ON GRADE

REMOVE WALL BEYOND GARAGE ENTRY CORNER LANDSCAPE OR FENCE PER LOP GUIDELINES

PROTECT BRACE AND STABILIZE IN PLACE RESTORE EXISTING STUCCO

REMOVE NON-ORIGINAL GATE AND REPLACE WITH STYLE GATE PER TREATMENT PLAN

REMOVE NON-FERROUS GATE AND REFERENCE WITH ORIGINAL STYLE GATE

PROTECT BRACE AND STABILIZE ENTRY ROOF STRUCTURE & CASA DE LOS AMIGOS GRANIO

PROTECT BRACE AND STABILIZE IN PLACE & RESTORE EXISTING STUCCO

REMOVE GARAGE DOOR AND INFILL W/ NEW WINDOW GLAZING

PROTECT BRACE AND STABILIZE WALLS CHIMNEY & ROOF IN PLACE

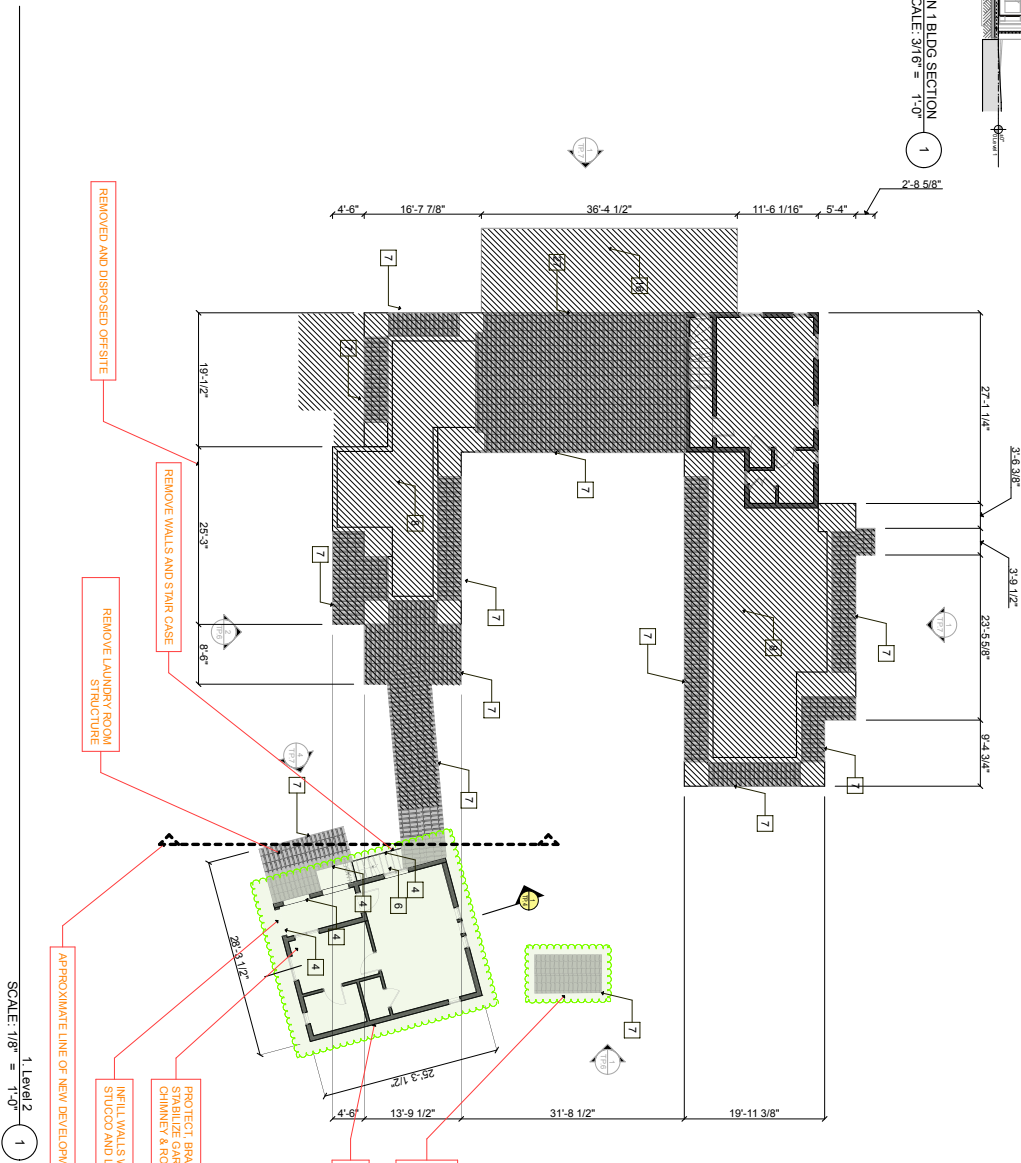
PROTECT BRACE AND STABILIZE ENTRY ROOF STRUCTURE NOTE: "CASA DE LOS AMIGOS" GRAPHIC IS NON-ORIGINAL AND WILL BE REMOVED

REMOVE WALLS AND STAIR CASE

REMOVE LAUNDRY ROOM STRUCTURE

PROTECT BRACE AND STABILIZE BRICK WALLS CHIMNEY & ROOF IN PLACE

INFILL WALLS WITH IN-KIND STUCCO AND LEAVE REVEAL

PROTECT BRACE AND STABILIZE IN PLACE & RESTORE EXISTING STUCCO
