V. DRAINAGE ANALYSIS

5.2 *Drainage Deficiencies*

District 3 Sidewalk Study - Phase III

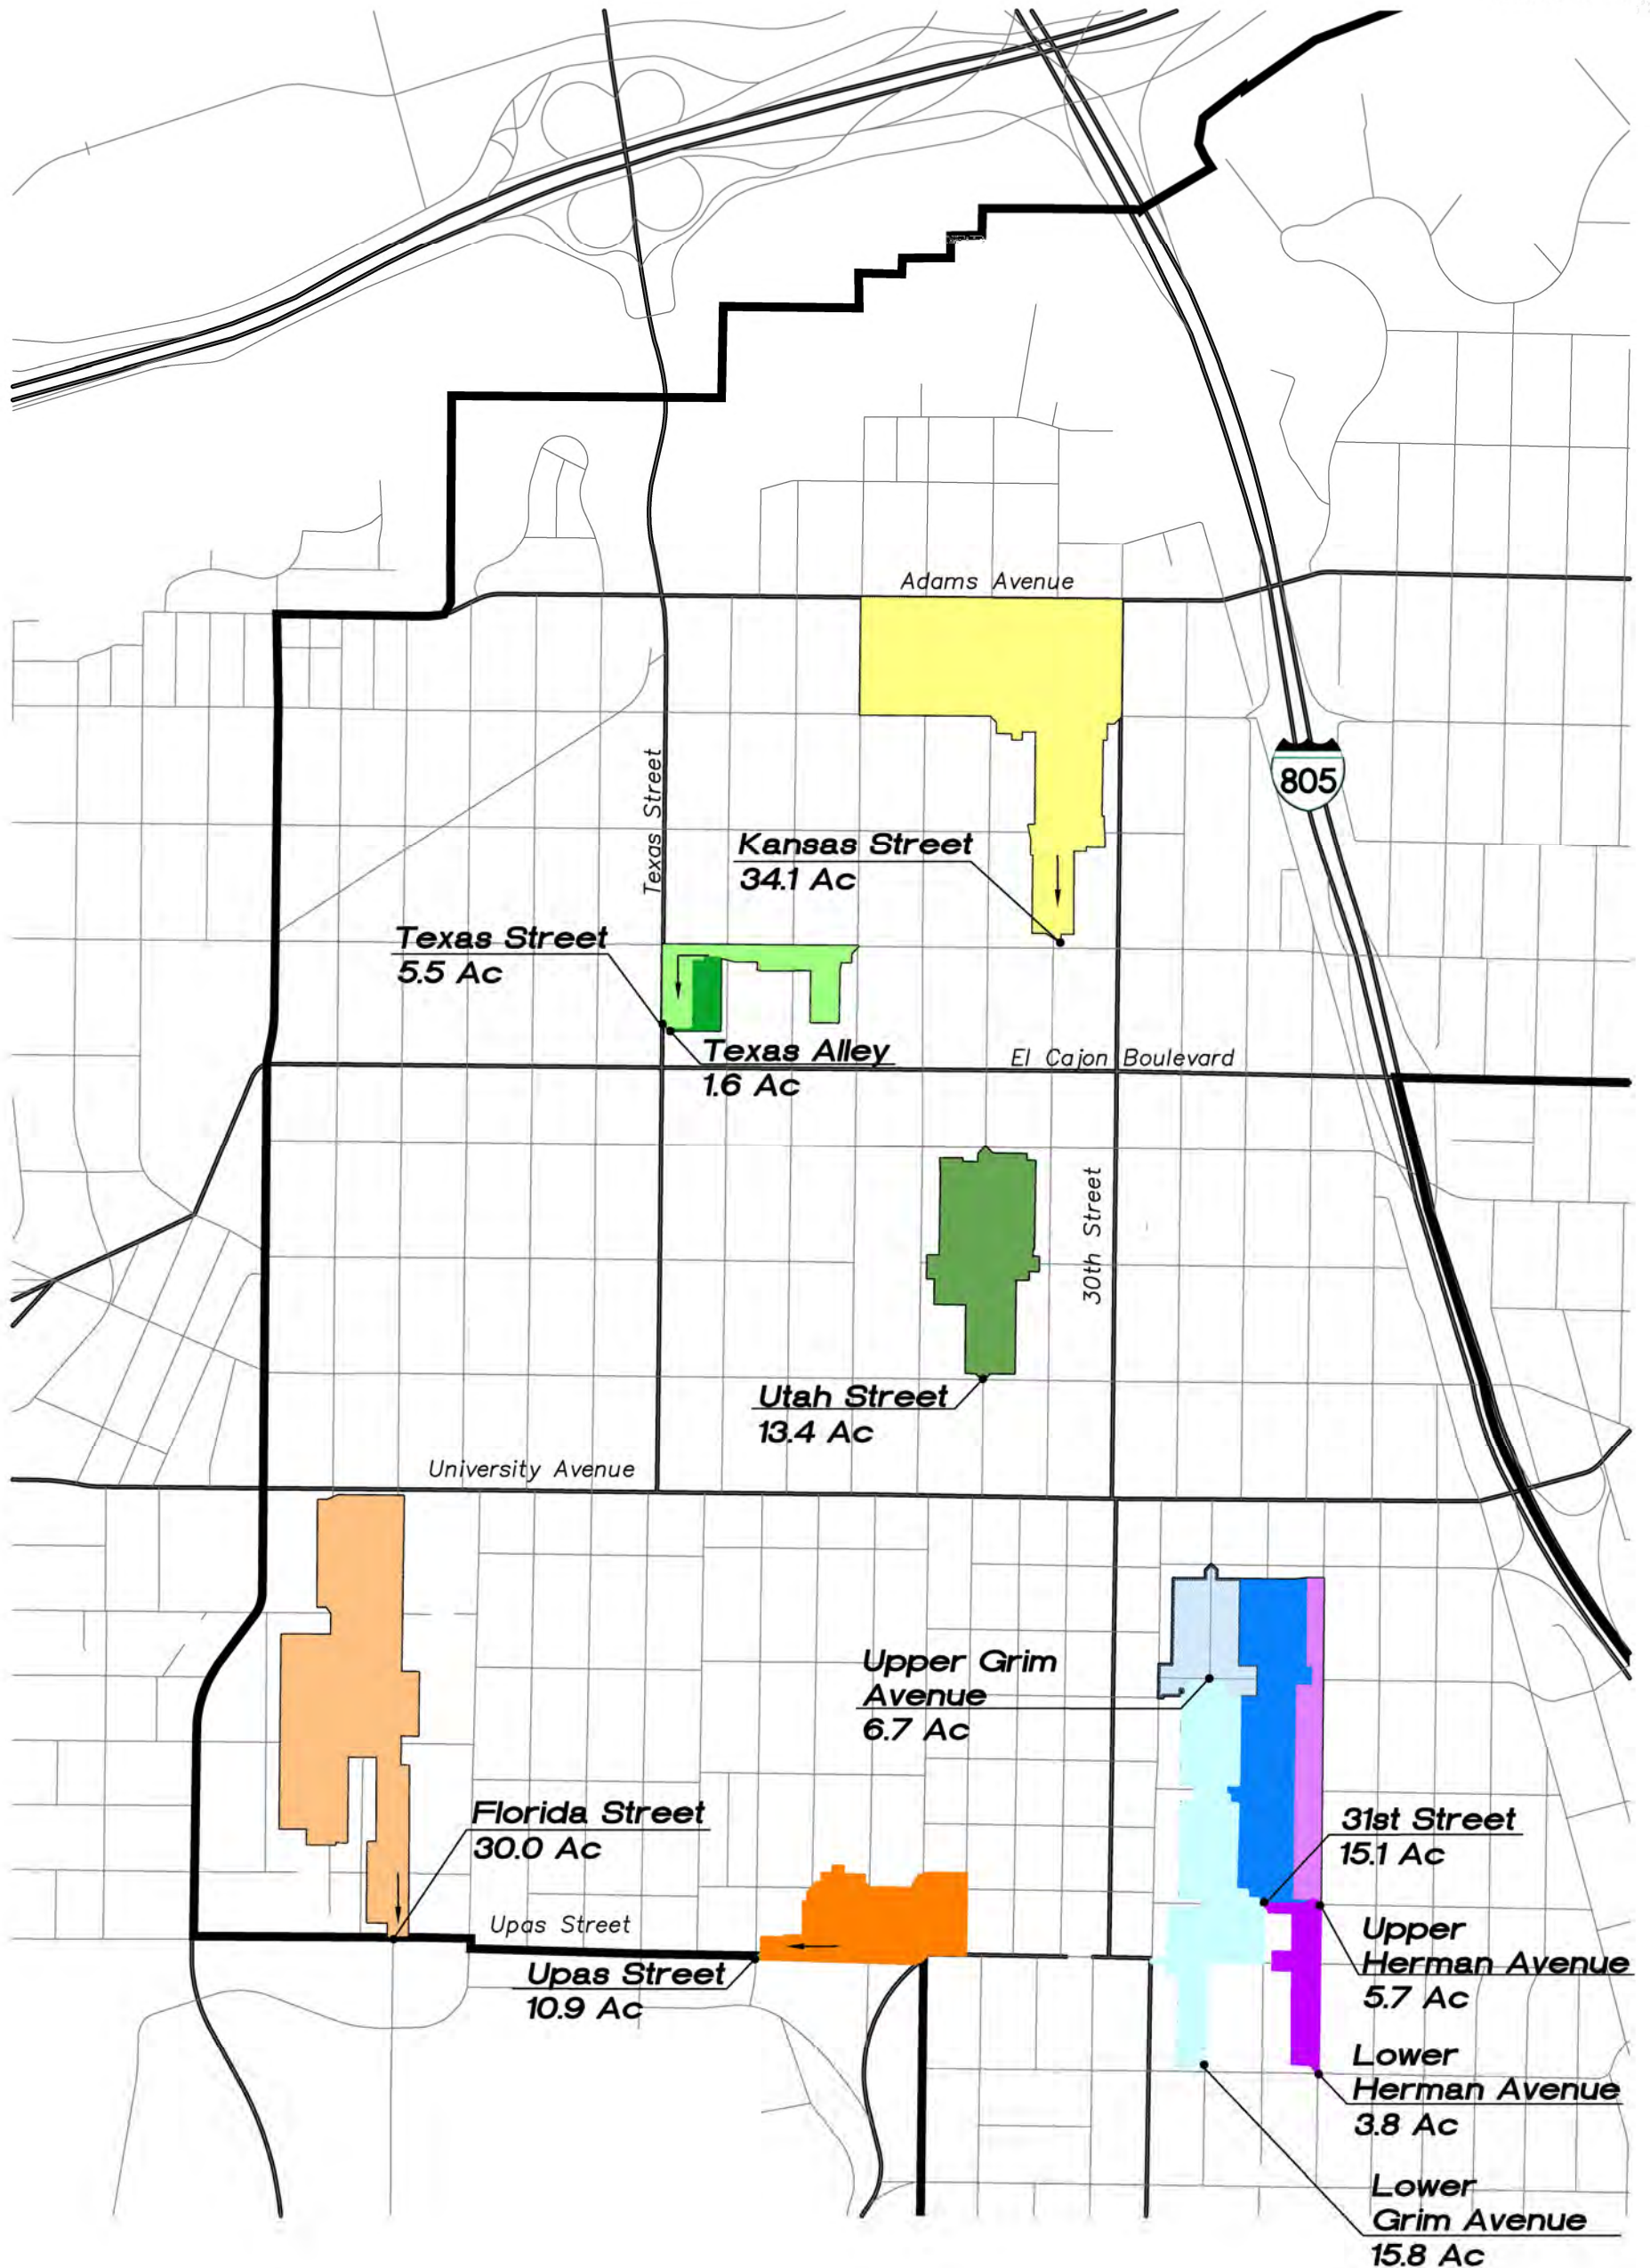
A number of blocks were found to serve unusually large drainage basins. These are shown on **Figure 2**, Major Drainage Basins. In almost every case, the very large watersheds have been the subject of citizen complaints regarding storm water. A few of these blocks have substantial slopes and some have even been constructed essentially as concrete channels, so the large watersheds don't necessarily result in substandard sidewalk conditions. For example, Florida Street (Block NP49) and Eugene Street (Block NH99) are both paved with concrete and have a swale down the center of the street rather than the typical crown, so that they function as channels. Although these conditions do not directly impact sidewalks, they still impair pedestrian movement since the deep rushing water in the center of such streets would be difficult for pedestrians to cross.

The most severely impacted blocks are those serving the very large watersheds, as shown on Figure 2. The runoff in those areas cannot be contained within the street section, and in most cases even a one-year storm exceeds the street capacity. Furthermore, in the most severely overloaded locations, even raising the curbs to full 6 inch height will not provide sufficient capacity. **Table 5-3** provides a comparison of the carrying capacity of these streets and their estimated 1 year and 50 year flow rates.

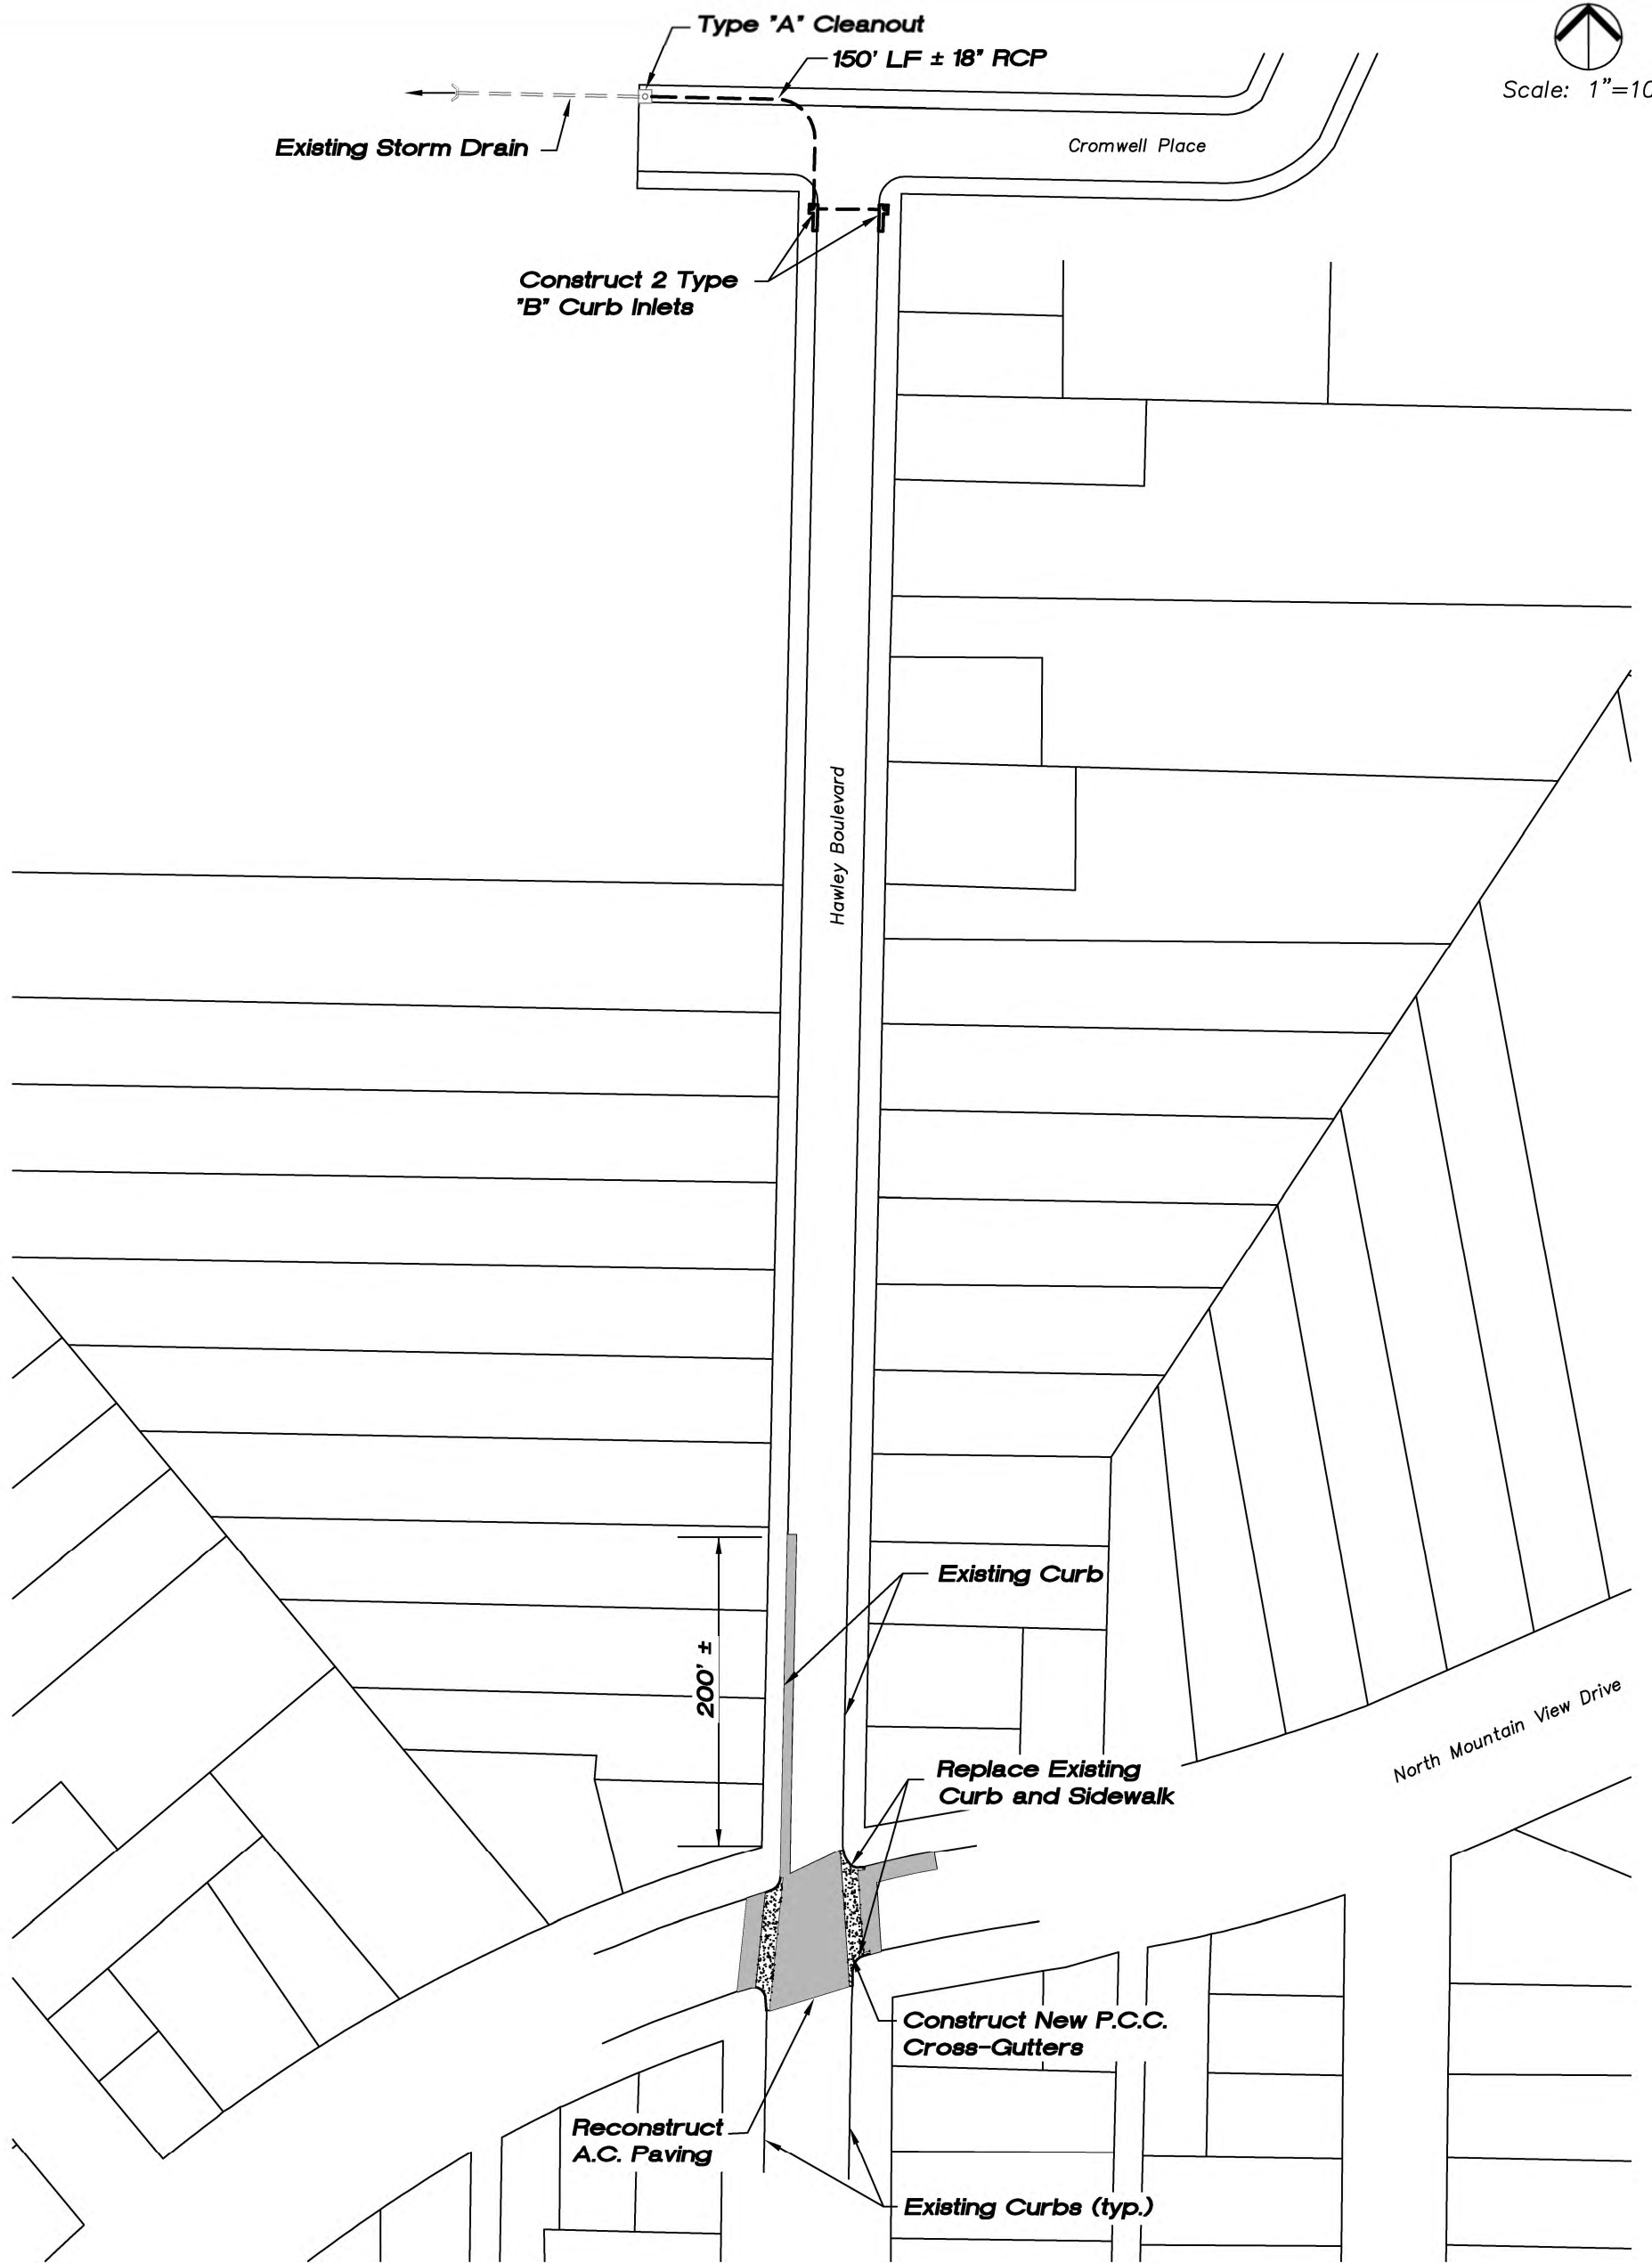
The intersection of Hawley Blvd. and North Mountain View Drive was identified by the Normal Heights Community Association as having an especially severe chronic drainage problem. The intersection is equipped with non-standard “pass-through” drainage tubes at all four curb returns. These do not appear to provide any useful function since they are below the elevations of the adjacent gutters and partially plugged. KHA performed field surveys which revealed that some of the street pavement is actually above the adjacent sidewalk and residential property.

In addition, the adjacent streets lie at near-zero slopes. Some of the existing top-of-curb elevations near the curb returns were found to be at essentially the same elevation as the gutters 100 feet north of the intersection, indicating that positive surface drainage is not achievable under normal design standards. Also, the crowned centerline of North Mountain View Drive is higher than the sidewalks at the two southerly curb returns. Thus, the road essentially forms a dam that causes persistent flooding of the sidewalks and adjacent yards at the two south corners.

From an examination of the surrounding topography, it appears that this intersection was historically intended to drain toward the north. This drainage pattern was probably never well developed due to flat terrain, and years of repaving projects have added to the deficiency.

The proposed improvement project consists of constructing new concrete cross gutters in a north-south direction across the intersection on both sides of Hawley Blvd. A strip of pavement would be removed and replaced along the sides of Hawley Blvd. and within the intersection to obtain positive drainage toward the north. It does not appear to be physically possible to achieve the City’s usual standard gutter slope of 0.6% in this location. It will be necessary to accept much flatter slopes and there is some possibility that minor ponding may occur along the north leg of Hawley Blvd. even after construction. However, this would be minor in nature and typically would not impact the ability of pedestrians to cross all four legs of the intersection, unlike the existing condition.

Because the project will re-establish the historic pattern of drainage toward the north, provisions should be made for intercepting this runoff at the north end of Hawley Blvd. (within Cromwell Place). This cul-de-sac is served by a pair of outlets, one at each end of the cul-de-sac. In addition, the two curb returns are equipped with non-standard “pass-through” drainage tubes similar to the ones that exist at North Mountain View Drive. The drainage tubes appear to provide little or no useful function. The proposed improvement at this location consists of new curb inlets at the north end of Hawley Blvd. to capture flows before they enter Cromwell Pl. A pipe would then convey the flows to the existing discharge system.

The proposed improvements are shown on **Figure 3, Hawley/North Mountain View Improvements.**

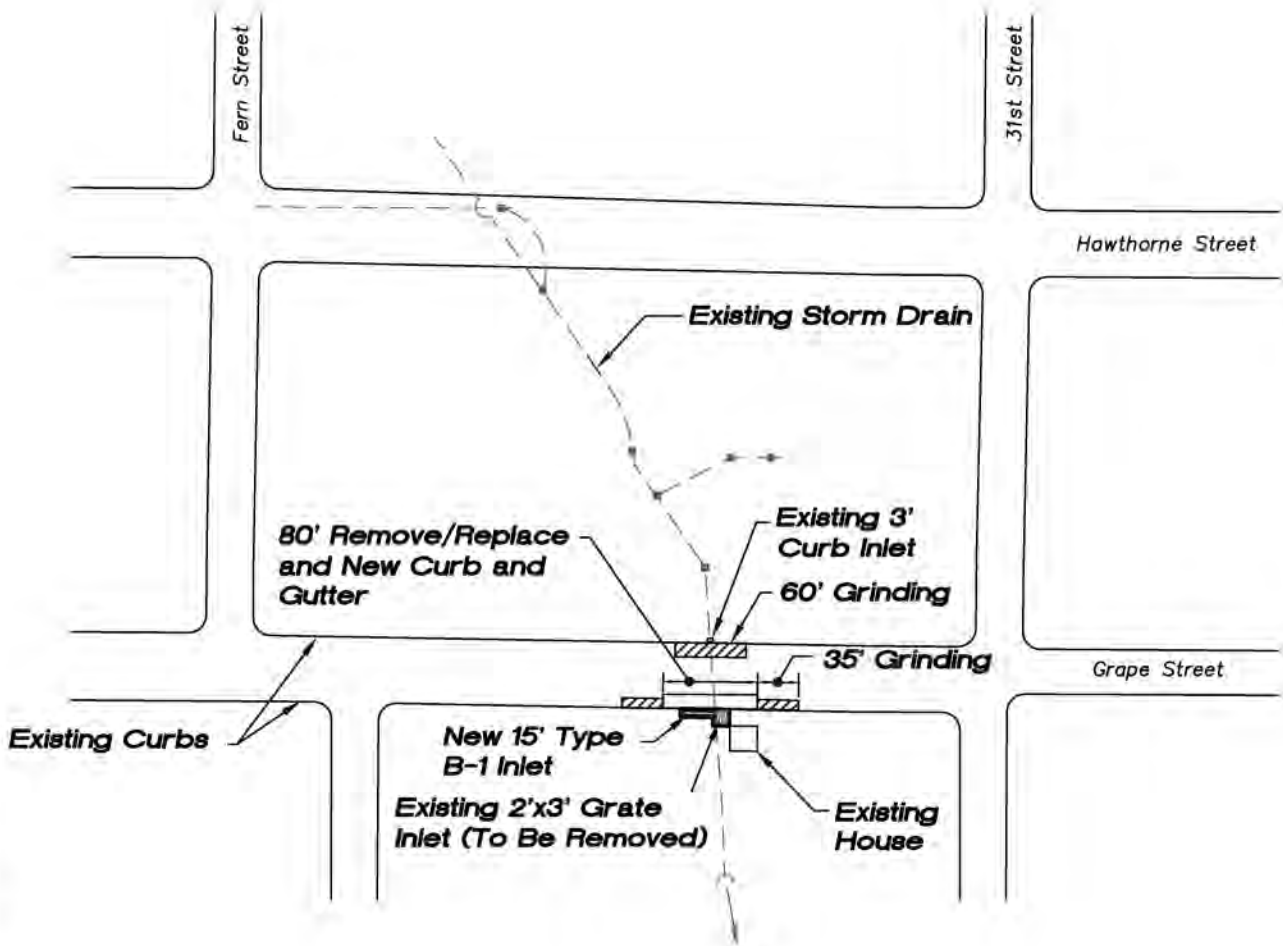
The drainage outlet for Segment SP49 is located at a low point along Grape Street in South Park. This location is in a canyon crossing where the street slopes down steeply from each side. The runoff is collected by curb inlets on both sides of the street which are not large enough to handle large storms without overflowing. Of particular concern is the south side of the street, where there is a near-zero curb height, resulting in probable frequent flooding of the sidewalk. The adjacent residential properties lie below the street, so in addition to the sidewalk flooding, the storm flows also have the potential to impact residences. Fortunately, an existing storm drain pipe is located directly beneath the existing inlets. The recommended improvement consists of enlarging the inlets and, on the south side, grinding the existing pavement to create an adequate gutter and curb height. Because of the potential for residential flooding, this project has been assigned a high level of improvement priority. See **Figure 4, Grape Street Drainage Improvement.**

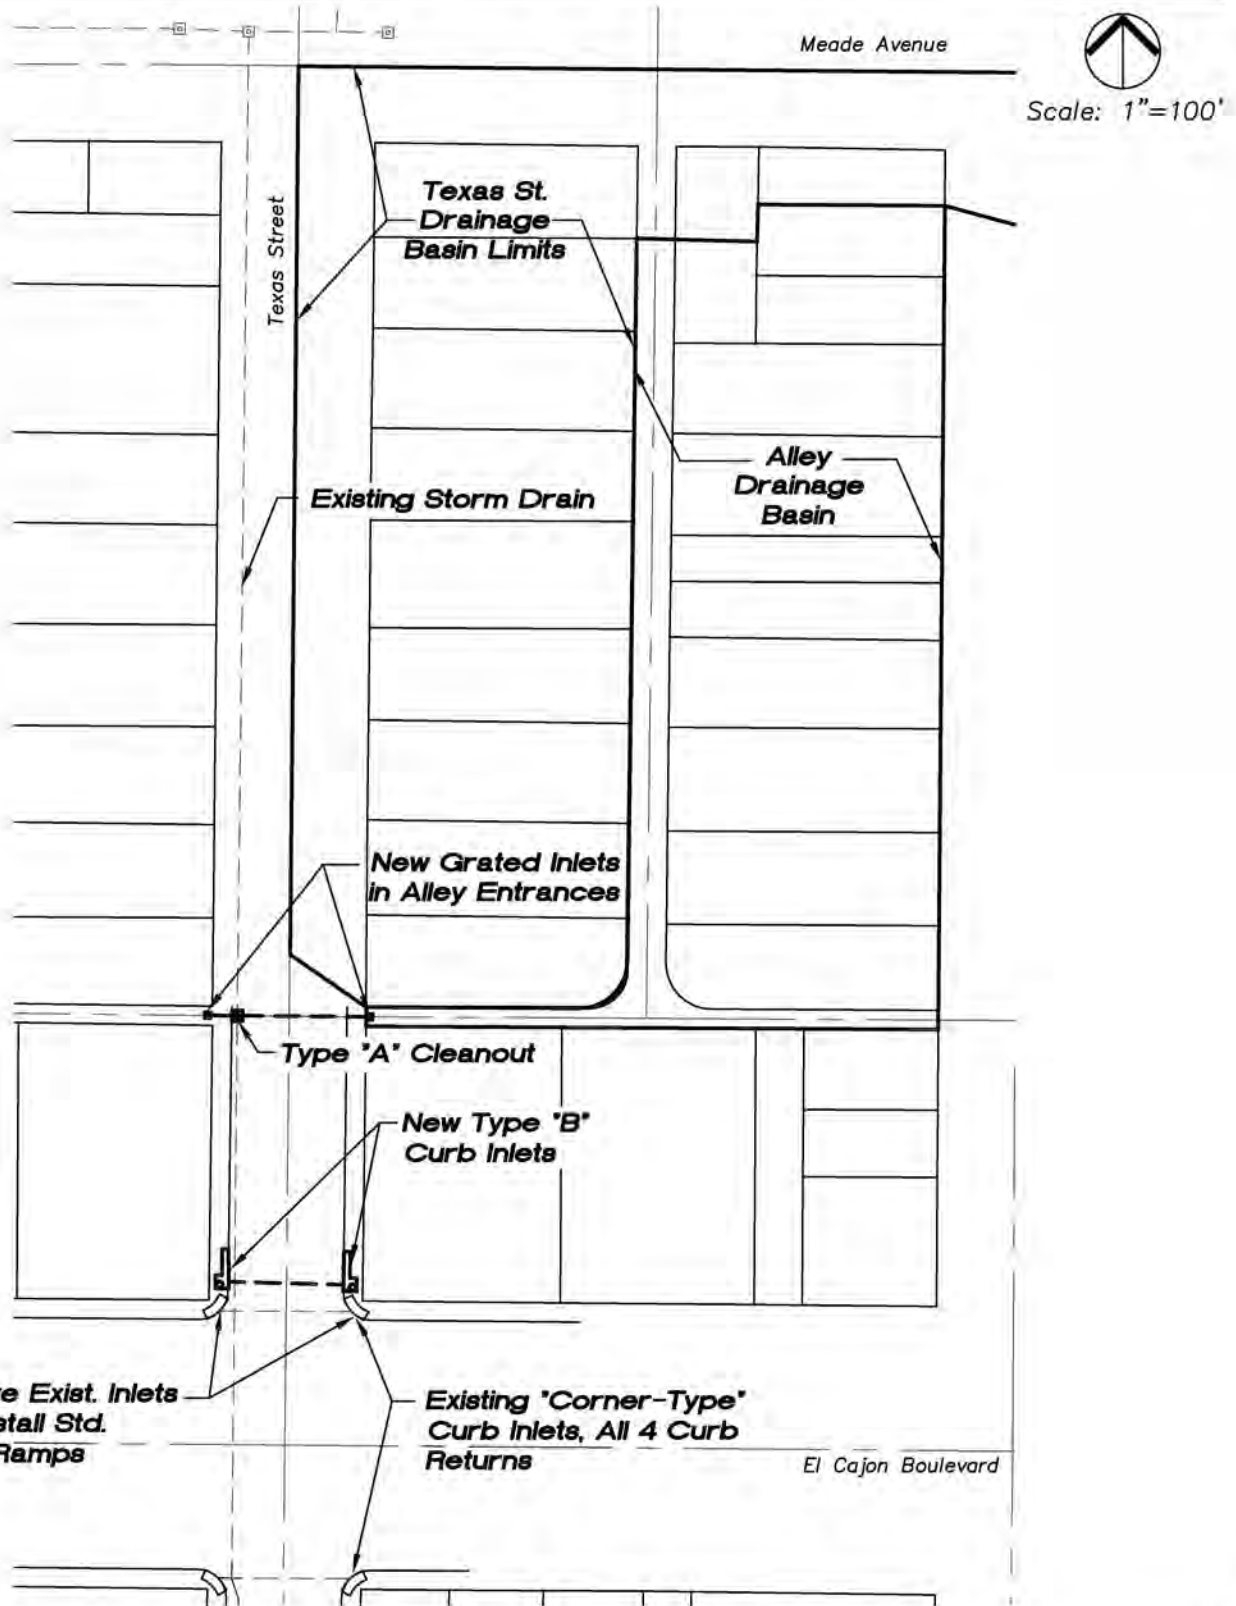
Figure 5

Several unique conditions exist along segment NP92, which is Texas Street just north of El Cajon Blvd. In the mid-block area a pair of alleys enter the street from both sides. These alleys have relatively significant drainage areas of about 1.6 acres. The drainage from these alleys is estimated as 3 cfs for one-year storms, and 7 cfs for 50-year storms. Even the one-year flow from

each alley equals the entire carrying capacity of the substandard gutter along Texas Street, without considering the other flows already being carried in the street. This problem is especially pronounced on the east side, which also serves an upstream basin of 5.5 acres.

On the west side of Texas Street, the upstream flows are not as great, but surface grades are defective, resulting in permanent ponding in the alley entrance which partially blocks pedestrian movement. The City's GIS storm drain mapping indicates a pair of inlets along Meade Avenue just west of Texas, which appear to provide protection to this segment. Field investigation revealed that the inlet on the south side of Meade does not exist, and only a small grated inlet exists on the north side.

Installation of storm drain inlets here could provide two benefits: a curb inlet along the east side of Texas Street could capture the significant upstream flows, reducing the likelihood of flows topping the curb, and a grated inlet in the alley just upstream of the sidewalk could capture the alley flows, so that pedestrians would not need to walk through the stream of runoff from the alley. A connection point for such a system is available about 200 feet away at the intersection of El Cajon Blvd. See **Figure 5, Texas Street Drainage Improvement**.

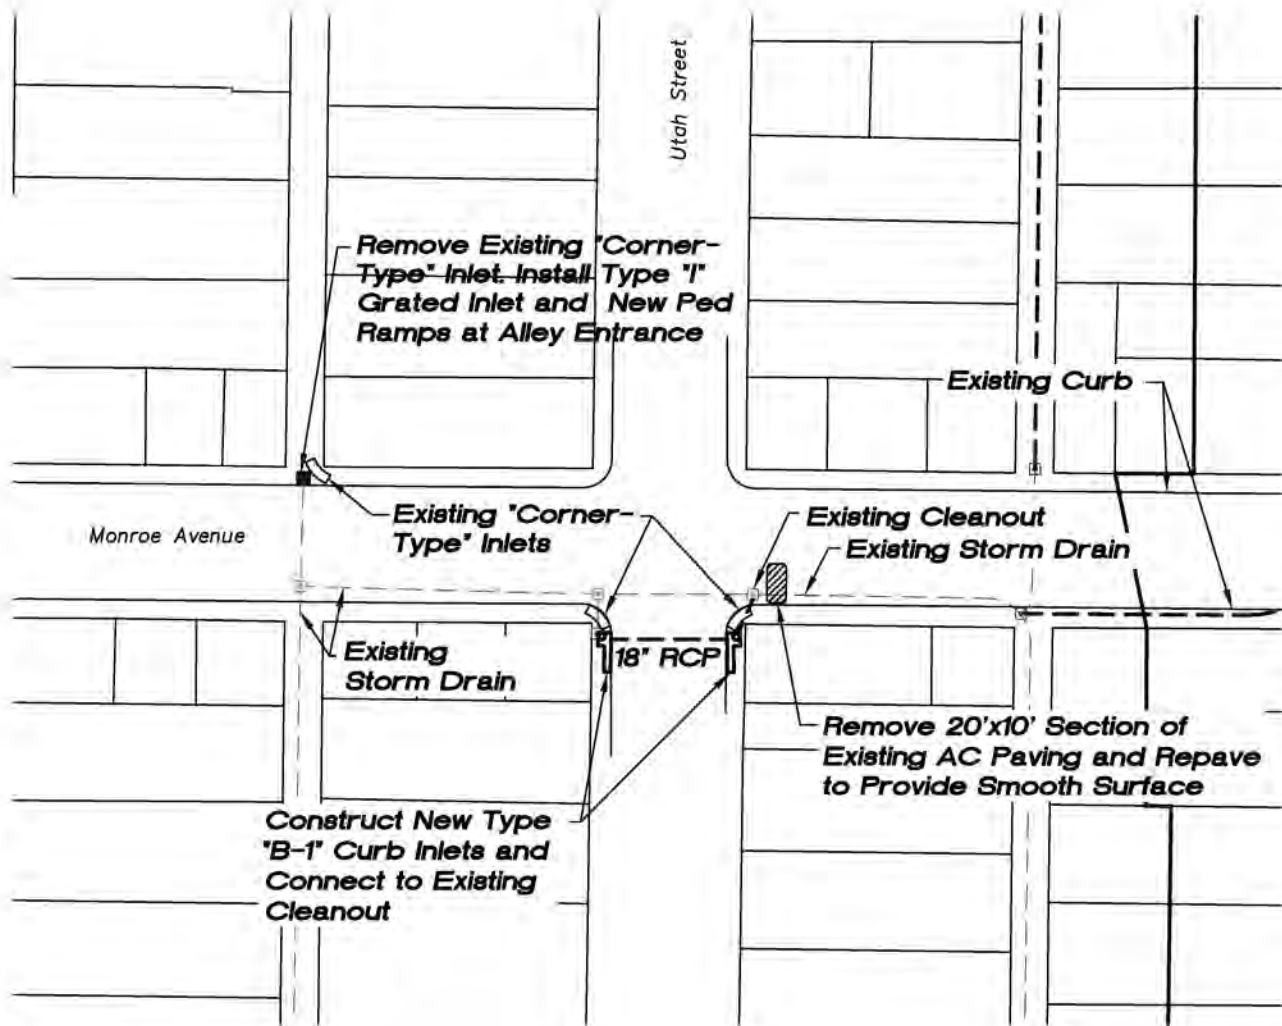
The two southerly curb returns here (west end of segment NP103) are occupied by non-standard “corner-type” curb inlets which preclude construction of curb ramps. The installation of a pair of new Type B curb inlets immediately south of the curb return would allow these older, non-standard inlets to be removed and proper curb ramps to be installed. A severe pavement hump exists near the southeast curb return which does not impact pedestrian movement but does create a poor driving surface for vehicles. This defect could be readily corrected as part of this work. See **Figure 6, Utah Street Drainage Improvement**.

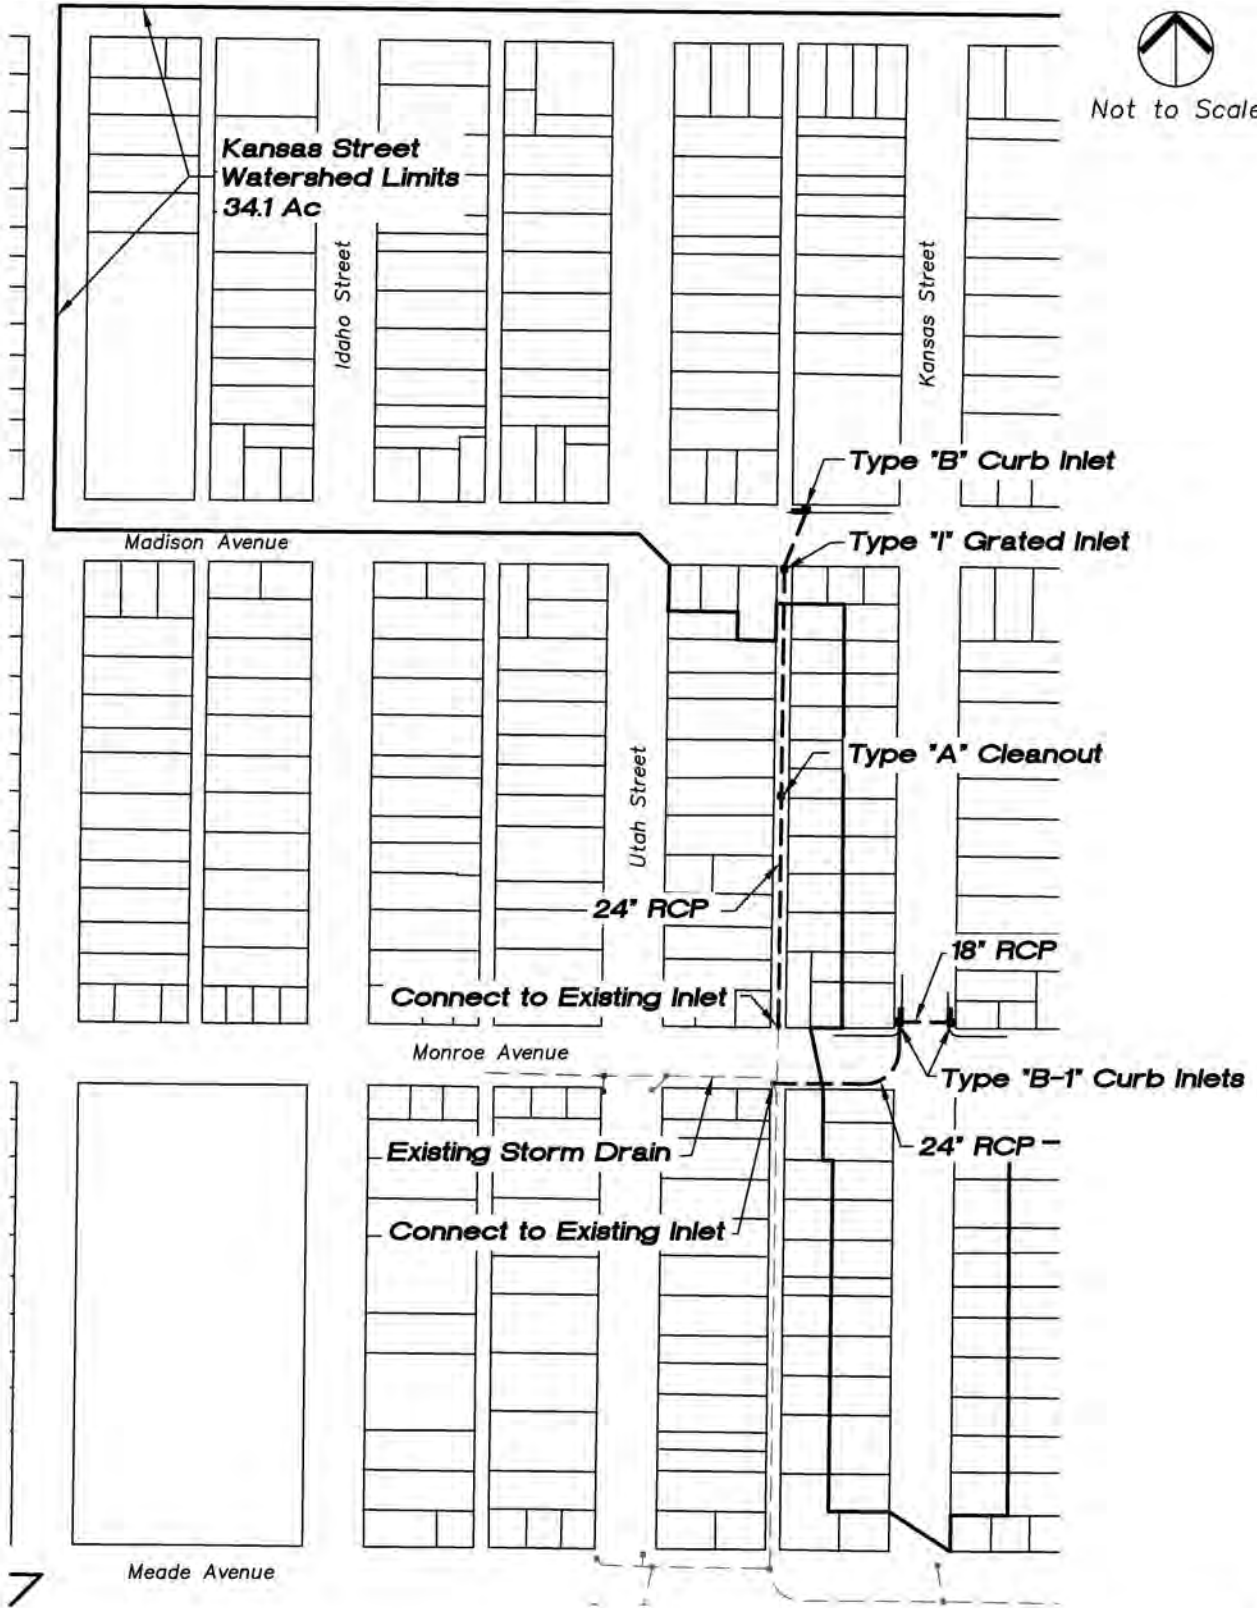
Figure 7

The segment of Kansas Street identified as NP99 drains the largest single drainage basin (34.4 acres) of any segment in the Detailed Study Area. The estimated runoff for even one-year storms is well in excess of the street’s carrying capacity, even if the curbs could be upgraded to full six inch height. In the existing condition, the 50-year runoff rate is about five times the capacity of the street. Furthermore, due to flat grades and limited inlet capacity on the north side of Adams Avenue, the basin may also receive overflow from areas north of Adams.

To resolve these problems, a storm drain extension has been proposed, as shown on **Figure 7, Kansas Street Drainage Improvements**. Because the lack of capacity is so severe at this location, two separate drainage connections are proposed, each of which would capture roughly half of the flows from the basin. However, the two connections will be listed as two separate projects in the list of Improvement Recommendations (Section 8) because if funding were only available to perform part of the work, the shorter and less costly connection provides the greater benefit by intercepting nearly the entire upstream basin.
