**GEOTECHNICAL RECONNAISSANCE
TORREY PINES ROAD REALIGNMENT
SAN DIEGO, CALIFORNIA**

June 4, 2010
Project No. 106843001

Subject: Geotechnical Reconnaissance
Torrey Pines Road Realignment
San Diego, California

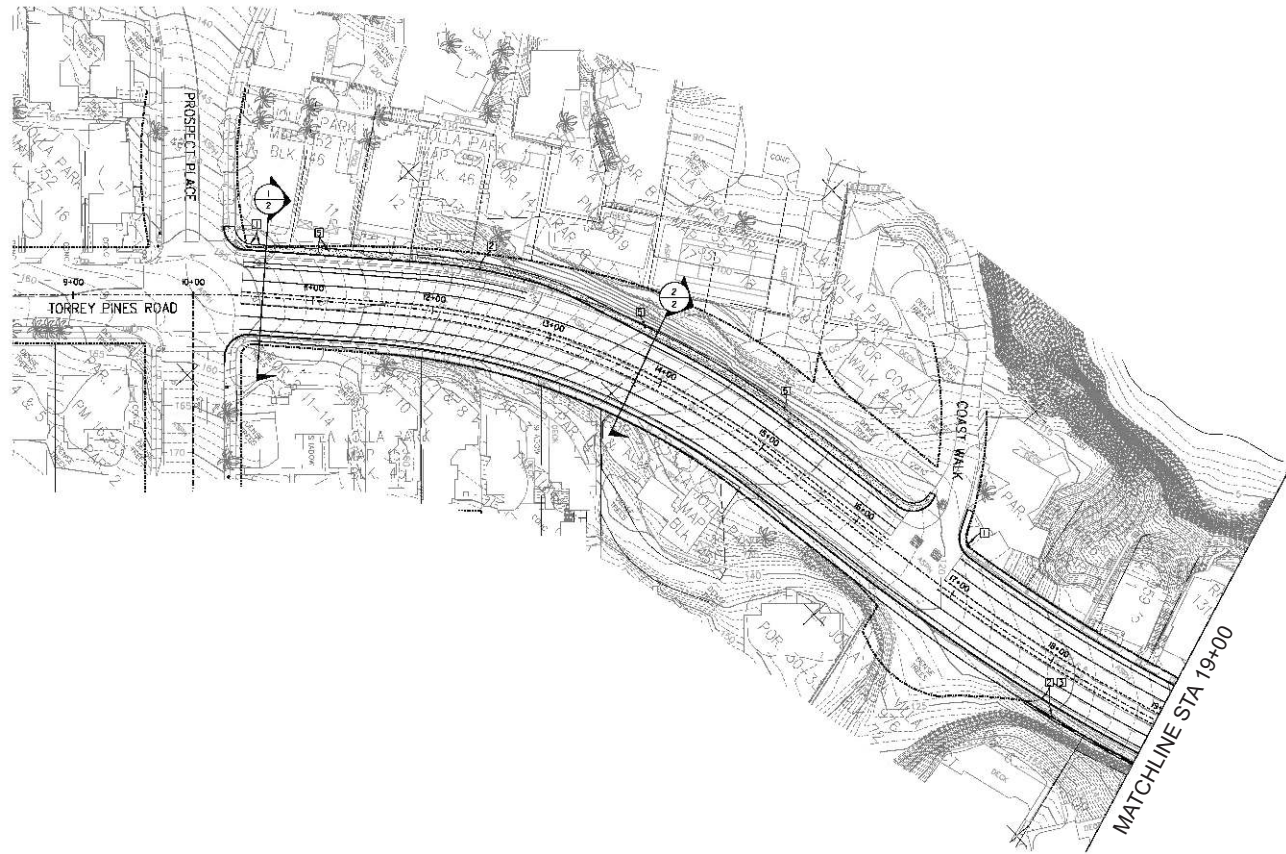
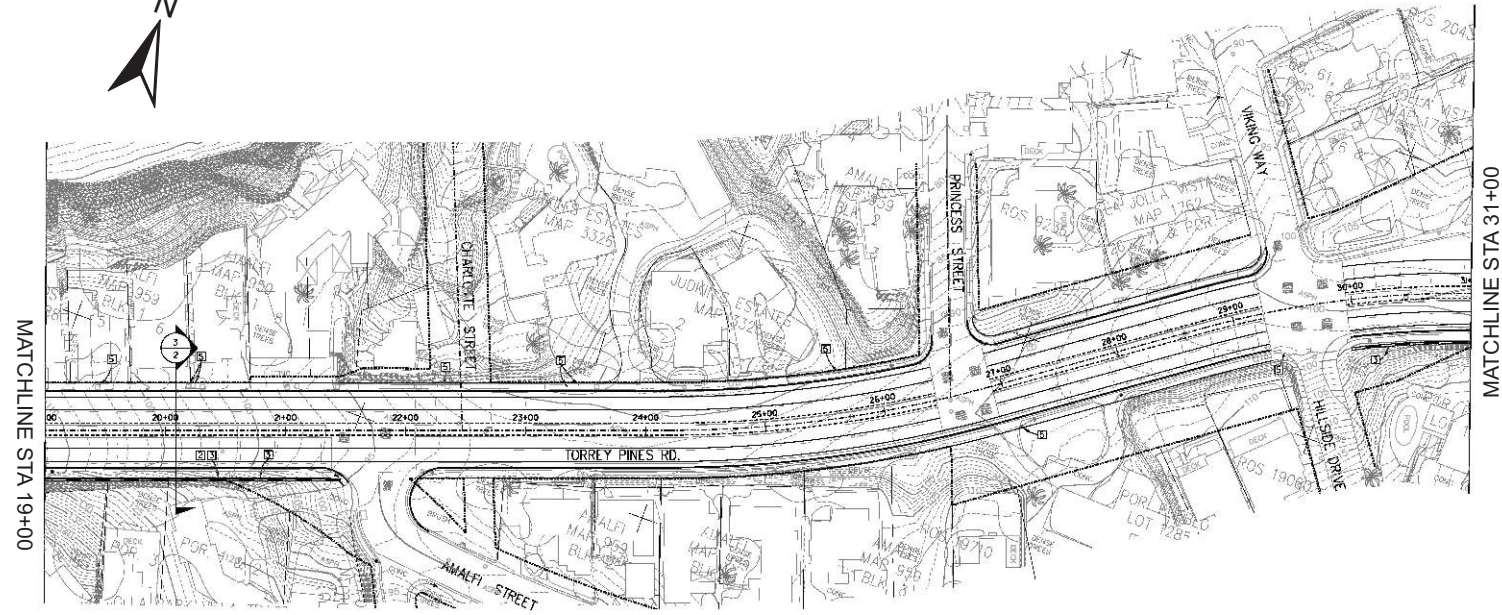
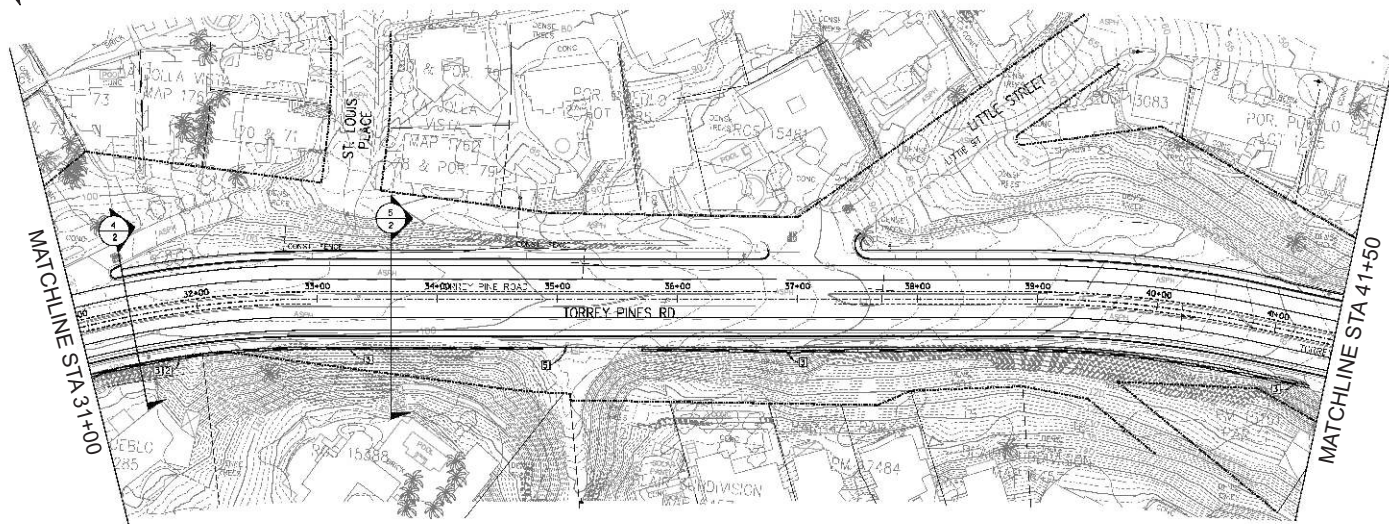
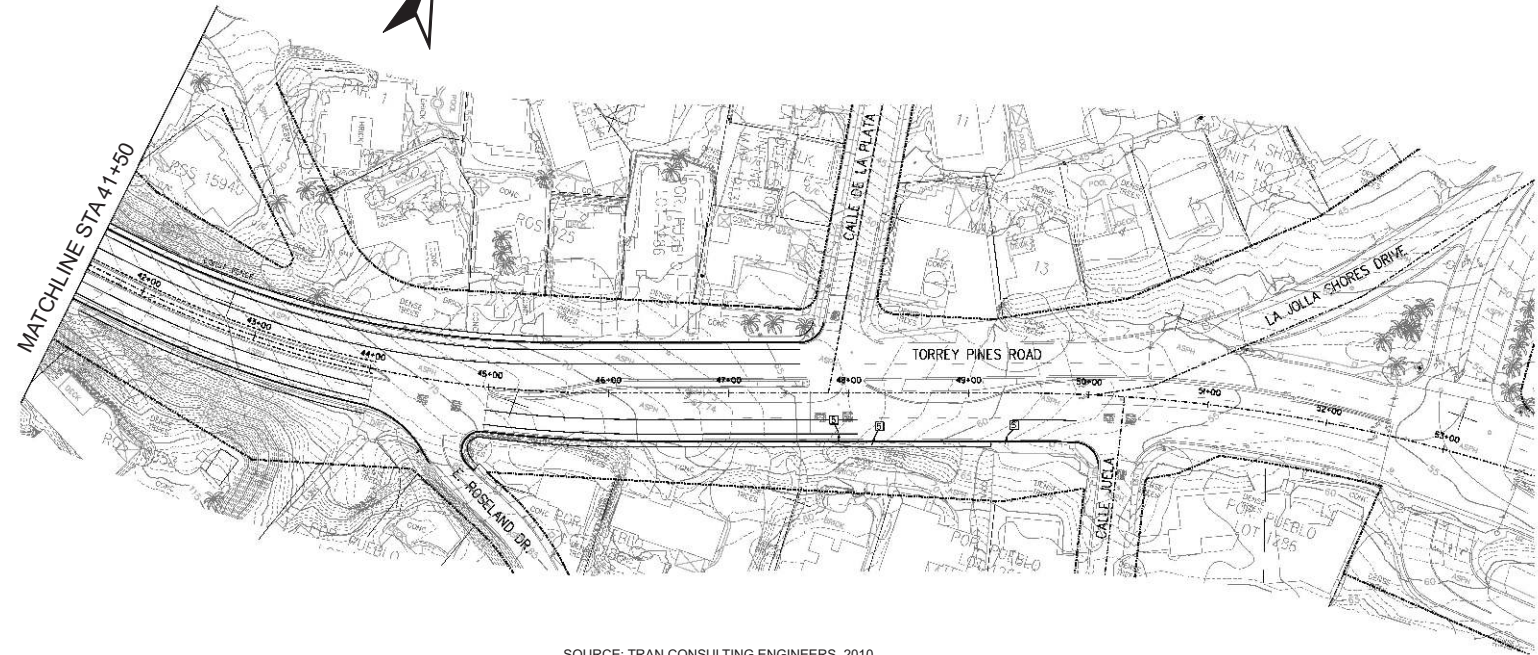
SITE PLAN TORREY PINES ROAD REALIGNMENT SAN DIEGO, CALIFORNIA	FIGURE
			2
PROJECT NO.	DATE		
106843001	6/10

The purpose of the project is to provide continuous sidewalks on both sides of Torrey Pines Road. Retaining walls, soil nail walls, durawalls or other measures are planned along portions of the

alignment west of Amalfi Street, and between Hillside Drive and East Roseland Drive. Relatively minor vertical and lateral changes in the roadbed (less than 3 feet) will be made to Torrey Pines Road.

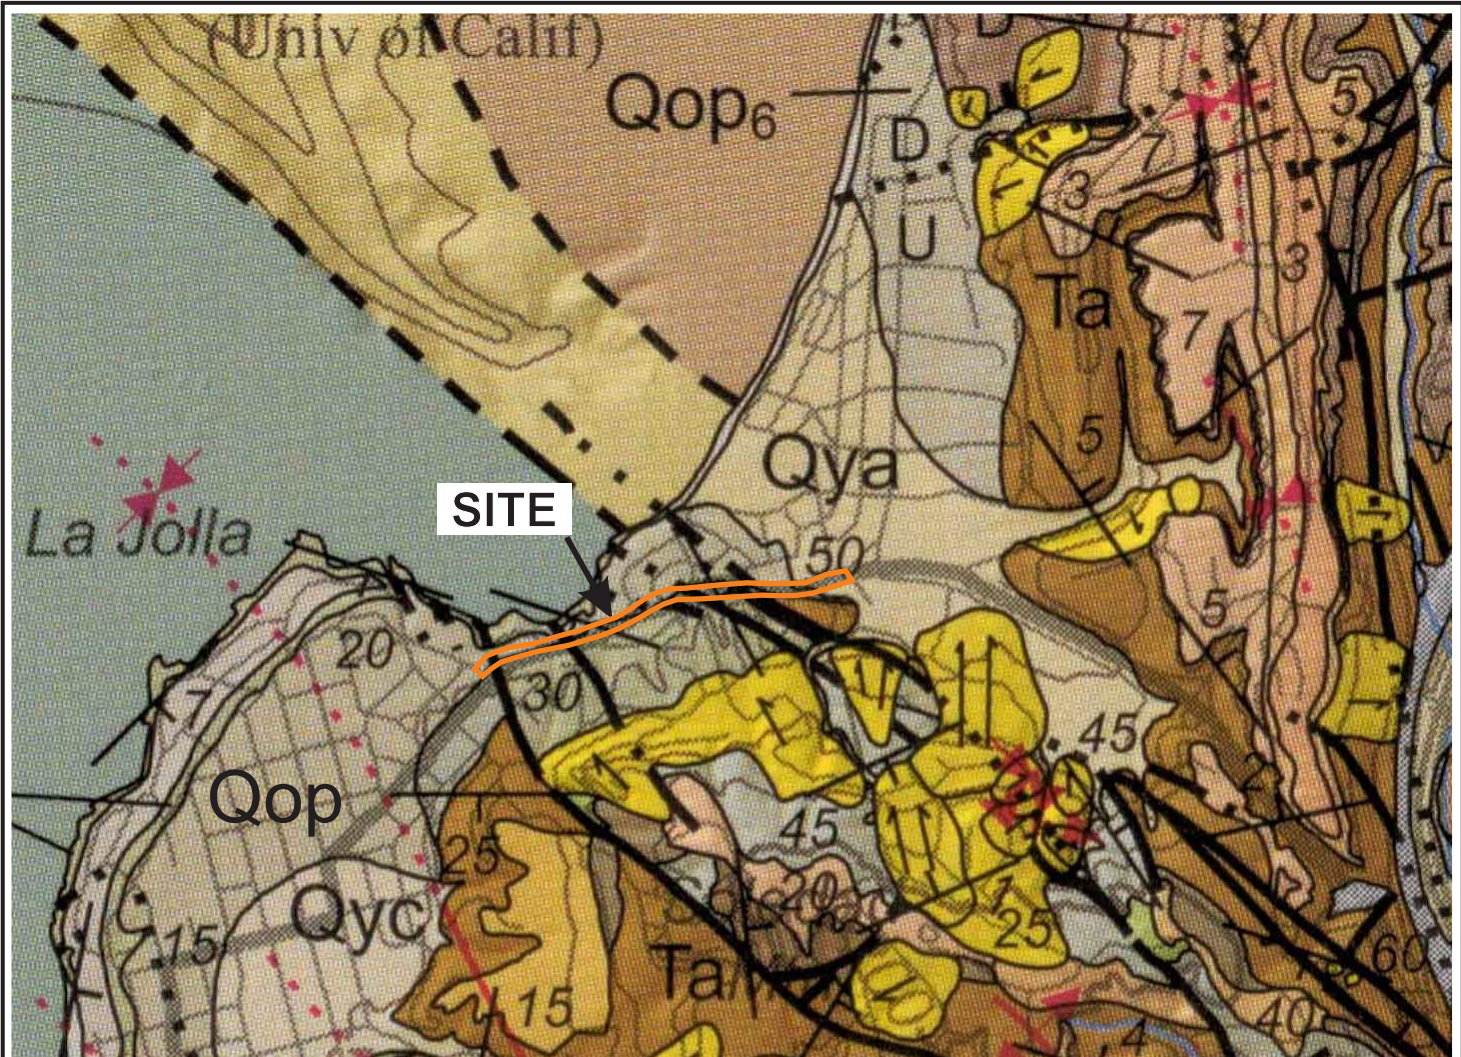
GEOLOGIC MAP TORREY PINES ROAD REALIGNMENT SAN DIEGO, CALIFORNIA	FIGURE
			4
PROJECT NO.	DATE		
106843001	6/10

Based on our literature review of published geologic maps and available geologic reports and our site reconnaissance, the project vicinity is underlain by surficial soils consisting of artificial fill underlain by young alluvium, old paralic deposits (formerly designated Bay Point Formation), the Cabrillo Formation, and the Point Loma Formation. A geologic map is provided as Figure 4. A brief description of these units, as described in the cited literature or as observed on the site, is presented below.

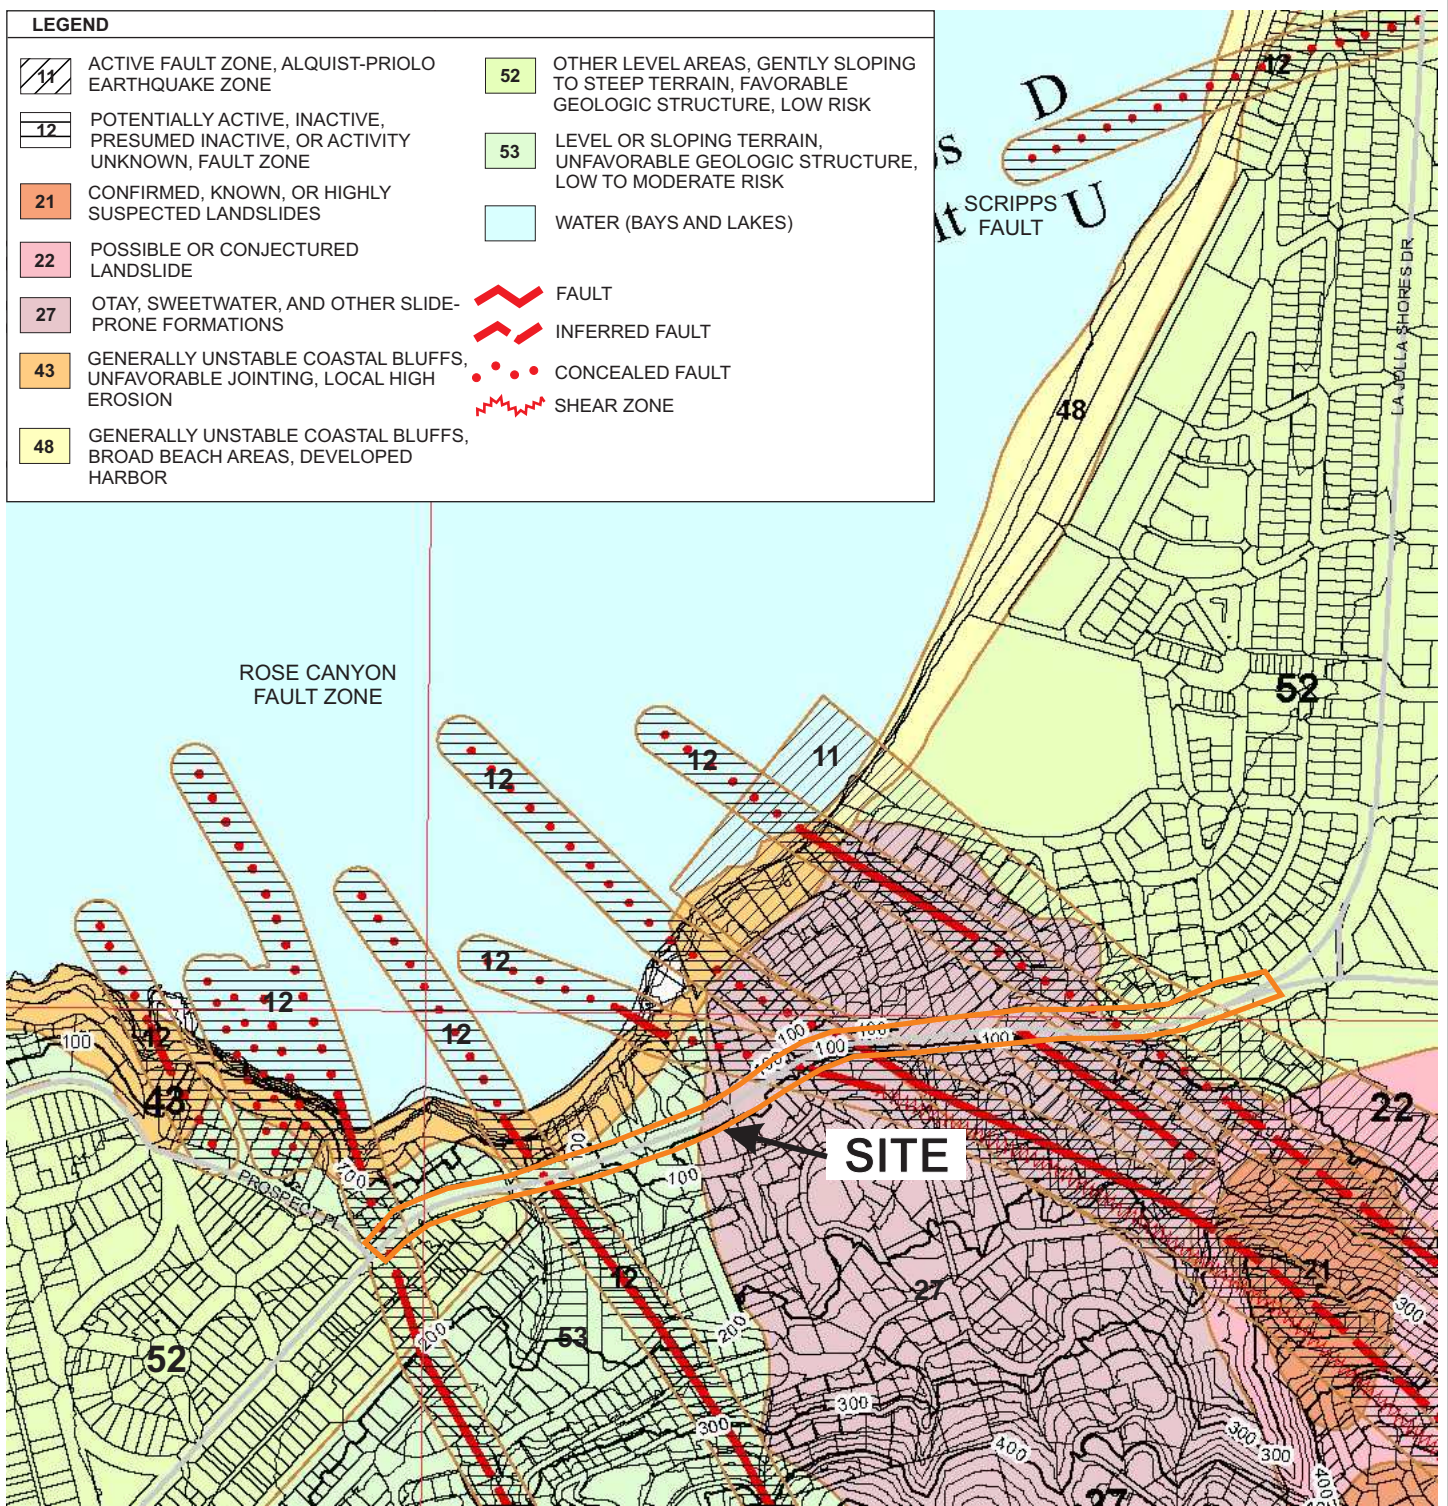
GEOLOGIC HAZARDS MAP

The project site, like the rest of southern California, is considered to be located in a seismically active area. The western portion of the alignment is located within a State of California Earthquake Fault (Alquist-Priolo Special Studies) Zone. In addition, multiple known, inferred, and concealed inactive or potentially active faults are located in the site vicinity. The approximate locations are shown on Figure 5.

We have included as Figure 5 a portion of Sheet 29 of the City of San Diego Seismic Safety Study that includes the site. The hazard map indicates the mapped location of known or suspected faults and landslides and areas of potentially unfavorable geologic structure relative to slope stability. The hazard map indicates that the Alquist-Priolo earthquake fault zone for the Active Rose Canyon fault crosses the eastern portion of the alignment. The active strand of the Rose Canyon fault crosses the alignment at approximately Roseland Drive. Multiple strands of the Rose Canyon fault which are classified as potentially active or inactive cross the western portion of the alignment.
