APPENDIX A-1

Channel and Ditch FMPs

Facility Maintenance Plan

Green Valley Creek - Pomerado Facility Group

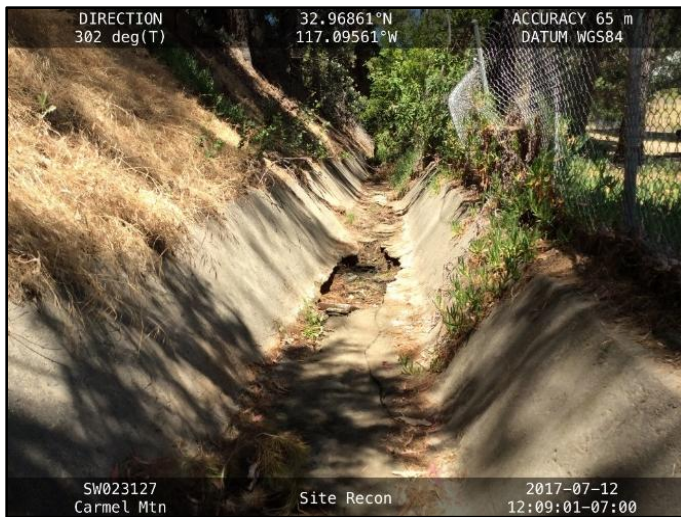
Figure 1: July 2017, photo depicts failure of gunite bottom of ditch, looking upstream

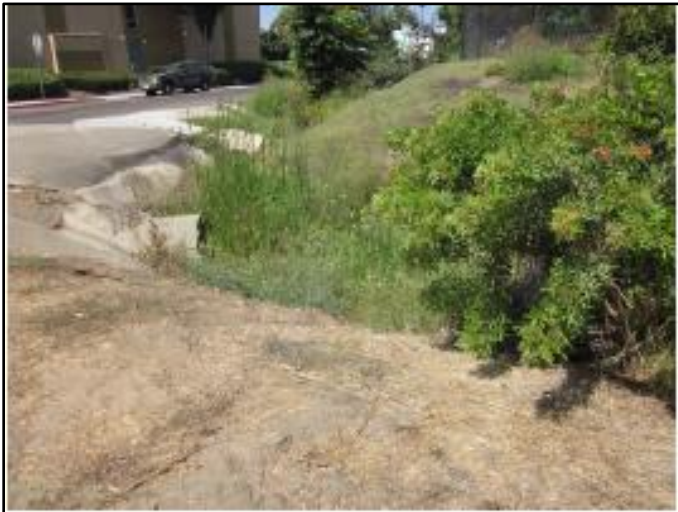
Figure 1: September 2013, downstream end looking east. High vegetation density and growth were observed

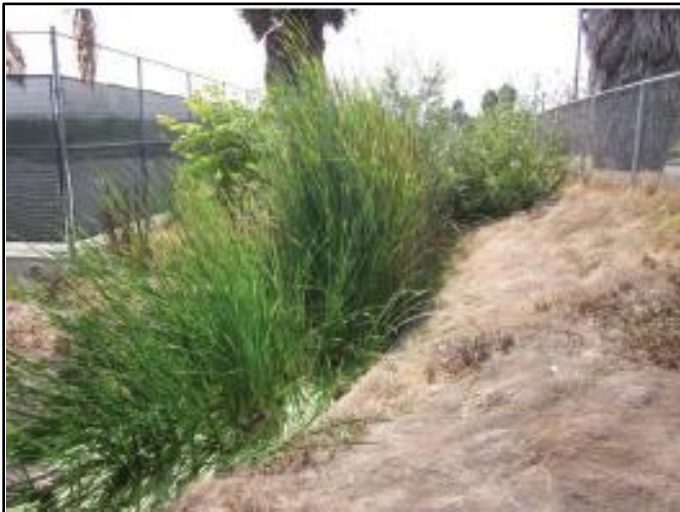
Figure 1: September 2013, at upstream end of segment, just downstream of 27-inch-diameter RCP and headwall. High density of vegetation observed, and concrete ditch is not visible.

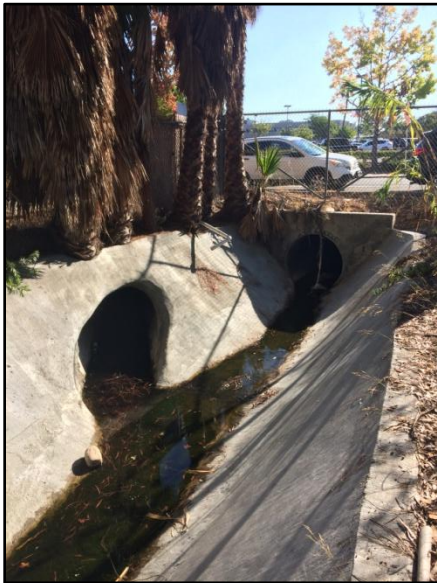
Figure 1: September 2017, facing the upstream end of the segment, at the location of the recent concrete lining repair work
