Facility Maintenance Plan

Green Valley Creek -Pomerado Facility Group

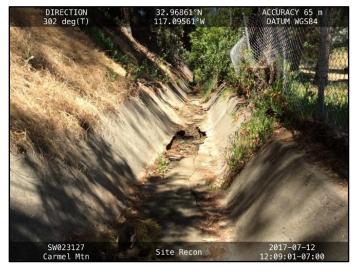
Figure 1: July 2017, photo depicts failure of gunite bottom of ditch, looking upstream

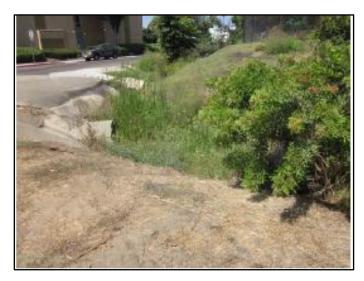
Figure 1: September 2013, downstream end looking east. High vegetation density and growth were observed

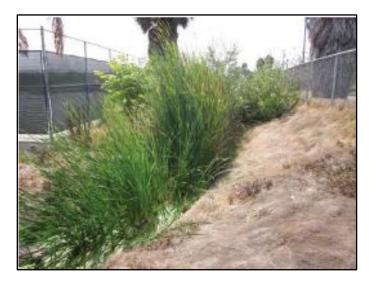
Figure 1: September 2013, at upstream end of segment, just downstream of 27-inch-diameter RCP and headwall. High density of vegetation observed, and concrete ditch is not visible.

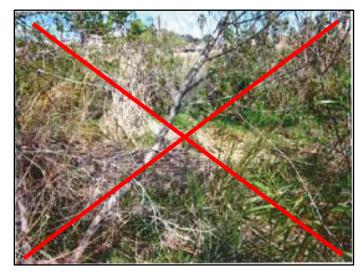
Figure 1: March 2013, looking upstream near area of recommended maintenance
