Facility Maintenance Plan

Washington Canyon Creek - Washington Facility Group

Segment Names (Facility numbers):
Washington 1 (5-02-151)
Washington 2 (5-02-153)

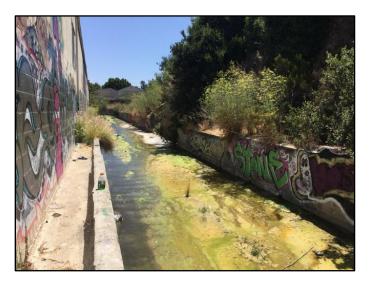
Figure 1: July 2017, looking upstream; missing sidewall and eroded bank at center

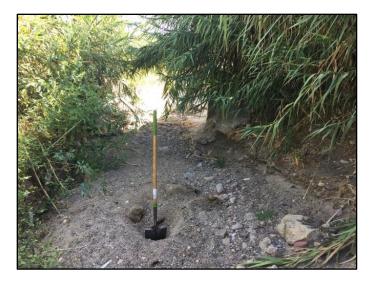
Figure 1: August 2017, looking upstream just after transition from concrete to earthen lining; deep sediment observed

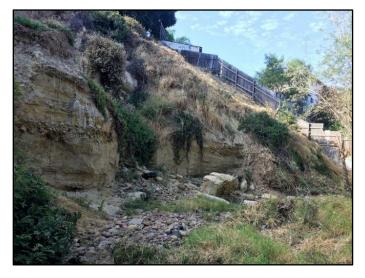
Figure 1: August 2017, looking downstream toward channel bank failure/erosion
